# Shire of Campaspe

## Aquatic Facilities Report

### Asset Review, Condition Summary, Capital Works Program & Recommendations.

January 2018

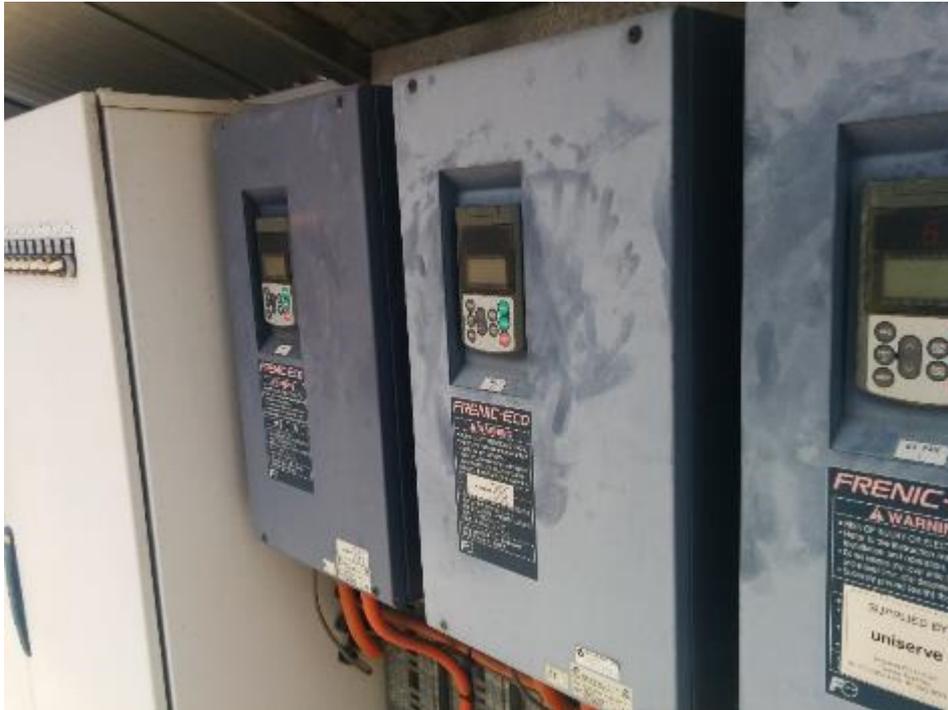
**Control board on the roof northern end of the pool hall**

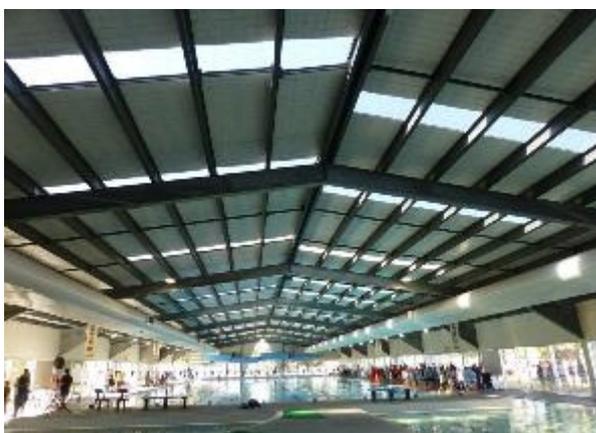
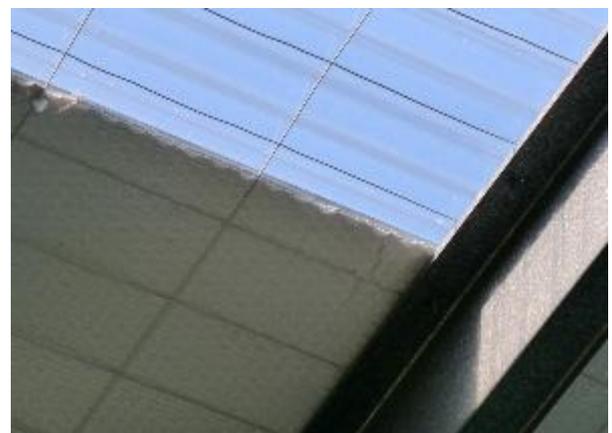
The sky lights are a single polycarbonate sheet offering no heat transmission protection. They need to be upgraded to a sheet suitable for a pool hall that provides condensation and thermal control. This would require removal of the solar matting and ideally should be carried out at the same time as the roof insulation is upgraded.

**Pool hall roof insulation, sky lights and air control duct work**

The underroof insulation is of poor quality that provides a vapour barrier but allows excessive heat loss in winter and excessive heat gain in summer. This should be replaced with a 75mm insulation material to provide some thermal quality. The replacement would involve the removal of the solar matting and roof panels to allow for the installation of the insulation.

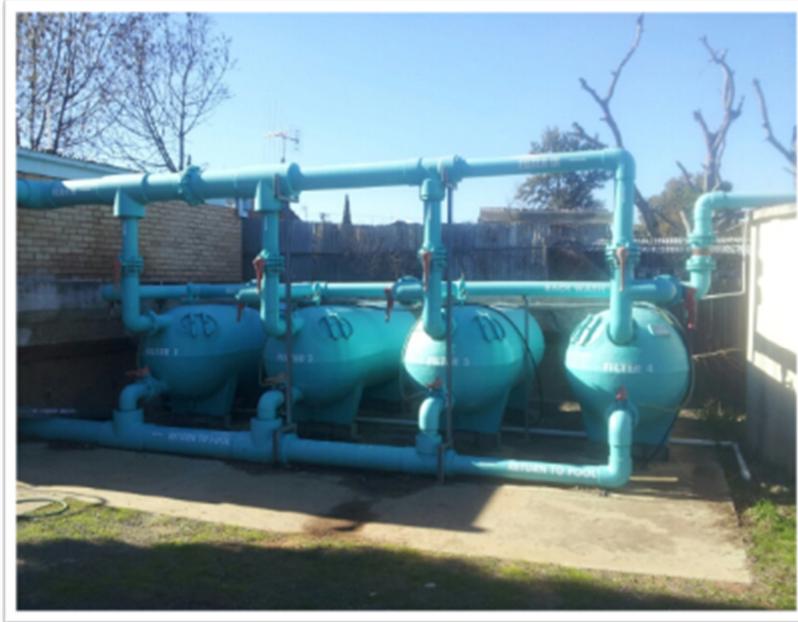
**High volume horizontal sand filters with associated pipework**

Filtering is provided through 4 x Chadson MHS3501 horizontal sand fibreglass filters. They appear fit for purpose and have significant life left. Their life expectancy would benefit from being under cover.

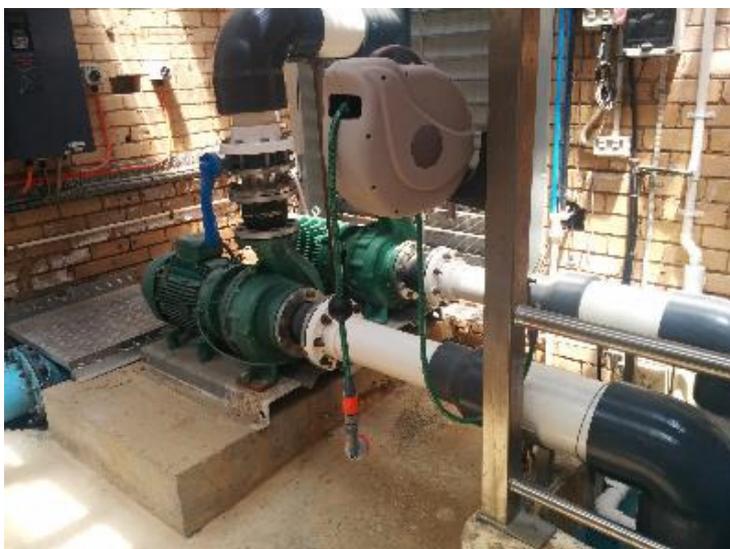
Two Southern Cross Centrifugal motor pump sets with hair/lint strainers are used for the water reticulation in the main/wading pools. These pump sets are in poor condition and not suitable for the application as it would require both pumps running to meet the design performance for filtration and pool water turnover. They should be replaced with appropriately designed units to meet the design performance of the filters.

**2 No. Southern Cross Reticulation pumps**

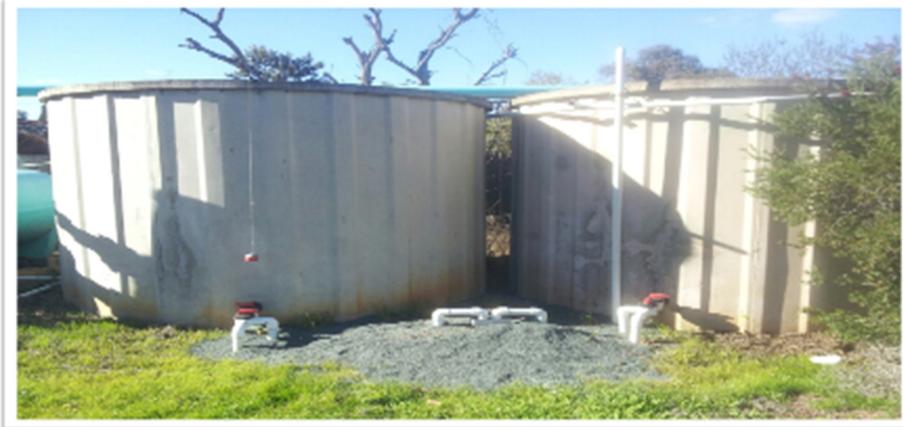
Two concrete tanks with a total capacity of 42,000 litres with pump are provided for the backwash system that is plumbed to sewer. This system is in good condition with the pump requiring periodic maintenance/replacement.

#### **Concrete backwash retention tanks, EWMAC**

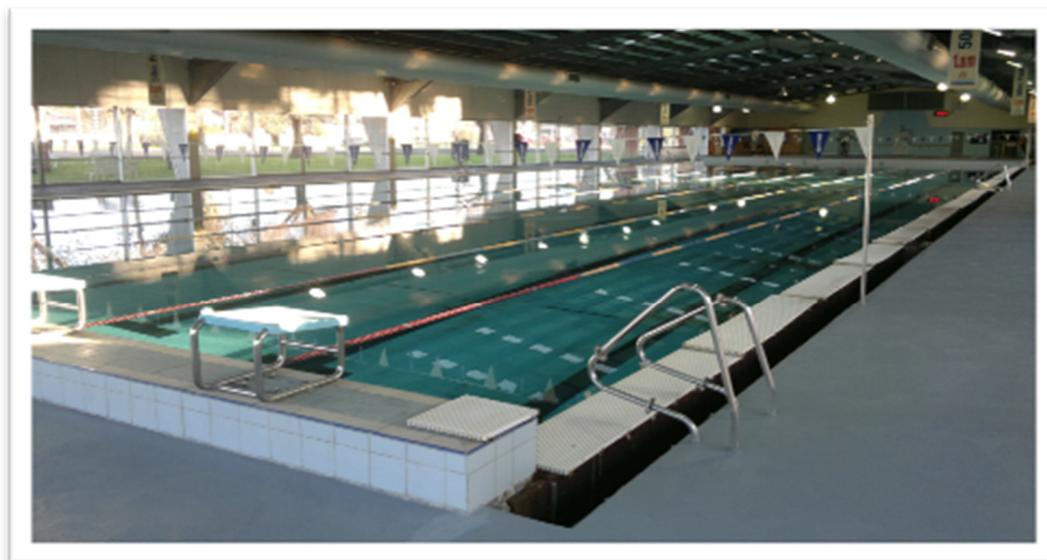
**Main Pool**

The main/wading pool is constructed from reinforced concrete that is painted, i.e. no internal liner. The main pool was constructed in the 1950's and was renovated in 1996 when the site was redeveloped from an outdoor pool to an indoor complex including the addition of the wading pool area. Melbourne Pools & Spa inspected the structure in 2013 and advised that the original structure was renovated to include a wet deck and wading pool. It generally looked in reasonable condition but would require detailed core sampling and reinforcement scanning to determine the quality of the structure. It was last repainted in 2016 and is listed for repaint in 2022/23 on a 7 year cycle.

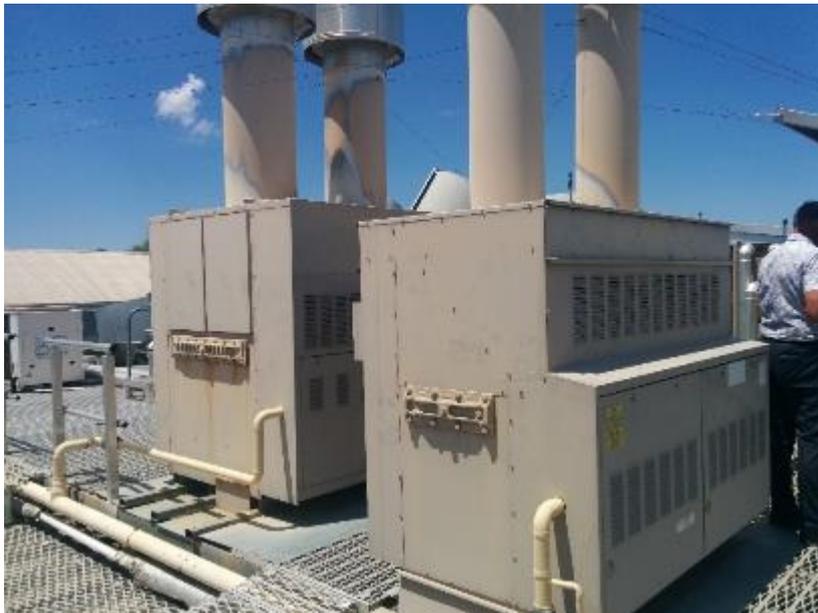
Echuca is an indoor heated pool via 2 gas fired boilers and a solar system set to maintain the pool at approximately 29 degrees. The boilers are located on the roof at the northern end of the pool hall and connected into the reticulation system. Although the boilers appear in reasonable condition no information was available on when they were installed or life expectancy. A special report prepared for council indicated that the gas boilers be replaced with electric heat pumps that would offering significant savings on pool heating costs. It indicated that savings would pay for the changeover in 4 to 5 years.

### LARS Mighty Boilers - EWMAC

It is recommended that the existing gas boilers be programmed for replacement with the more efficient and less costly electric heat pumps.

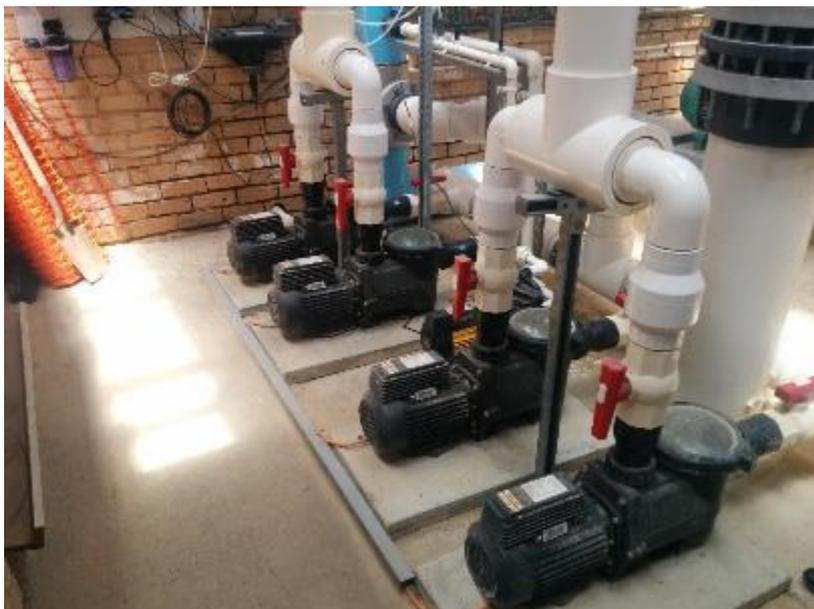
Solar heating comprises 900m<sup>2</sup> of black rubber tube solar heat matting laid on the main pool hall roof. This is connected into the pool water reticulation system via 4 pumps located in the pump shed. This system was installed in 2014. The matting, pumps and pipe work appears to be in very good condition.

#### **4 X Austral Solar pumps in the plant room with reticulation system**

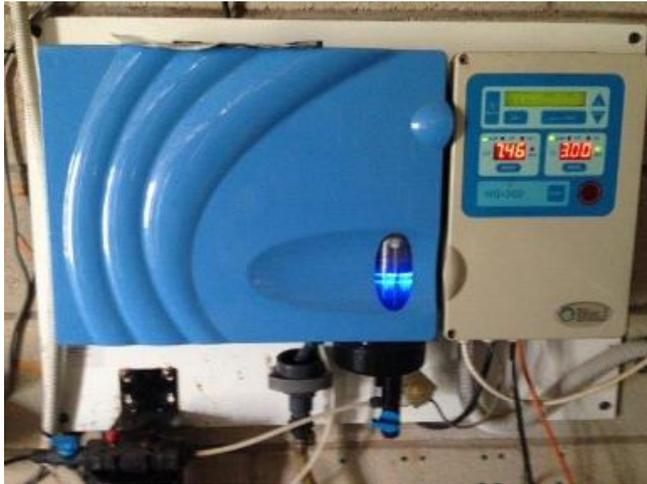
**HG 302 Chemical dosing controller**

The pool runs a chlorine/acid injection system through dosing pumps that are controlled by a Blue Chemical Controller HG302. This system is in good condition with the 2 dosing pumps delivering acid and chlorine requiring periodic maintenance/replacement.

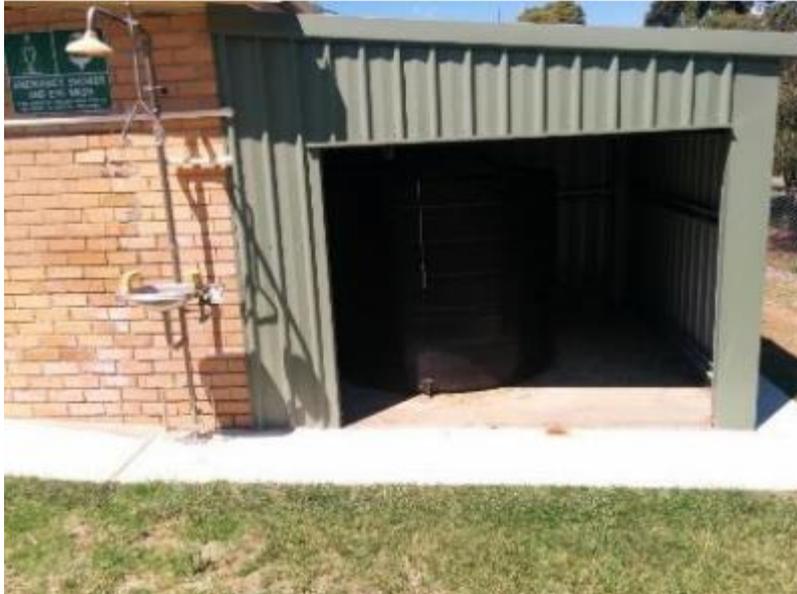
Dry chemicals are stored on 2 bunded plastic pallets in a new colour bond shed. This is a new structure in very good condition. Appropriate eye/body wash shower is in place and appears in good condition.

### **Sodium Hypochlorite Shed and Tank, Rushworth**

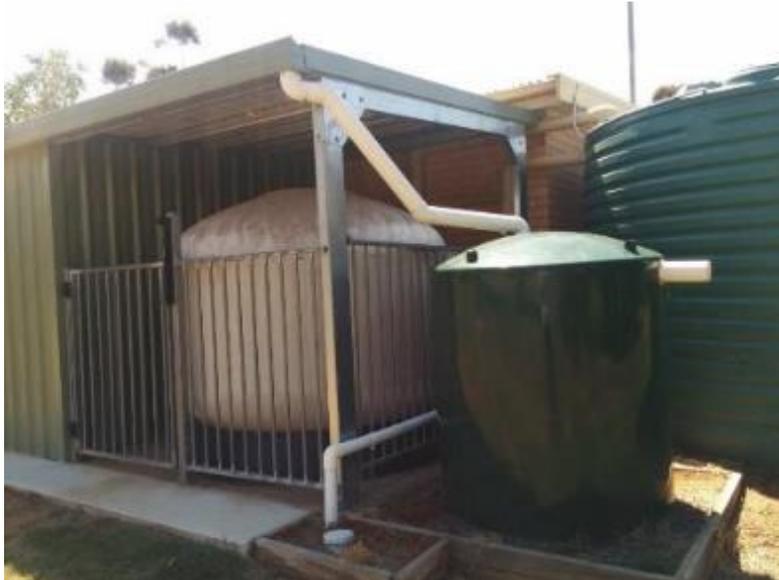
### **Filter & weather protection structure with small rainwater tank (front) & backwash tank**

A 13,500litre plastic rain water tank with pump is provided for the backwash system that is plumbed to sewer. This is in good condition with the pump requiring periodic maintenance/replacement.

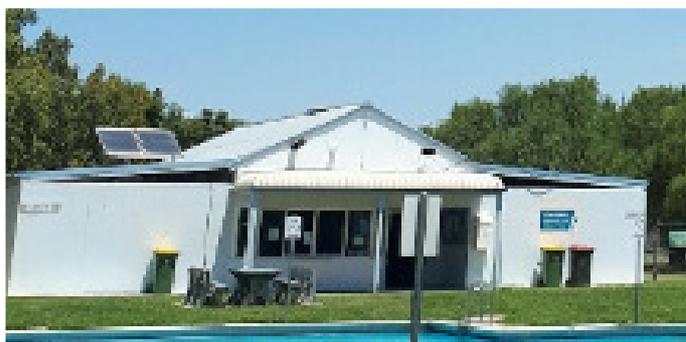
The amenities are constructed of brick with the kiosk in the middle and the amenities each side. They are in an average condition and will require a major upgrade to be DDA compliant. The kiosk requires a full internal refit.

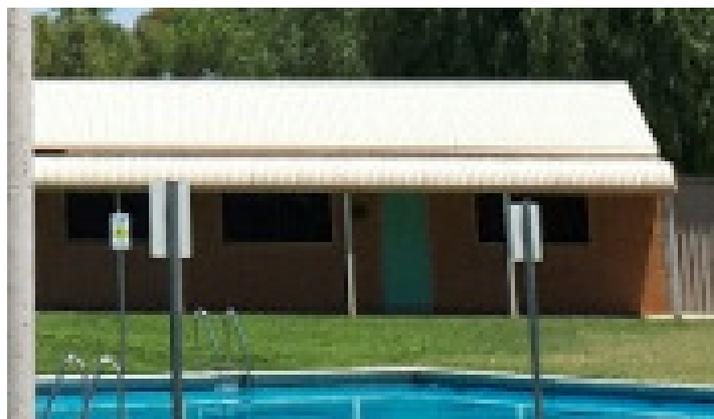
The Swimming Clubrooms are constructed of brick with an iron roof and veranda. The building is in very good condition but does not provide DDA access.

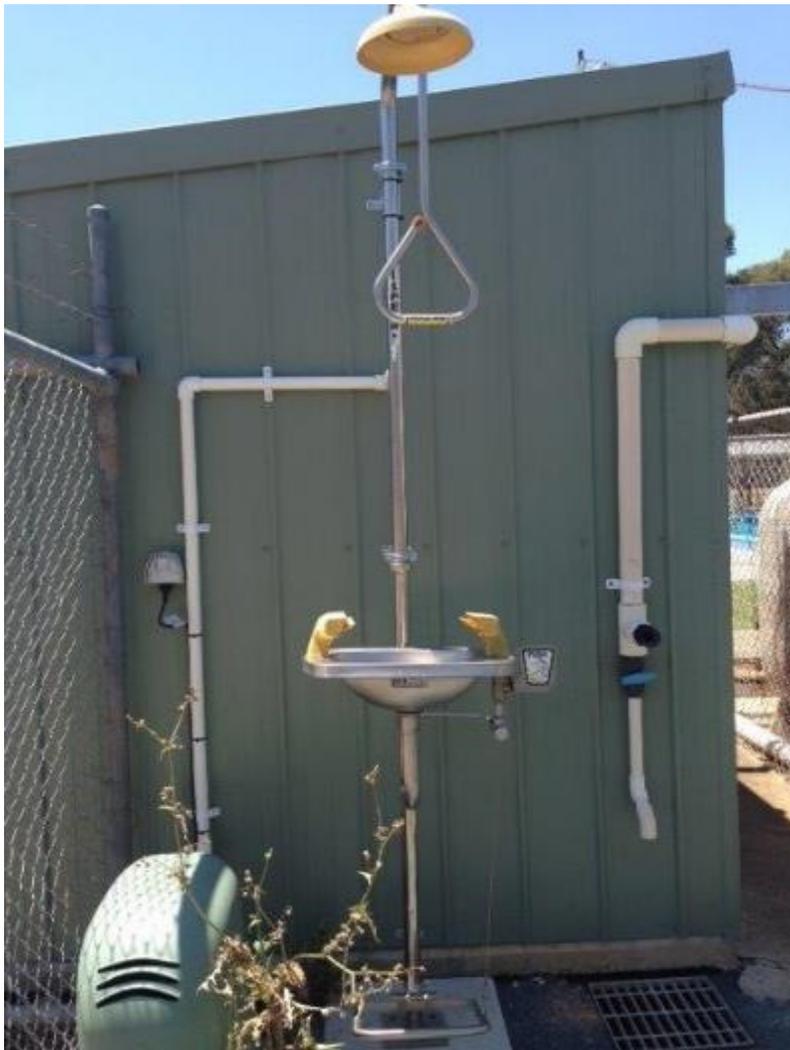
Dry chemicals are stored on 2 bunded plastic pallets in a colorbond shed. The structure is in good condition. Appropriate eye/body wash shower is in place and appears in good condition.

### **Sodium Hypochlorite Shed with eye wash attached**

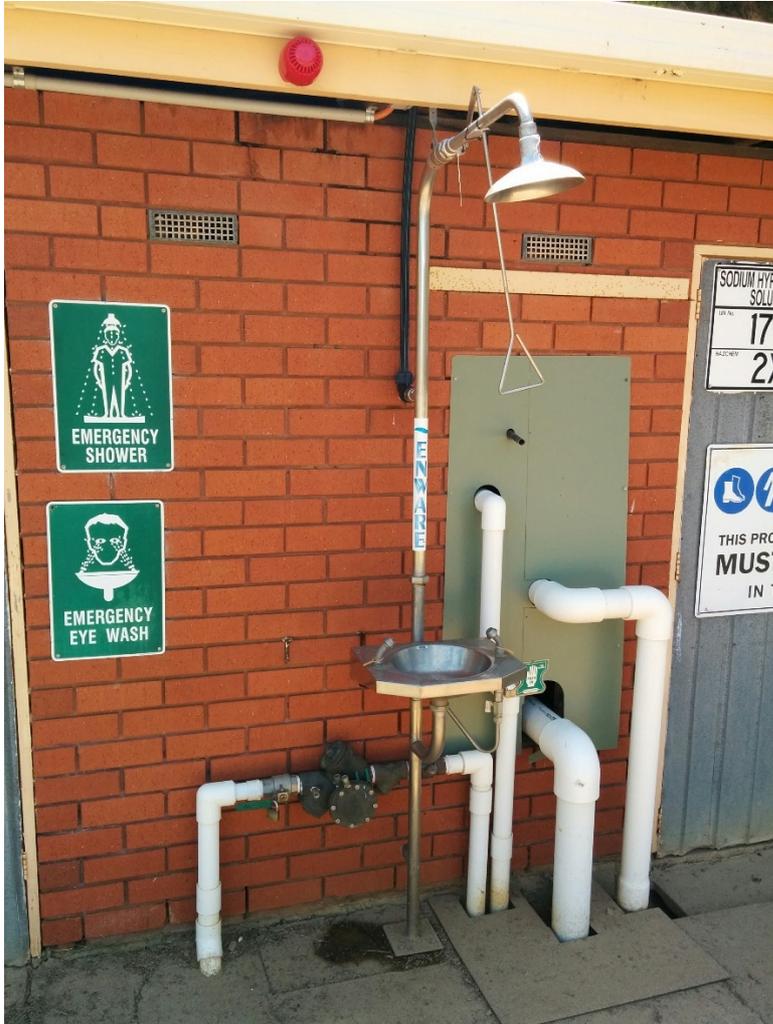
The plant room is constructed of brick with steel roof and used for pumping equipment and chemical storage. The building is in very good condition. It does not require renewing in the next 10 years.

**Plant shed with sodium Hypochlorite tank & pumping equipment**

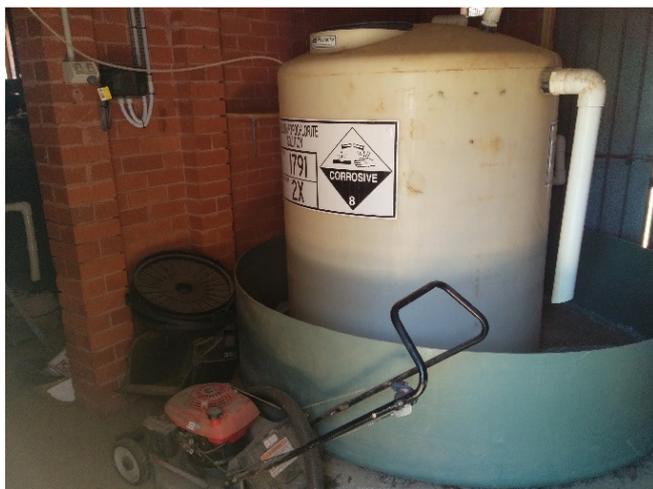
Sodium hypochlorite is stored in a 2,200 litre special plastic tank on a bund in the plant shed. The tank is in good condition but as they have a limited life will need renewing in next 10 years.

**Hypo tank in plant shed**

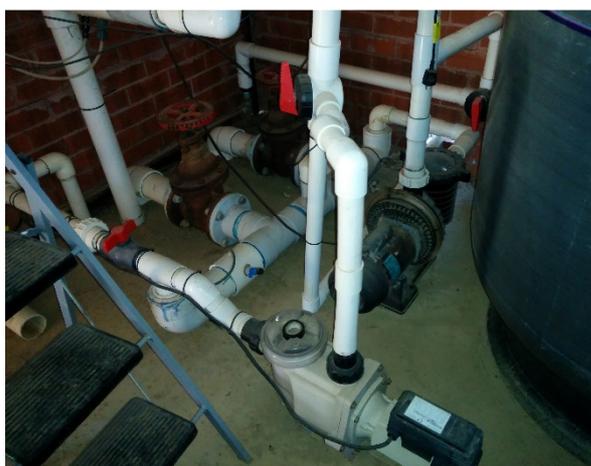
A 20,000litre plastic rain water tank with pump is provided for the backwash system that appears to be draining to grass. is plumbed to sewer. The tank is in good condition. Need to check compliance for drainage.

**Colbinabbin Backwash and Reticulation pumps. Sta-rite at rear**
