# ***Heritage Review 2014 - Part B***

## ***Heritage Precincts***

**Heritage Review 2014**  
**PART B – Heritage Precincts**

**September 2014**  
**(Amended February 2016)**

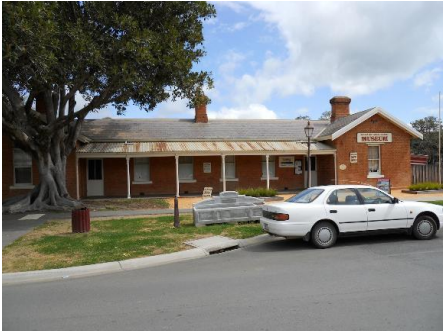
| 1-3 Dickson Street, Echuca | Place Type | Former Police Station, current museum |

**Place Description** – A single storeyed red brick police station with central timber verandah flanked by gable ended pavilions. The roof linings are slate with cast iron gutters. The interior is substantially intact. At the rear, the gable roofed celled have axe finished granite dressings to the opening and stuccoed dados. It is an important early public building in Echuca.

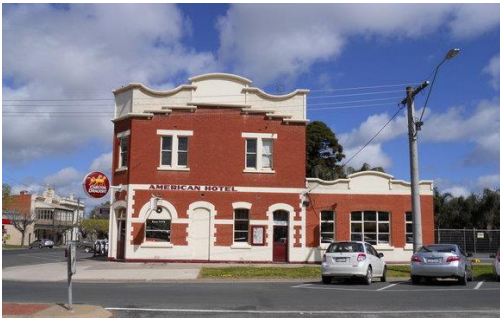
| 239-249 Hare Street, Echuca (American Hotel) | Place Type | Hotel |

**Place Description** – a prominent two storeyed tuckpointed bi-chrome brick and stuccoed hotel, probably created in three stages, the first being distinguished by the use of bi-chrome brickwork at the corner (ground floor only) and segmented head openings. The second and principle stage consisted of the provision of a second storey (possibly in 1920'2) with a rough cast and fair faced stuccoed parapet and cornice with curvilinear profile in the style of the day. Interior features of note include the surviving staircase and varnished timber ceilings with patterned borders. Windows to the upper level lobby are lead lit. At a later date, a two storeyed addition was provided along Heygarth Street in a sympathetic style. There has also been a major redevelopment of the site in recent times with mainly interior alterations and the addition of a large courtyard to the northern elevation.

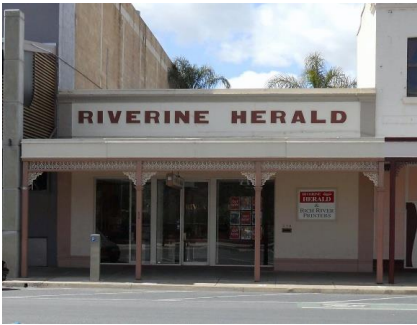
| 270 Hare Street, Echuca (Riverine Herald) | Place Type | Commercial/office building |

**Place Description** – 270 Hare Street is a restrained rendered masonry shop front. It has a rectangular parapet. The verandah has fine cast iron frieze with cast iron brackets to the timber posts. The glazed shop front is later. It contributes to the historic and aesthetic significance of the Old Echuca Township Precinct.

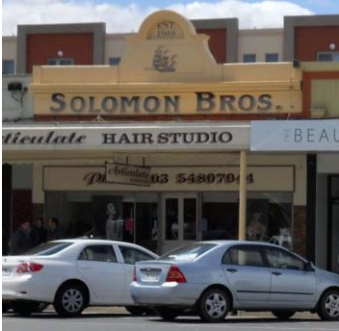
| 282 Hare Street, Echuca | Place Type | Commercial/office building |

Place Description – 282 Hare Street is a rendered masonry shop front with a strong cornice line. The semicircular pediment is unusual. The canopy has later metal posts. The glazed shop front has a central entry. It contributes to the historic and aesthetic significance of the Old Echuca Township Precinct.

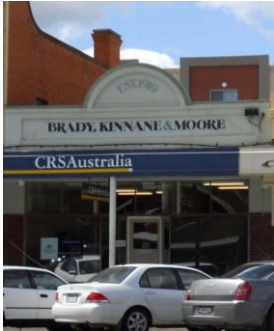
| 284 Hare Street, Echuca | Place Type | Commercial/office building |

Place Description – 284 Hare Street is a rendered shop front with a rectangular parapet with a semicircular pediment. The canopy has later metal posts. The glazed shop front has a central entry. It contributes to the historic and aesthetic significance of the Old Echuca Township Precinct.

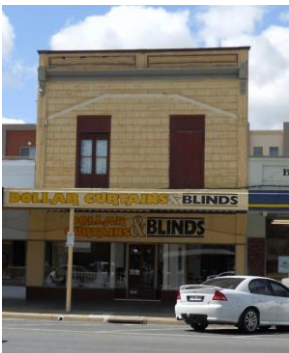
| 286 Hare Street, Echuca | Place Type | Commercial/office building |

Place Description – 286 Hare Street is a timber block fronted double storey shop front. It has two upper floor openings one with windows and the other is blocked. The canopy has later metal posts. The glazed shop front has a central entry. It contributes to the historic and aesthetic significance of the Old Echuca Township Precinct.

Surviving structures from this period of early settlement illustrate the built character and specific activities that were associated with the port. Much of the 1854 Philip Chauncy survey area falls within the heritage overlay area. Of particular note is the wharf and port area and the surviving rudimentary timber shop fronts (found at 531 - 535 High Street and the relatively sophisticated timber shop front 286 Hare Street).

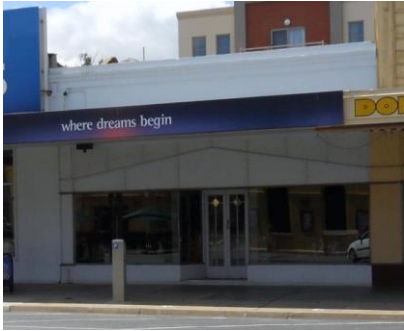
| 288 Hare Street, Echuca (Part of Forty Winks) | Place Type | Commercial/office building |

**Place Description** – 288 Hare Street is a single storey early 20th century commercial building. It is constructed from rendered masonry. The shop front has retained a number of original features and this includes the upper panels and the glazed shop front with the central entrance. The canopy is later. It contributes to the historic and aesthetic significance of the Old Echuca Township Precinct.

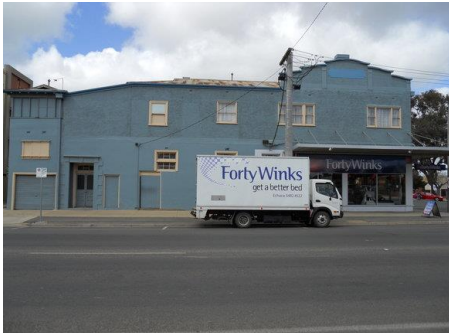
| 290-292 Hare Street, Echuca (Part of Forty Winks) | Place Type | Commercial/office building |

**Place Description** – 290-292 Hare Street is a double storey early 20th century commercial building. It is constructed from rendered masonry. The canopy is later. It contributes to the historic and aesthetic significance of the Old Echuca Township Precinct.

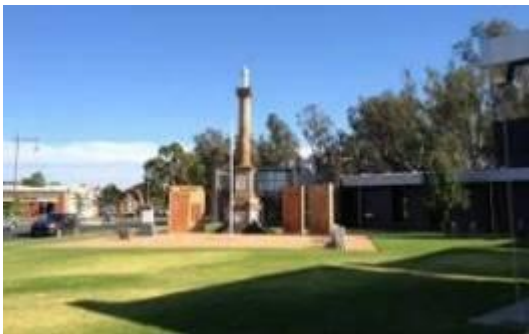
| 310 Hare Street, Echuca (War Memorial and parkland setting) | Place Type | War Memorial |

**Place Description** – 310 Hare Street the WWI cenotaph compares with others of its type but is more imposing because of its proportions and height. It adopts typical memorial forms of the day including plinth and column and is locally significant for its connection with A J inches, Echuca's pre-eminent architect of the day. The other memorials are also typical for their period. Of note are the copper plaques. It contributes to the historic and aesthetic significance of the Old Echuca Township Precinct. It is an imposing cenotaph with stepped bluestone base surmounted by a faceted "drum" of bluestone and marble, with marble pilasters. The dominant upper section is of sandstone, also with marble inlays at the base, and having a plain Ionic column with marble infantryman above. A smaller memorial to the fallen in the South African War (1899-1901) adjoins and consists of a bluestone base with cast iron lamp standard above.

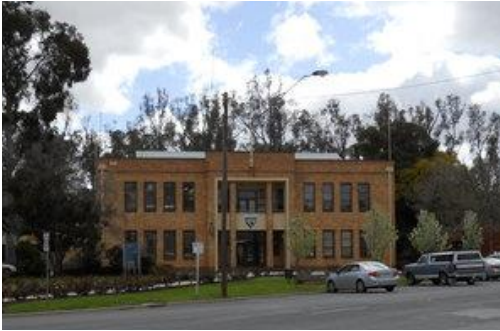
| 2 Heygarth Street, Echuca (Campaspe Shire Offices) | Place Type | Office |

Place Description – 2 Heygarth Street offices are imposing and demonstrates many of the architectural conventions associated with this period. This includes the architectural language of stripped classicism which can be identified in the symmetry of the façade with its strongly centralised recessed portico. The contrasting colours found within the brickwork add to its aesthetic significance. It contributes to the historic and aesthetic significance of the Old Echuca Township Precinct.

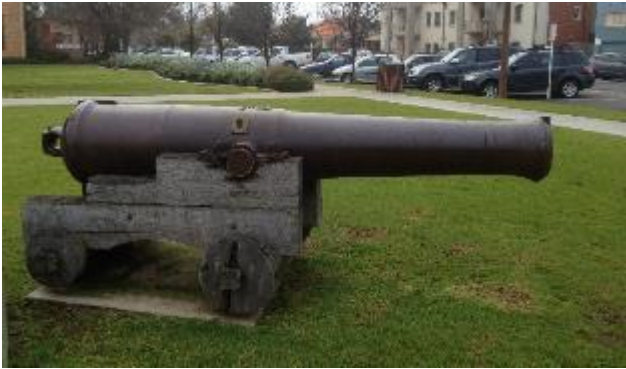
| 2 Heygarth Street, Echuca (Cannon) | Place Type | Cannon Display |

Place Description – A side gun from the battleship “Nelson” with rebuilt timber carriage having the following markings “VR”, “weight 6748lb, 6.3in., prep. 732lb”, Sir W.G. Armstrong & Co., Palliser, no.1678, Gun 1867”.

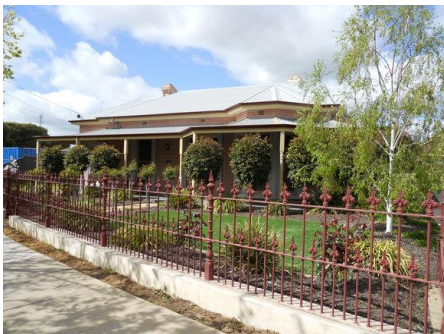
| 9 Heygarth Street, Echuca | Place Type | Dwelling |

Place Description – 9 Heygarth Street has undergone some reconstruction. It has been constructed from face brickwork with a corrugated metal hip roof. Its architectural style relies on an expression of the picturesque. This is found in the asymmetry, the bay window and the complex roof forms. It contributes to the historic and aesthetic significance of the Old Echuca Township Precinct.

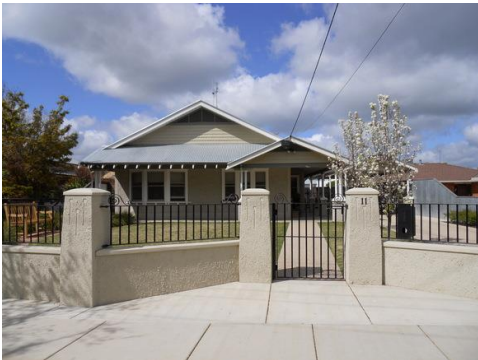
| 11 Heygarth Street, Echuca | Place Type | Dwelling |

Place Description – 11 Heygarth Street is an Interwar bungalow. It is constructed from rendered masonry and has a corrugated metal roof. It has two gable roofs and these have decorative scalloped timber boards to the gable front and timber strapping to the apex of the gable. The verandah posts have masonry plinths and posts. The windows are in bands. It contributes to the historic and aesthetic significance of the Old Echuca Township Precinct.

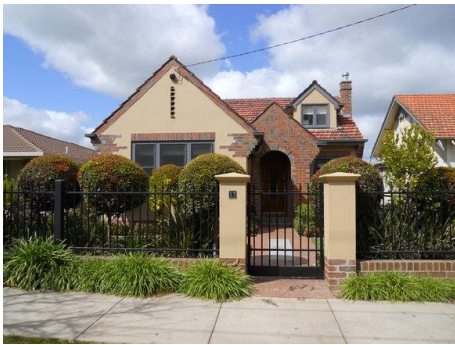
| 17 Heygarth Street, Echuca | Place Type | Dwelling |

Place Description – 17 Heygarth Street is an Interwar house that has been designed in the style of 'Old English'. This is a picturesque expression that relies on asymmetry, irregularity, contrasting textural qualities and a style that draws on traditional English vernacular architecture. This can be identified by the varied brickwork, for instance the basketwork pattern brickwork, brick corbelling, brick quoins, brickwork to the eaves and the steeply pitched gables and the use of dormer windows. This textural use of brickwork is contrasted with the rendered walling. The roof is clad with terracotta tiles and this also contributes to the textural qualities associated with this style. It contributes to the historic and aesthetic significance of the Old Echuca Township Precinct.

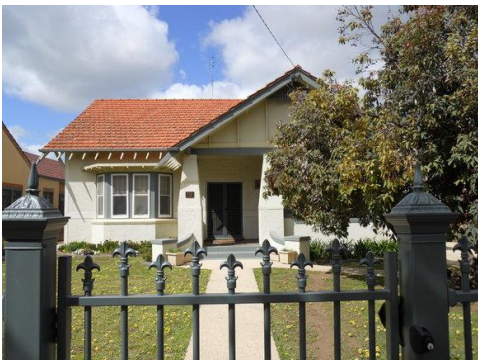
| 19 Heygarth Street, Echuca | Place Type | Dwelling |

Place Description – 19 Heygarth Street is a stylish Interwar Bungalow. It is constructed from rendered masonry and has a terracotta tiled roof with exposed timber rafters. Its architectural expression relies on a transverse gable and an opposing gable roof. The

imposing gable front has timber strapping to the apex of the gable. The entry porch has a large masonry columns. There is a bay window. It contributes to the historic and aesthetic significance of the Old Echuca Township Precinct.

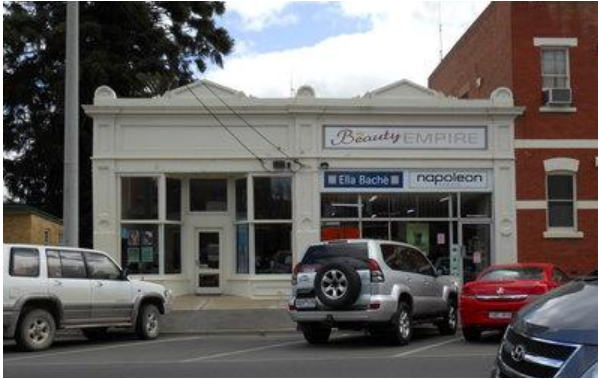
| 30-32 Heygarth Street, Echuca | Place Type | Commercial |

Place Description – 30-32 Heygarth Street are two rendered masonry shopfronts. The parapet is stylised with recessed bands with both rectangular and circular motifs. Both parapets have a shallow pediment. The shop fronts have glazed panels with a splayed entry. It contributes to the historic and aesthetic significance of the Old Echuca Township Precinct.

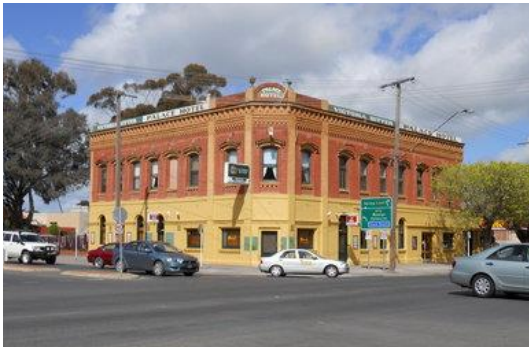
| 37-45 Heygarth Street, Echuca (Palace Hotel) | Place Type | Hotel |

Place Description – a substantial two storeyed bi-chromatic tuckpointed brick hotel with richly detailed cornice having “Lombardic” corbelled treatment, cast terra cotta tiles and brackets in reds and whites, the corner splay being enriched with a curved pediment and urns. Openings are round arched and segmental with drip moulds and consoles.

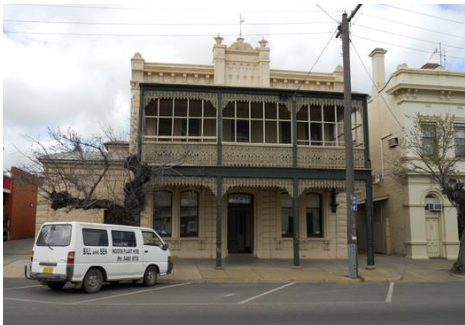
| 47-49 Heygarth Street, Echuca (Heygarth House) | Place Type | Former Dr. Crosson's Residence and Surgery (current office) |

Place Description – a richly decorated two storeyed Italianate residence with two storeyed timber posted verandah and attached single storeyed wing on the east side. Cast cement ornamentation consists of a central urn surmounting opposed volutes, cornice brackets and anthemion to the pilaster terminations. Cast cement crosses are possible references to Crosson's occupation, forming a frieze surmounting Moorish motifs. The lower level is rusticated with bracketed sills and spandrels to the windows. The verandah

floor is carried on massive timber brackets. The attached single storeyed wing is distinguished by its upper level glazing, now over painted, with cornice brackets, valances and glazing bars.

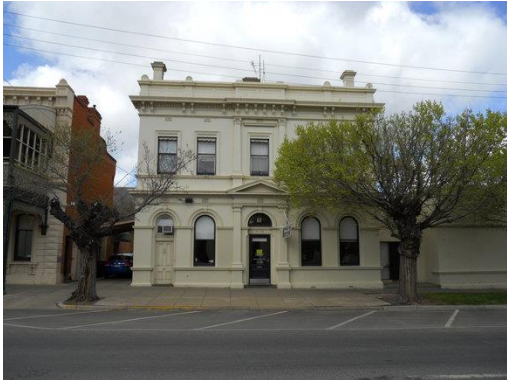
| 51-55 Heygarth Street, Echuca (Former London Chartered Bank) | Place Type | Former bank (current office) |

**Place Description** – a two storeyed rendered brick building with symmetrical façade and heavy classical plaster detailing with heavy brackets supporting the upper entablature and engaged columns at ground and first floor surrounding the central door and window above. Further enrichment includes detailed dental work at first floor and below parapet entablature, square headed windows first floor and round headed windows and door at ground floor level. Mouldings above front door at first floor level include a pediment motif.

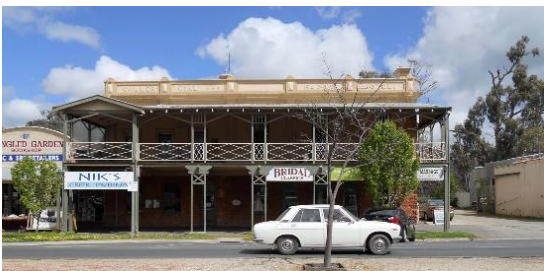
| 499-501 High Street, Echuca (former Commercial Family Hotel) | Place Type | Former hotel |

**Place Description** – 499 High Street-501 High Street is a large two storey commercial building. It is constructed from masonry and its parapet has raised lettering with the name of the former establishment. The parapet is divided into bays. The upper floor has retained most of its original windows. The ground floor has less integrity with a number of new openings constructed over different periods. The two storey verandah has decorative timber balustrading with a diagonal pattern and with paired timber posts. It contributes to the historic and aesthetic significance of the Old Echuca Township Precinct.

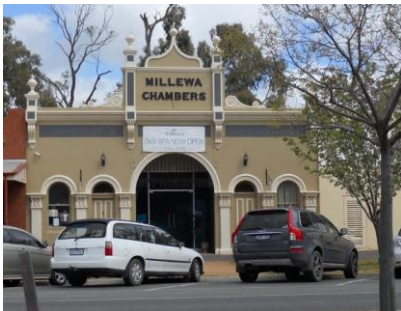
| 509-511 High Street, Echuca (Millewa Chambers) | Place Type | Former arcade of offices (current spa) |

**Place Description** – a single storeyed with central walkway stuccoed Italianate building with Saracen motif to pediment having “Millewa Chambers” in low relief. The parapet is further enriched with consoles and ball finials, the frieze being composed of

vermicated panels. At ground level, the windows are enriched with pilasters and Corinthian capitals and the arcade entry has iron gates, cast by Roberts and Sons, Sandhurst in 1878. A continuous illuminated lantern surmounts the arcade.

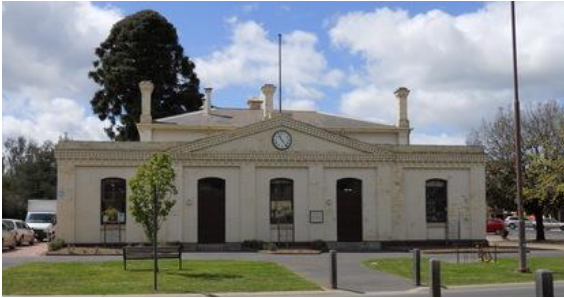
| 524-528 High Street, Echuca | Place Type | Former Town Hall & Library |

**Place Description** – an imposing early public building in the Italian renaissance manner having polychrome brickwork (over painted) with trabeated facades, enriches cornice and pediment with clock face over the former entrances to the court house and town hall. Inside, solid plaster enrichment and distinctive timber ceilings are intact along with some wood grading pertaining to an early decorative scheme. Mature trees are situated at the rear. The building has recently been renovated and resorted for use as offices. The exterior has been repainted in a colour scheme more sympathetic with the era of the building.

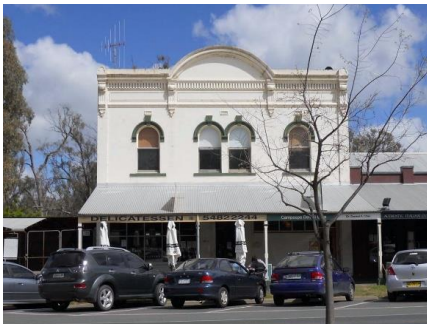
| 525 High Street, Echuca | Place Type | Chemist/ commercial |

**Place Description** – 525 High Street is a finely designed two storey Victorian commercial building. The upper floor has Renaissance inspired detailing with arched windows and label moulds. The parapet has a cornice, console brackets and dentil mouldings. The pediment is arched. The verandah is a relatively steeply sloping straight profile verandah with timber verandah posts. The ground floor shop fronts have been modified. It contributes to the historic and aesthetic significance of the Old Echuca Township Precinct.

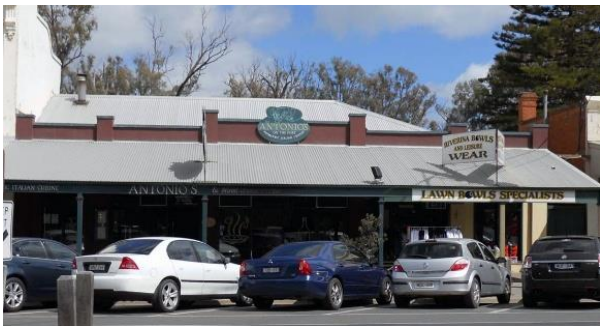
| 527 High Street, Echuca | Place Type | Commercial |

**Place Description** – 527 High Street is a rendered masonry Interwar commercial building. The parapet is rectangular and has capped pilasters which are typical for this period. . The verandah is a relatively steeply sloping straight profile verandah with timber verandah posts. The ground floor shop fronts have been modified. It contributes to the historic and aesthetic significance of the Old Echuca Township Precinct.

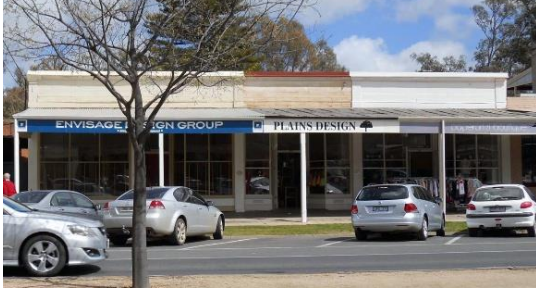
| 531-535 High Street, Echuca | Place Type | Shops/ offices |

Place Description – a comparatively unenriched row of four brick shops with timber fronts and posted verandah. The parapet has been defaced but retains its original lining below the cornice line and is subdivided into four sections by timber pilasters. The timber posted verandah is unenriched. Each of the remaining shop fronts has a central ingo with double doors.

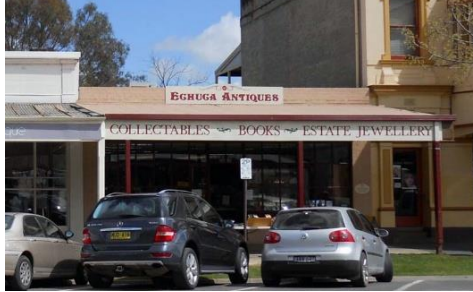
| 537 High Street, Echuca | Place Type | Shops/ offices |

Place Description – 537 High is a modest shopfront with a shallow rectangular brick parapet. The shopfront is glazed and the shallow pitched verandah has a straight profile and timber verandah posts. It contributes to the historic and aesthetic significance of the Old Echuca Township Precinct.

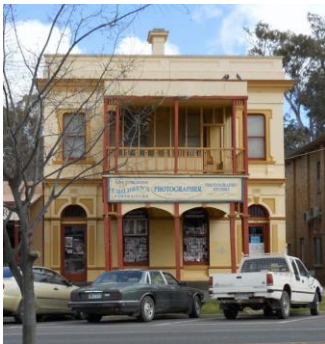
| 539 High Street, Echuca | Place Type | Former Colonial Bank |

Place Description – a two storeyed stuccoed Italianate façade with round arched openings at street level and projecting entries. Ornamentation is restrained. A later two storeyed timber verandah protected the central portion of the façade but has recently been removed from the building.

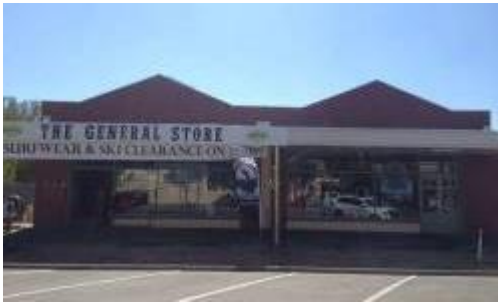
| 542-544 High Street, Echuca | Place Type | Commercial |

Place Description – 542-544 High Street is a double shop front with a pedimented parapet. The canopy has metal posts. The shopfronts have been reconstructed to replicate the original layout. They are large glazed shopfronts with side entries. It contributes to the historic and aesthetic significance of the Old Echuca Township Precinct.

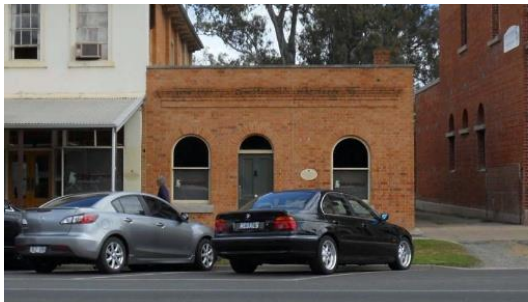
| 543 High Street, Echuca | Place Type | Bank/survey office |

Place Description – An usual stuccoed brick single storeyed residence formerly with timber posted verandah now removed distinguished by its symmetrical façade with round arched openings and cornice treatment beneath a plain parapet.

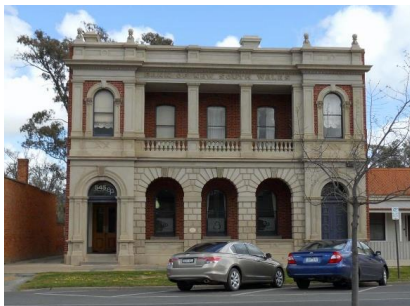
| 545 High Street, Echuca | Place Type | Former Bank of New South Wales |

Place Description – a substantial stuccoed Italianate bank with central loggia and flanking pavilions. Openings are mostly round arched with pilastered surrounds. The cornice is dentillated and the parapet enriched with ball finial.

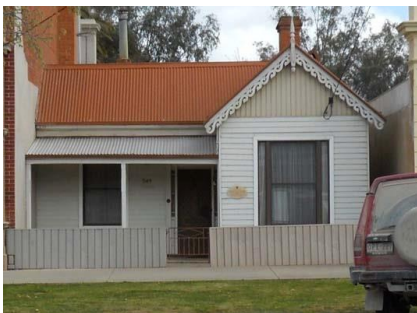
| 549 High Street, Echuca | Place Type | Dwelling |

Place Description – 549 High Street has a picturesque and asymmetrical facade. The roof is relatively steeply pitched and is clad with corrugated metal. It has a projecting gable roofed section with a decorative barge board. The recessed section has a verandah with the entrance and single window. It contributes to the historic and aesthetic significance of the Old Echuca Township Precinct. The area contributory to the precinct is the lot fronting High Street measuring 60.6 x 9.4 meters and does not include the lot to the rear measuring 24.2 x 8.9 which is currently vacant and landlocked with no legal access. The contributory area is highlighted on the map above.

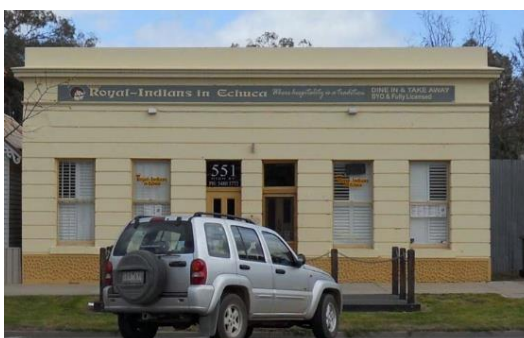
| 551 High Street, Echuca | Place Type | Former bank |

Place Description – a small neo-classical pair of offices with rusticated and vermiculated front elevation, plain cornice and parapet. A “Savings Bank” sign is still visible on the south wall.

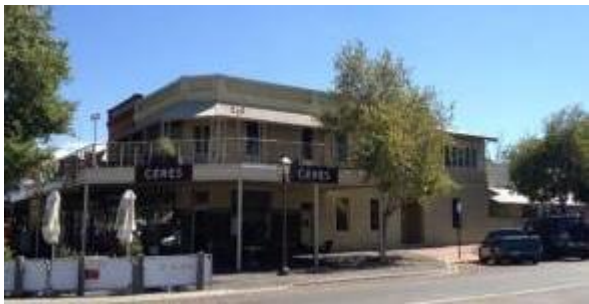
| 554 High Street, Echuca | Place Type | Former hotel/pharmacy |

Place Description – a two storeyed unenriched corner former hotel with rough cast walls, corner splay and narrow timber cantilevered balcony to both elevation. A later posted verandah faces High Street.

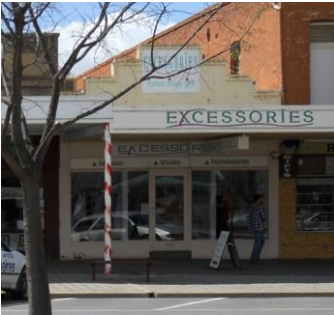
| 558 High Street, Echuca | Place Type | Shop |

Place Description – 558 High Street has stepped masonry parapet with brick capping. The canopy is later. The glazed shop front has a central door. It contributes to the historic and aesthetic significance of the Old Echuca Township Precinct.

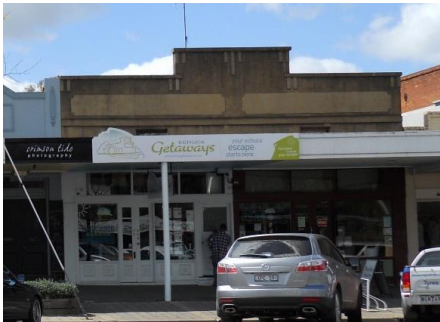
| 560-562 High Street, Echuca | Place Type | Shop |

Place Description – 560 High Street has a stepped rectangular parapet. It is constructed from masonry and its finish consists of a very fine unpainted rough cast with smooth rendered detailing. The canopy is later and the ground floor shopfronts have been modified. It contributes to the historic and aesthetic significance of the Old Echuca Township Precinct.

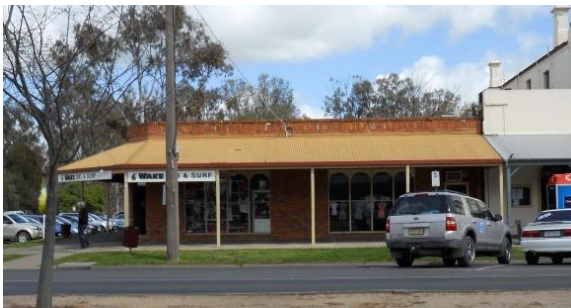
| 563- 565 High Street, Echuca | Place Type | Shop |

Place Description – 563 High Street is a face red brick shopfront with a low rectangular brick parapet with brick on edge capping. The verandah has a straight profile. The ground floor has a modified shopfront. It contributes to the historic and aesthetic significance of the Old Echuca Township Precinct.

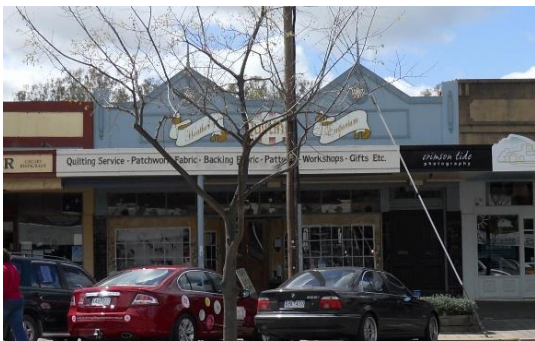
| 564-566 High Street, Echuca | Place Type | Shop |

Place Description – 564-566 High Street is a double shopfront with a double pediment. The parapet has relief mouldings. The canopy is later and the ground floor shopfronts have been modified. It contributes to the historic and aesthetic significance of the Old Echuca Township Precinct.

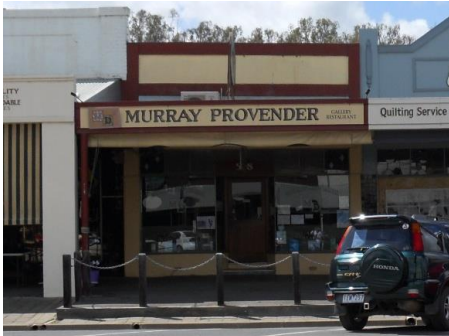
| 568 High Street, Echuca | Place Type | Shop |

Place Description – 568 High Street is a single storey shop front. It has a rectangular parapet. The canopy has a deep fascia. The glazed shop front has a central entrance. It contributes to the historic and aesthetic significance of the Old Echuca Township Precinct.

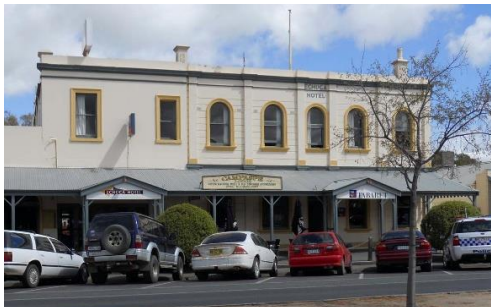
| 569-571 High Street, Echuca (Echuca Hotel) | Place Type | Hotel |

Place Description – 569-571 High Street is two storey rendered masonry hotel. The upper floor is divided into bays with tooled render and pilasters and a cornice. The windows are arched and are regularly placed across the façade. The ground floor has windows in traditional locations. The verandah has a straight profile with breakfronts. It contributes to the historic and aesthetic significance of the Old Echuca Township Precinct.

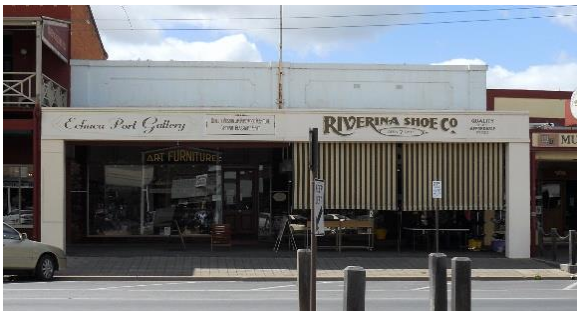
| 570-572 High Street, Echuca | Place Type | Shop |

Place Description – 570-572 High Street is a double shop front. It has a rectangular parapet with recessed panels and the capped pilasters divide the parapet into two bays. The canopy has a deep fascia with columns on either side of the double shop fronts. The entrance is centralised. It contributes to the historic and aesthetic significance of the Old Echuca Township Precinct.

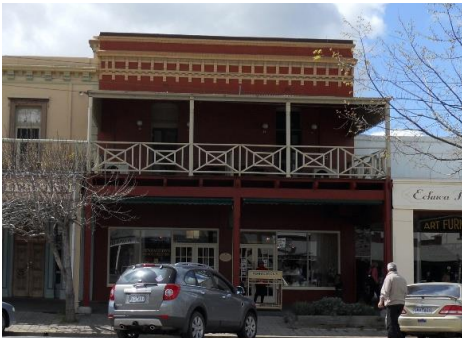
| 574-576 High Street, Echuca | Place Type | Commercial |

Place Description – 574-576 High Street is a two storey brick commercial building with a double storey verandah. The verandah has a timber Regency styled balustrading. The parapet has contrasting brickwork which includes cornices and brackets. The ground floor has a glazed shopfront. It contributes to the historic and aesthetic significance of the Old Echuca Township Precinct.

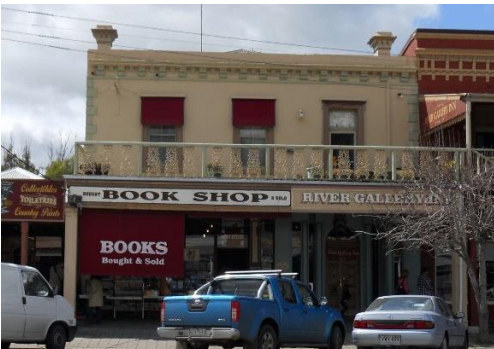
| 578-580 High Street, Echuca | Place Type | Shop |

Place Description – 578-580 High Street is a two storey rendered masonry commercial building with a single storey verandah with balcony. The parapet is distinguished by the cornice and masonry brackets. The upper floor has quoining to the building edges only. The balcony has a balustrade with cast-iron balustrading. The upper floor has three regularly placed windows. The glazed ground floor shop front has been modified. It contributes to the historic and aesthetic significance of the Old Echuca Township Precinct.

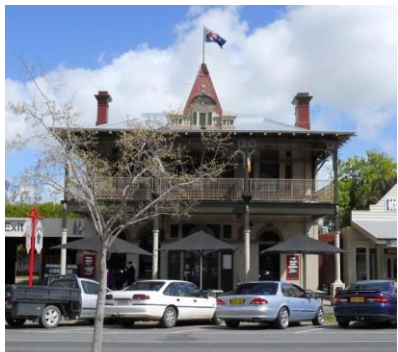
| 579-587 High Street, Echuca (Shamrock Hotel) | Place Type | Hotel |

Place Description – a two storeyed stuccoed Italianate hotel with hipped roof and balustrade parapet with pinnacle tower surmounting the entry. Upper level windows are framed with pilasters in Palladian form. A later two storeyed timber verandah incorporates a shamrock motif in the frieze. Lower level columns are iron on pedestals. Inside, the public areas have been altered.

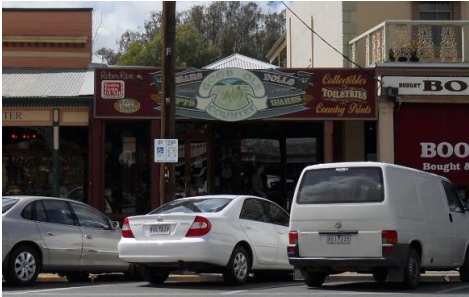
| 582 High Street, Echuca | Place Type | Shop |

**Place Description** – 582 High Street is a single storey shop front. The canopy has a deep fascia. The glazed shop front has a central entrance. It contributes to the historic and aesthetic significance of the Old Echuca Township Precinct.

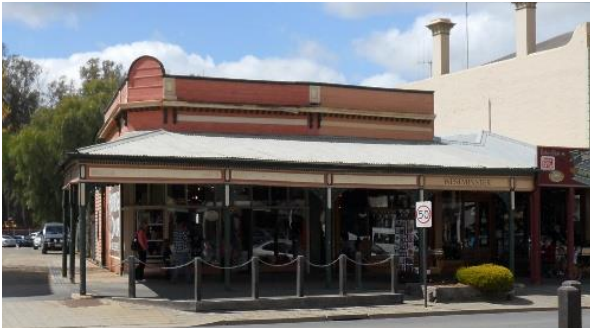
| 584-586 High Street, Echuca | Place Type | Shop |

**Place Description** – a single storeyed brick pair of shops with rear residences, timber shop fronts and posted verandah. The parapet has a bracketed cornice line and curved pediment over the corner splay with panelled frieze. The timber verandah has a dentillated beam and returns along the laneway alignment. The shop fronts are substantially intact.

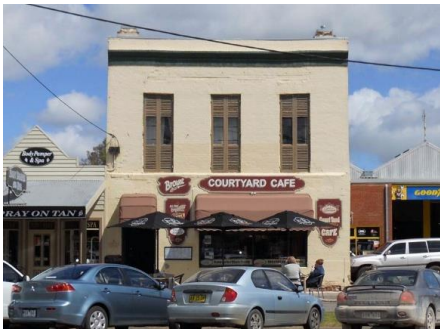
| 589-591 High Street, Echuca (Former Bank of Victoria) | Place Type | Former bank (current Café) |

**Place Description** – a comparatively austere two storeyed brick former bank with full length louvred shutters to the upper level windows formerly opening onto a balcony. Inside, the banking chamber is substantially intact.

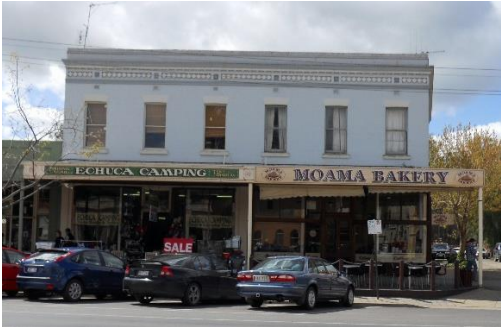
| 590 - 592 High Street, Echuca | Place Type | Shop |

**Place Description** – a substantial two storeyed with cellar bi-chromatic brick commercial building with later posted verandah and richly decorated cornice and frieze former with moulded bricks and terra cotta tiles set corner to corner. Early shop fronts have central ingos.

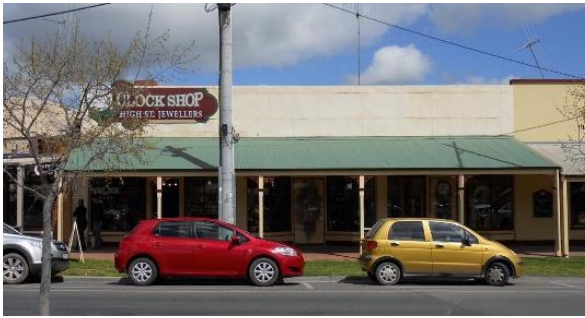
| 603-607 High Street, Echuca | Place Type | Shop |

**Place Description** – 603-607 High Street consists of three single storey shopfronts. The parapet is clad with sheet metal. The verandah has a straight profile with timber verandah posts. The three shop fronts each have a centralised entrance. It contributes to the historic and aesthetic significance of the Old Echuca Township Precinct.

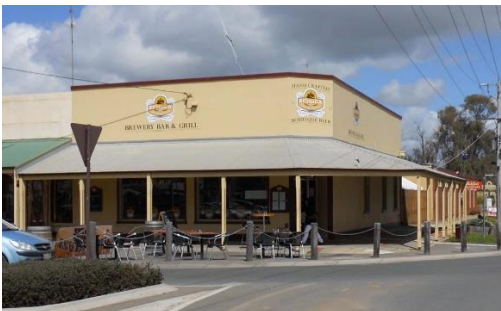
| 609 High Street, Echuca | Place Type | Commercial |

**Place Description** – 609 High Street is a large single storey masonry commercial building. Its corner position is reinforced by the splayed corner entry. The parapet is rectangular with a splayed corner. The verandah has a straight profile with timber verandah posts. There is a glazed shop front to High Street and rectangular windows on the other façade. It contributes to the historic and aesthetic significance of the Old Echuca Township Precinct.

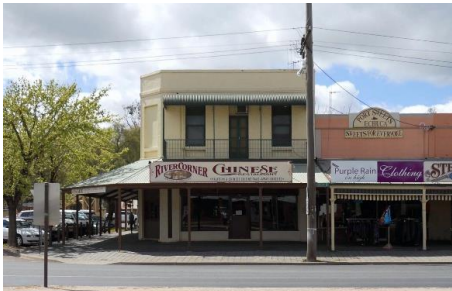
| 614 High Street, Echuca | Place Type | Shop |

**Place Description** – 614 High Street is a two storey commercial building. The corner position is reinforced by the splayed corner entry and the splayed verandah. The upper floor has a symmetrical façade with a central door flanked on either side by double hung windows. The upper floor has a verandah facing onto High Street. The ground floor has glazed shop front. It contributes to the historic and aesthetic significance of the Old Echuca Township Precinct.

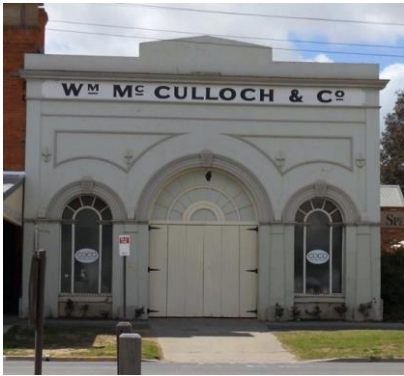
| 622 High Street, Echuca (former W M McCulloch Building) | Place Type | Part of Former Shackell's Bond Store, 43 Murray Esplanade, Echuca |

**Place Description** – a former bond store with grandiose façade to High Street composed of three round arched openings, with architrave moulds and fan lights and central carriageway. A plain frieze and cornice is surmounted by a plain parapet and pediment with “Star ..... AD 18 .....” now mostly obliterated. At the rear “Shackell Bond” is painted on the end gable which has the Star of David pattern to its oculus vent. A carriageway flanked by offices completes the Esplanade façade.

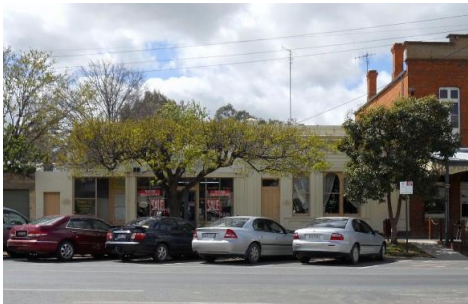
| <div>628- 632 High Street, Echuca</div> | Place Type | Shop |

Place Description – 628-632 High Street consists of a group of shopfronts. These have been altered and the façade is idiosyncratic with a slightly recessed section, a large glazed area and a pair of arched windows. There is a restrained and simply finished parapet. It contributes to the historic and aesthetic significance of the Old Echuca Township Precinct.

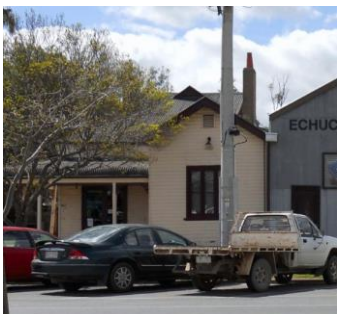
| <div>640 High Street, Echuca</div> | Place Type | Former Campbell's Coach House |

Place Description – 640 High Street is a turn of the century asymmetrical residence clad with weatherboards. The projecting front has a gable roof with a centralised pair of windows. The recessed section has bullnosed verandah. The main roof has a gablet vent and the roofs are clad with corrugated metal. It contributes to the historic and aesthetic significance of the Old Echuca Township Precinct.

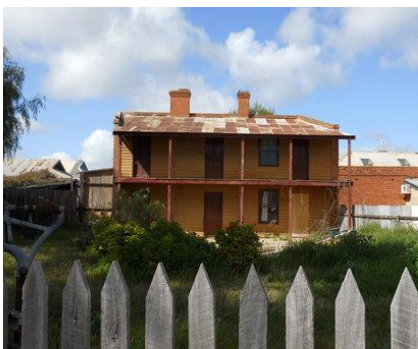
| Little Hopwood Street, Echuca | Place Type | Former brothel |

**Place Description** – a two storeyed weatherboard lined construction with double storey balcony, skillion roof to a rear parapet brick wall. Building divided into three rooms downstairs and three rooms upstairs, each separated by brick walls which are expressed on the face of the weatherboard façade. One single and one double chimney, the six external doors are four panel identical doors, windows timber double hung sashes divided into two panes each. A very simple building.

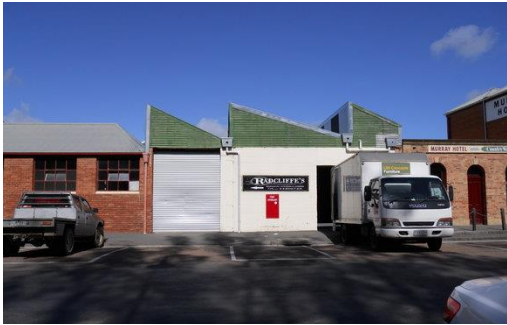
| 6 Murray Esplanade, Echuca | Place Type | Commercial |

**Place Description** – 6 Murray Esplanade is a former industrial and commercial building. It is characterised by its saw tooth roof and minimal architectural detailing. It is constructed from façade brick and rendered masonry. The windows are small paned windows that were typically found on these types of industrial buildings. It contributes to the historic and aesthetic significance of the Old Echuca Township Precinct.

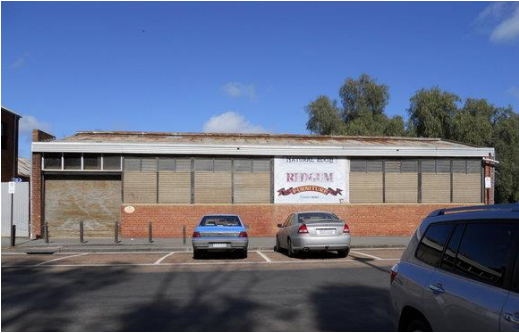
| 13 Murray Esplanade, Echuca | Place Type | Former store / foundry |

Place Description – 13 Murray Esplanade is a simple commercial face brick building with a band of windows to the upper section. It has a shallow pitched corrugated metal roof. It contributes to the historic and aesthetic significance of the Old Echuca Township Precinct.

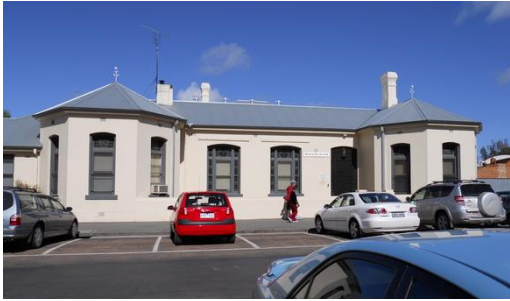
| 19 Murray Esplanade, Echuca (Echuca Club) | Place Type | Social Club |

Place Description – 19 Murray Esplanade is a rendered masonry single storey building with a corrugated metal roof. It has a symmetrical façade with bays at either end. The central windows are decorative with segmented high lights and side lights. It contributes to the historic and aesthetic significance of the Old Echuca Township Precinct.

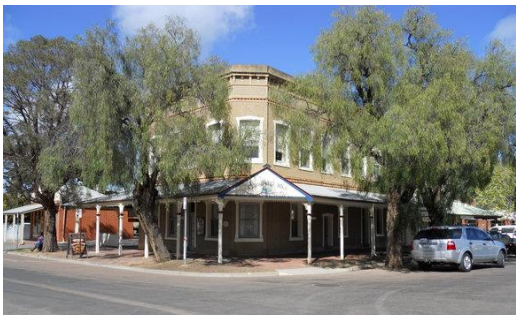
| 37 Murray Esplanade, Echuca (Steam Packet Inn) | Place Type | Accommodation |

Place Description – a two storeyed with corner splay brick hotel with later rough cast finish. The bracketed cornice is of moulded white bricks and the frieze and string course is defined with reds. The timber posted verandah protects the front and side elevations.

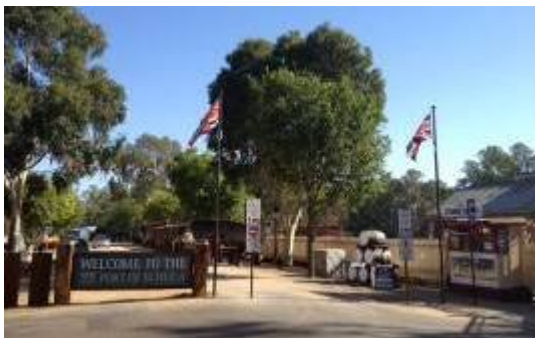
| 40 - 60 Murray Esplanade, Echuca | Place Type | Echuca Wharf and Port Area |

**Place Description** – 40-60 Murray Esplanade is part of the former Echuca Wharf area. It includes a relocated station, newly constructed restaurant and a variety of industrial type buildings and sheds. The road is gravelled and there are a number of other structures that are associated with the wharf. It contributes to the historic and aesthetic significance of the Old Echuca Township Precinct.

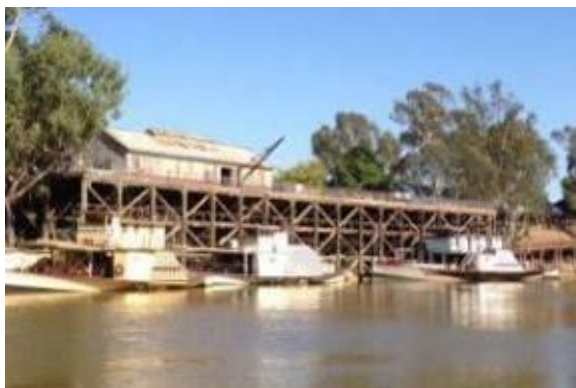
| 40 - 60 Murray Esplanade, Echuca | Place Type | Echuca Wharf |

**Place Description** – 40-60 Murray Esplanade includes the Echuca Wharf which was built as part of the Echuca port. The wharf is 75.5 long and is constructed from river red gum felled and milled locally. The wharf is over ten metres high to allow for variations in winter and summer river levels, allowing goods to be unloaded all year round. It contributes to the historic and aesthetic significance of the Old Echuca Township Precinct.

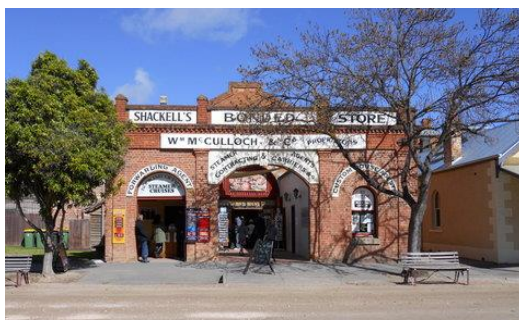
| 43 Murray Esplanade, Echuca | Place Type | Former Shackell's Bond Store |

**Place Description** – a former bond store with grandiose façade to High Street composed of three round arched openings, with architrave moulds and fan lights and central carriageway. A plain frieze and cornice is surmounted by a plain parapet and pediment with "Star ..... AD 18 ....." now mostly obliterated. At the rear "Shackell Bond" is painted on the end gable which has the Star of David pattern to its oculus vent. A carriageway flanked by offices completes the Esplanade façade.

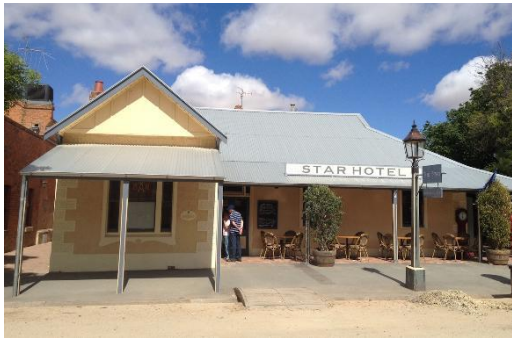
| <div>45-47 Murray Esplanade, Echuca (the Star Hotel)</div> | Place Type | Former dwelling / hotel |

Place Description – an asymmetrical rough cast flashed brick building with timber posted verandah and vermiculated quoins. The projecting wing has a half timber timbered gable end in the Edwardian English Domestic Revival manner. The verandah roof to two elevations is continuous with the main roof and has a Dutch gable form.

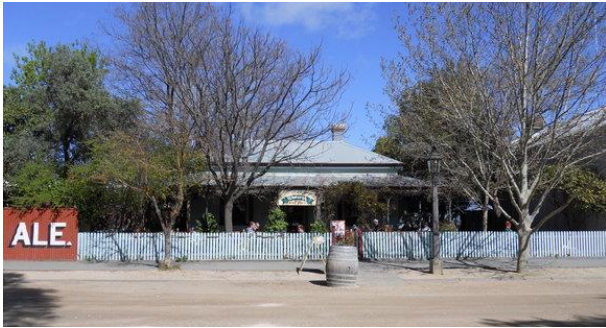
| <div>51 Murray Esplanade, Echuca (Wisteria Tea Rooms)</div> | Place Type | Former dwelling (current café) |

Place Description – 51 Murray Esplanade is a typical late Victorian period house. It is clad with weatherboards and has a hipped corrugated metal roof with brick chimneys. The verandah to the front is bullnosed and has timber verandah posts. It has a symmetrical façade with a central door and double hung windows. The house is set in pleasing landscaped gardens and has a sympathetic timber picket fence. It contributes to the historic and aesthetic significance of the Old Echuca Township Precinct.

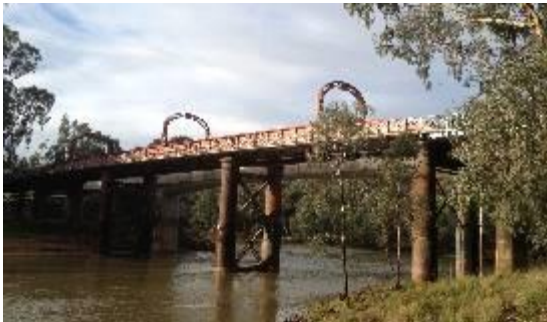
| Former Road/Rail Bridge over Murray River | Place Type | Former bridge structural arch |

**Place Description** – the main spans, carried on circular cast iron cylinders with Tuscan capitals and cross braced with riveted iron work, are of riveted iron girder construction, the three main spans being set to a high level obviating the need for a lift section. The main span girders slope downwards at their north and south terminations and are braced about the roadway at three points, one to each span. The approaches to the main spans commence at brick and stone abutments and consist of smaller diagonally braced Tuscan order cylinders carrying iron longitudinal beams with iron cross beams supporting the road deck. The road formally carried a single line of railway and retains a pedestrian walkway on the upstream side, the railings throughout being original lattice iron work.

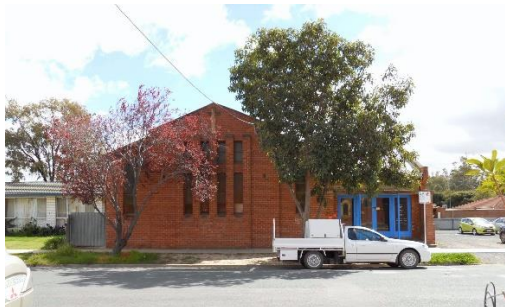
| 4 Percy Street, Echuca | Place Type | Former Church Hall |

**Place Description** – 4 Percy Street is a face brick building with a gable roof. The façade is characterised by the four narrow windows in the main bay and the single narrow window to either side. The brickwork is finely executed. It contributes to the historic and aesthetic significance of the Old Echuca Township Precinct.

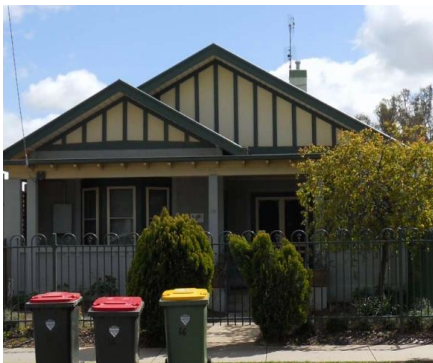
| 16 Percy Street, Echuca | Place Type | Dwelling |

**Place Description** – 16 Percy Street is an Interwar Bungalow with a double gable to the façade. The gables have a striking vertical timber strapping with a strong horizontal base. The gables have timber brackets to their underside. The front gable has a bay window and the recessed area includes the entrance and a pair of windows. It contributes to the historic and aesthetic significance of the Old Echuca Township Precinct.

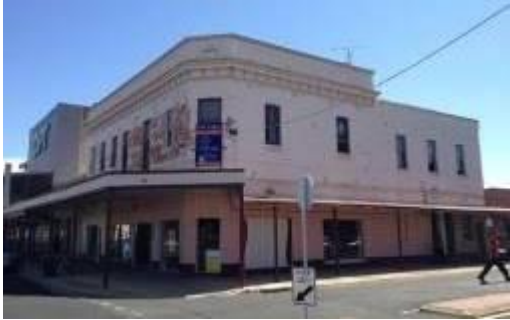
| <div>264-266 Hare Street &amp; 32 Percy Street</div> | Place Type | commercial building |

**Place Description** – 264-266 Hare Street & 32 Percy Street is a large painted brick commercial building. It is located on a corner and the former entry [an upper floor opening] once defined this location. The cornice is the main architectural feature for this façade and has brackets to its underside. The windows are double hung. The ground floor has been modified and there are glazed shopfronts. The verandah has been replaced with a later canopy. It contributes to the historic and aesthetic significance of the Old Echuca Township Precinct.

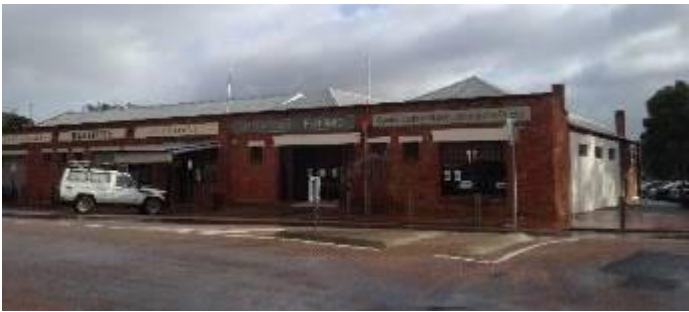
| <div>2-10 Radcliffe Street, Echuca</div> | Place Type | Former Holden Sales Centre |

**Place Description** – 2-10 Radcliffe Street is a former industrial and commercial building. It is constructed from masonry and the roof is a series of hips and gable roof that has been clad with corrugated metal. The openings are large glazed shopfront windows. It contributes to the historic and aesthetic significance of the Old Echuca Township Precinct.

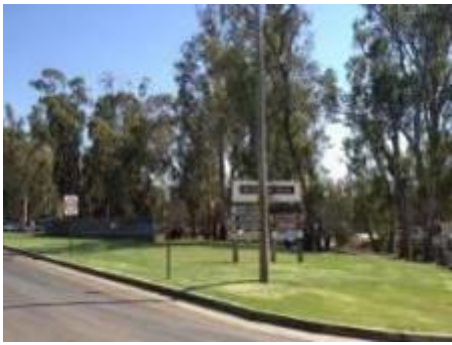
| <div>2, 51 &amp; 52 Watson Street, Echuca</div> | Place Type | Hopwood River Park |

**Place Description** – 2, 51 & 52 Watson Street consists of parkland to the river banks. It includes a former timber punt. This area is distinguished by the natural riverine environment with its treed banks. It contributes to the historic and aesthetic significance of the Old Echuca Township Precinct.

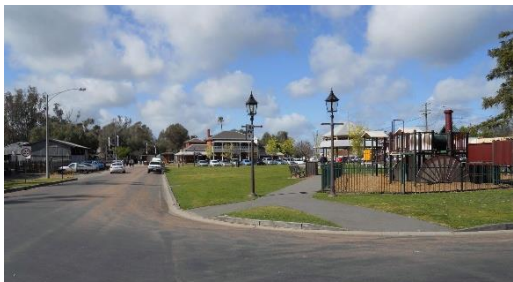
| <div>Hopwood Place Park, Echuca</div> | Place Type | Hopwood Gardens |

Place Description – Hopwood Place Park is a large parkland and consists of open grassed areas bisected by pathways. The rotunda provides a strong visual interest. There is a contemporary children's playground. The trees reinforce the axial arrangements of the hard landscaping. It contributes to the historic and aesthetic significance of the Old Echuca Township Precinct.

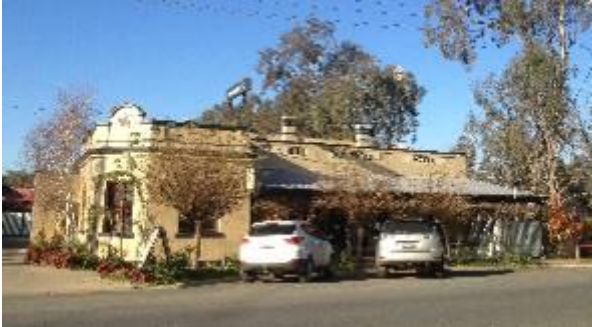
| 17-21 Warren Street, Echuca (Cock 'N' Bull Hotel) | Place Type | Former Henry's Inn & Sale Yards Hotel |

Place Description – a single storeyed brick (painted over) former hotel with rear two storeyed wing. An austere front elevation with timber posted verandah is enriched by a projecting parapeted corner section with stuccoed cornice and corner splay surmounted by a curved pediment. It is significant for its association with the former Shackell White & Co. saleyard opposite, its location on the Warren Street approach to the old town centre and as a substantially intact early hotel.

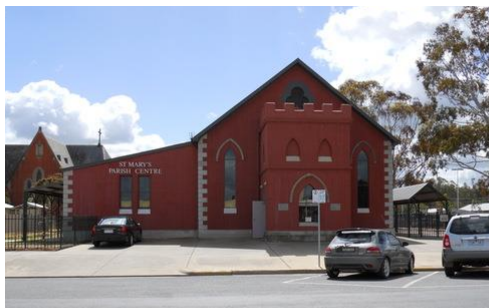
| 222 Anstruther Street, Echuca (St Mary's Parish Centre) | Place Type | Parish Centre |

Place Description – St Mary's Parish Centre is a face brick building (painted). It has dressed quoining to the original section as well as the later addition to the side. The original section has some striking architectural features and this includes the castellated entrance with the pointed blind windows and large ground floor pointed window with a drip mould. There is a trefoil at the apex. There are lancet windows to either side of the main window and these contribute to the Gothic Revival architecture. The Parish Centre contributes to the historic and architectural character of the Echuca Central Precinct.

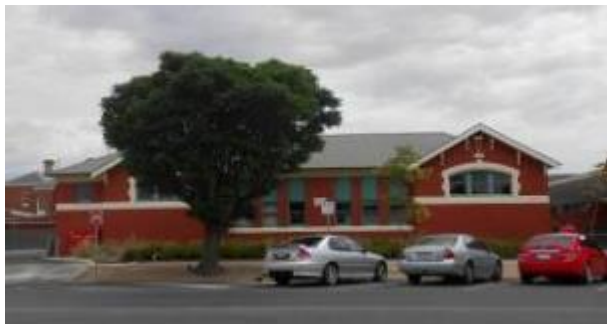
| 216 Anstruther Street, Echuca (1919 Red Brick Building) | Place Type | Former Library/part of school |

Place Description – The 1919 brick building demonstrates many popular Interwar architectural features associated with institutional buildings. The main building has opposing gables with corrugated metal roofing. Typical features include the: face brick work and contrasting cream banding; the flat arches to the upper windows; the bracketed eaves; the two sets of triple timber double hung windows. This building contributes to the historic and architectural character of the Echuca Central Precinct.

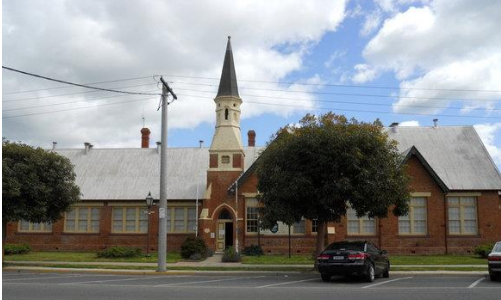
| 103-107 Hare Street, Echuca | Place Type | Former 208 School site - Echuca Primary School |

**Place Description** – a substantial single storeyed brick public school retaining elements of its gothic design including the belltower with porch beneath, buttresses, steeply sloping gable roof with characteristics barge enrichment and drip moulds to openings. It is a representative of the Public Works Department's designs under the direction of Henry Barstow. The former state school contributes to the historic and architectural character of the Echuca Central Precinct.
