# ***Heritage Review 2014 - Part B***

## ***Heritage Precincts***

**Heritage Review 2014**  
**PART B – Heritage Precincts**

**September 2014**  
**(Amended February 2016)**

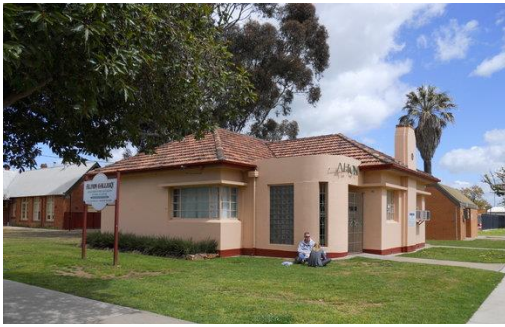
| 109 Hare Street, Echuca | Place Type | Infant Welfare Centre |

**Place Description** – The former Infant Welfare Centre demonstrates a number of stylistic features that are typical of the mid- 20<sup>th</sup> century Moderne style. These include the curved entry porch, the corner windows, and the asymmetrical design of all of the facades. The terracotta tiled roof consists of a series of hip roofs and these complement the varieties found within the facades. The former Infant Welfare Centre contributes to the historic and architectural character of the Echuca Central Precinct.

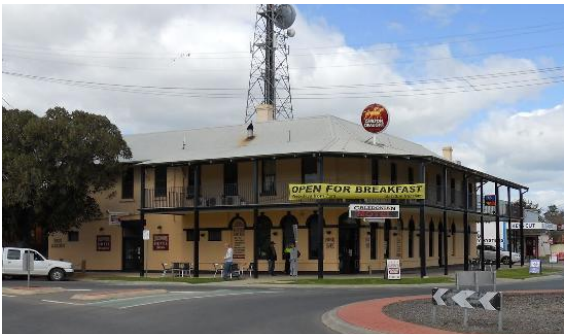
| 110 Hare Street, Echuca (Caledonian Hotel) | Place Type | Hotel |

**Place Description** – a substantial two storeyed stuccoed masonry hotel occupying a prominent corner site and having round arched openings at ground level and flat arched openings at first floor level with a later timber posted verandah. The roof is a large hip roof with a broken back verandah. The hotel contributes to the historic and architectural character of the Echuca Central Precinct.

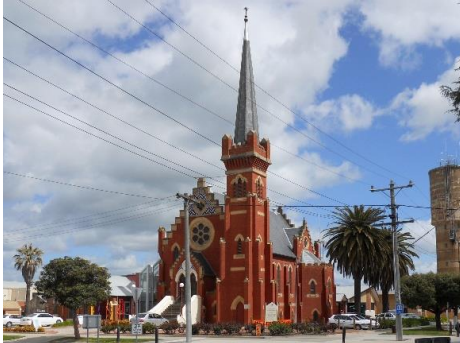
## 115 -117 Hare Street, Echuca (St Andrews Uniting Church)

**Place Description** – an Edwardian gothic revival church distinguished by its castellated parapets, stepped gable treatment and glazed tile work substituting for other more traditional forms of enrichment. The engaged spire has a machicolated and castellated parapet wall at the base with buttress copings enhancing the impact of the stepped gables. The nave is approached by means of a flight of slate steps with outward curving cast cement balustrades terminating at cast iron lamps. The nave is elevated about the Sunday school adding prominence to the structure. The church contributes to the historic and architectural character of the Echuca Central Precinct.

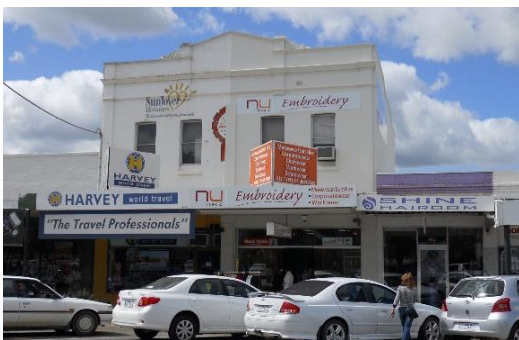
## 148 Hare Street, Echuca

**Place Description** – a prominent two storeyed brick pair of shops with dwellings above having a stuccoed façade above verandah level with plain frieze, simple cornice and central pediment with supporting volutes. The commercial building contributes to the historic and architectural character of the Echuca Central Precinct.

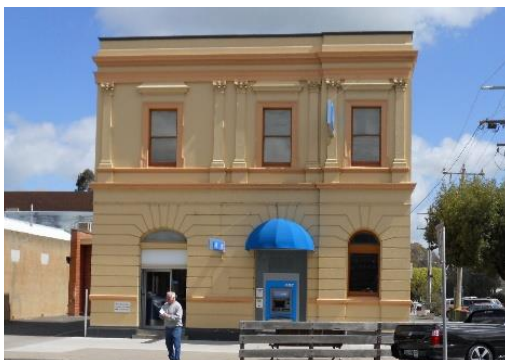
## 179 Hare Street, Echuca (ANZ Bank)

**Place Description** – The former bank demonstrates a fine Renaissance inspired façade. It is a two storey stuccoed masonry building. The ground floor has a stylised rusticated tooling to the stucco. The windows have arched heads with tooled voussoirs. The upper floor has a rectangular windows and these are flanked by pilasters with Corinthian capitals. There is a distinctive cornice to the upper

floor as well as string coursing and cornice to the mid-section. It is notable for its intactness. The former Bank contributes to the historic and architectural character of the Echuca Central Precinct.

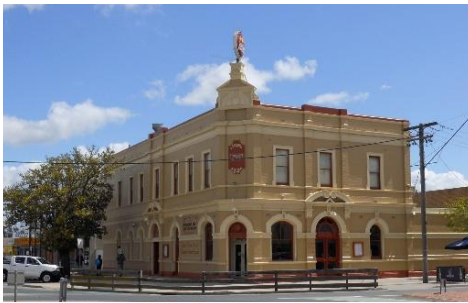
| 183-187 Hare Street, Echuca (Harvest Hotel) | Place Type | Hotel |

**Place Description** – The Harvest Hotel is a good example of the Renaissance revival style. It is a two storey stuccoed masonry building. The ground floor has arched windows and arched openings. The arched openings are of a slightly larger scale and this contrast creates a lively feature within the architectural presentation. The upper floors have rectangular double hung windows. The corner is addressed with a corner door and corner pediment to the parapet. The upper floor is divided into bays by flat pilasters. The hotel building contributes to the historic and architectural character of the Echuca Central Precinct.

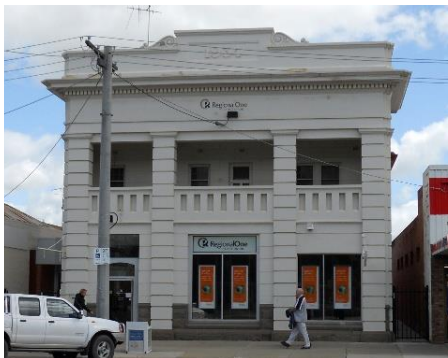
| 197 Hare Street, Echuca | Place Type | Former Bank |

**Place Description** – an imposing classical revival two storeyed building with symmetrical stuccoes façade formed by rusticated pilasters subdividing into three bays with upper level residential balcony and surmounting frieze, detilated cornice and parapet having a raised central section with “1934” in low relief and supporting volutes. At street level an unpainted axe finished bluestone plinth is representative of its period but unusual in Echuca (compare St Mary’s fence opposite). Façade treatment returns for depth of balcony. The former bank building contributes to the historic and architectural character of the Echuca Central Precinct.

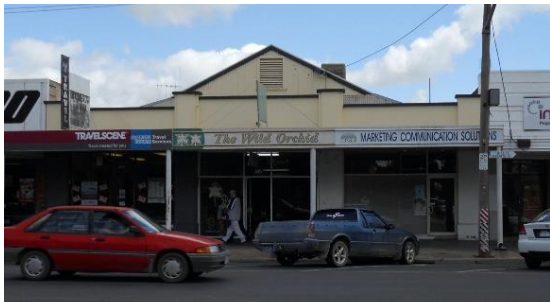
| 205 Hare Street, Echuca | Place Type | Commercial |

**Place Description** – 205 Hare Street demonstrates architectural features associated with the Interwar period. This includes the masonry parapet with capped masonry piers. The rear gable roof provides a de facto pediment to the overall façade as viewed from the streetscape. It has a posted canopy and the ground floor glazed shop fronts are later modifications. This commercial building contributes to the historic and architectural character of the Echuca Central Precinct.

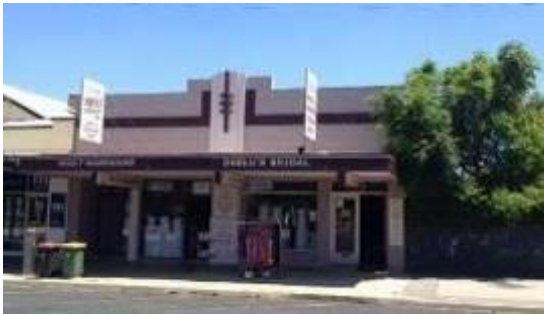
| 209-211 Hare Street, Echuca | Place Type | Commercial |

**Place Description** – 209 – 211 Hare Street is a very fine example of an Art Deco building. The parapet has bands of horizontal relief panels with a centralised vertical panel with a decorative central motif. This central decorative feature – a vertical element rising up through the parapet with horizontal band to the top is a common Art Deco Motif. The cantilevered canopy is original fabric and has complementary horizontal strips. The parapet is distinguished by its intactness and integrity. This commercial building contributes to the historic and architectural character of the Echuca Central Precinct.

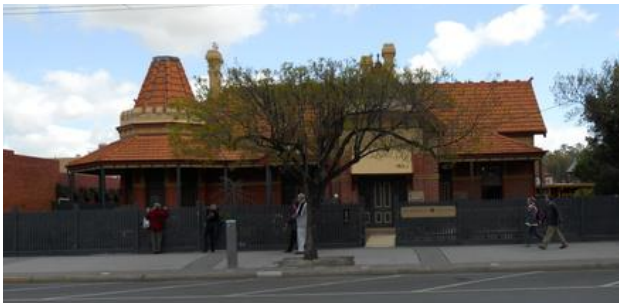
| 213-219 Hare Street, Echuca | Place Type | Former Christ Church Rectory |

**Place Description** – 213-219 Hare Street is a fine example of a Federation era building. It is a face red brick building, with contrasting cement dressings and a red terracotta tiled roof. The rendered chimneys are slender and have a cornice and string coursing. The gable roof has decorative terracotta ridge tiles. The large bay has a castellated parapet with a part demolished 'candle snuffer roof.' The verandah encircles the bay. There is a large gable breakfront to the front entrance. The dwelling is a former doctor's consulting rooms and residence and contributes to the historic and architectural character of the Echuca Central Precinct.

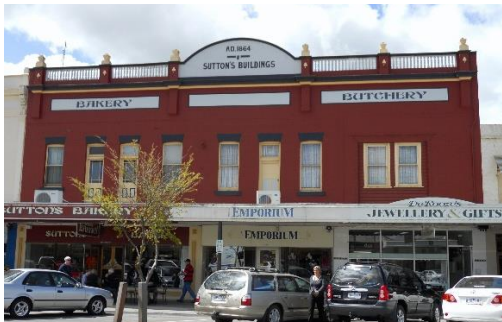
| 216 Hare Street, Echuca (Suttons Building) | Place Type | Bakery/ commercial |

**Place Description** – a prominent two storeyed brick shop with distinguishing balustrade parapet and semicircular pediment, subdividing the upper sections by means of pilasters into three bays with stuccoed frieze panels. The pediments has "AD 1964 Sutton's Buildings" in low relief and the pilasters have clover leaf motifs. The juxtaposition of doors and windows at first floor level expresses the sequence of additions. This commercial building contributes to the historic and architectural character of the Echuca Central Precinct.

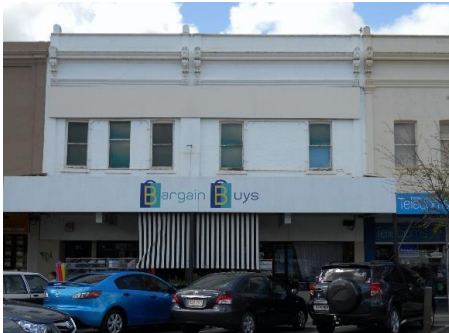
| 220-222 Hare Street, Echuca | Place Type | Commercial |

**Place Description** – 220 – 222 Hare Street is a typical pair of 19<sup>th</sup> century commercial buildings. They are two storey stuccoed masonry buildings. 220 Hare Street has been altered with the removal of the central windows. There is also some form of sheeting that has been applied to the wall above the windows of both shops. The first floor of 222 Hare Street has a triple band of windows. The façades are distinguished by pilasters, cornices and console brackets. The ground floor has a cantilevered canopy and modified glazed shopfronts. 220 – 222 Hare Street are similar to 218 Hare Street. These commercial buildings contribute to the historic and architectural character of the Echuca Central Precinct.

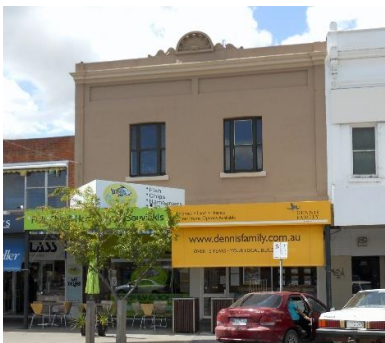
| 224-226 Hare Street, Echuca | Place Type | Commercial |

**Place Description** – 224 – 226 Hare Street is a two storey stuccoed masonry building. Some of the decorative features are missing from the first floor but there is sufficient detailing to support its late 19<sup>th</sup>/early 20<sup>th</sup> century façade. The two upper floor windows are timber framed windows with side lights. The cornice has stripped recessed panels to its underside. This commercial building contributes to the historic and architectural character of the Echuca Central Precinct.

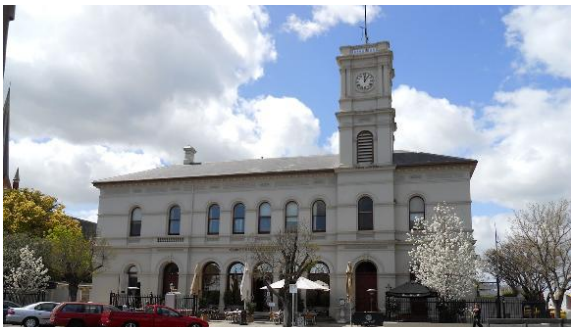
| 256 Hare Street, Echuca | Place Type | Former Post Office |

**Place Description** – an imposing two storeyed stuccoed Italianate public building with two staged clock tower and round arched openings with former loggia facing Hare Street. The cornice is bracketed with guilloche motif in panels to the frieze, whilst the entries for the public and to the post master's residential entry are set in front of the main façade. The former Post Office contributes to the historic and architectural character of the Echuca Central Precinct.

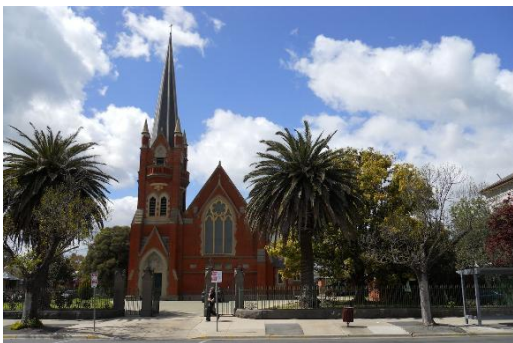
| 258 Hare Street, Echuca (St Mary's Catholic Church) | Place Type | Church |

**Place Description** – a substantial tuck pointed red brick early English gothic revival church with distinctive corbelled balconette and pinnacles to the slated spire. The spire with porch beneath is balanced by a porch at the south-west corner and there are transepts with an apsidal end. Inside the crossing is emphasised by intersecting trusses which are typically scissor formed supporting a roof with diagonal timber linings. The helical staircase to the spire is cast iron and the pews and fit out is of a later date. The church contributes to the historic and architectural character of the Echuca Central Precinct.

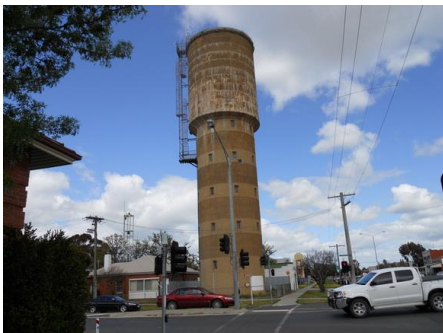
| Crn High Street & Pakenham Street, Echuca | Place Type | Water Tower |

**Place Description** – The concrete water tower has contrasting concrete banding to the access tower. The upper storage area has evidence of a number of repairs. This is a landmark feature within the Echuca Central Precinct and it contributes to the historic and architectural character of the Echuca Central Precinct.

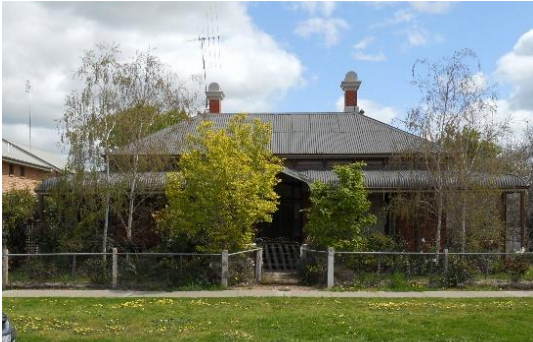
| 391 High Street, Echuca | Place Type | Dwelling |

**Place Description** – 391 High Street is a typical late Victorian residence. It is constructed from face red brick and has a hipped and corrugated metal roof with a bull nosed verandah to three sides with a breakfront to the entrance. The chimneys are decorative and have rendered cappings. The windows are placed symmetrically around the central entrance. This residence contributes to the historic and architectural character of the Echuca Central Precinct.

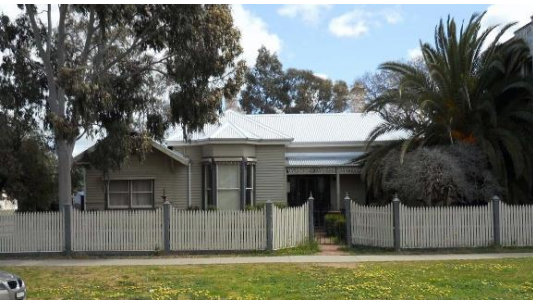
| 397 High Street, Echuca | Place Type | Dwelling |

**Place Description** – The residence at 397 High Street Echuca is a late Victorian residence. It is a timber weatherboard house with a corrugated metal hipped roof with a projecting bay. The verandah has a decorative cast iron frieze. There is a later 20<sup>th</sup> century addition with a gable front and a pair of timber double hung windows. The timber picket fence complements the architectural character of the house. This residence contributes to the historic and architectural character of the Echuca Central Precinct.

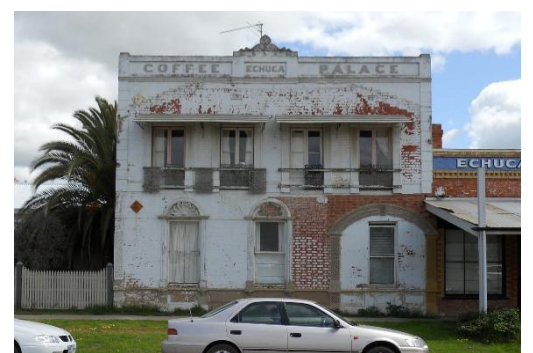
| 399 High Street, Echuca | Place Type | Former Coffee Palace, Weymouth's Temperance Hotel |

**Place Description** – a composition of brick buildings of various ages, all Victorian, dominated by a street boundary façade comprised of two abutting buildings, one single storey and one two storey. Clear evidence on the façade indicated fenestration modifications to both. The single storey section is typical mid-Victorian. It conceals a double pitched gable ended roof running parallel with the street. The present large windows facing High Street indicate possible past use as a shop or tea room. The two storey section of the complex, the most recent, has a partially rendered façade with dado moulding and with parapet mouldings framing plain raised lettering "Coffee Echuca Palace". The smaller central word "Echuca" is surrounded by elaborate entablature featuring a shell motif.

This shell motif is repeated above the two windows of the ground floor. The third window is in the middle of the window opening. Four French windows in rendered surrounds used to open to a first floor verandah no missing but its location is clearly evident on the façade. This building contributes to the historic and architectural character of the Echuca Central Precinct.

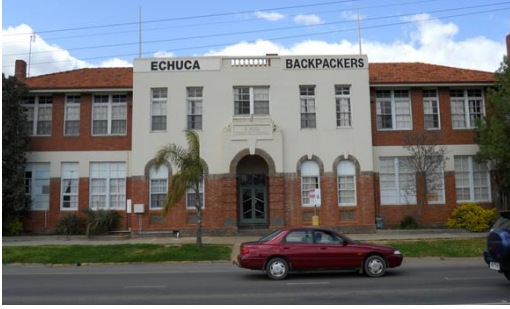
| 410 High Street, Echuca (Echuca Backpackers) | Place Type | Former Echuca Technical School |

**Place Description** – The former technical school shares many of the architectural characteristics associated with this type of Interwar building. It is a symmetrical building with a formalised central section. This section is distinguished by the arched entrance way which is flanked on either side by two arched windows. The base of this section has been constructed with face brickwork with a rendered upper section. The remaining sections of the building flank this entrance panel have horizontal bands of windows to the ground and upper floors. The roof is terracotta tiled hipped roof. The former school contributes to the historic and architectural character of the Echuca Central Precinct.

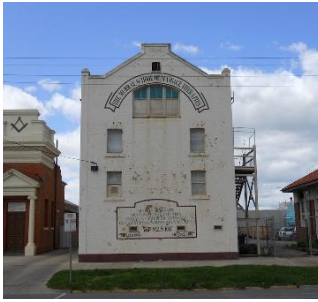
| 424 High Street, Echuca | Place Type | Former Flour Mill |

**Place Description** – a substantial formerly four storeyed over painted red brick with stuccoed dressings former flour mill. The corrugated iron clad gable roof is concealed from High Street by a parapeted gable end, enriched with the date of alteration works (1914) in cast cement and corner “pilaster” terminations. Openings have slightly segmental heads to High Street although c. 1914 work is either flat arched or with an enriched segmental arch (to High Street). Single storeyed corrugated iron outbuildings are attached at the rear and a later timber staircase provides access to the upper level on the southern elevation. A recent alteration has seen an access door added to the front (High Street) façade. This building contributes to the historic and architectural character of the Echuca Central Precinct.

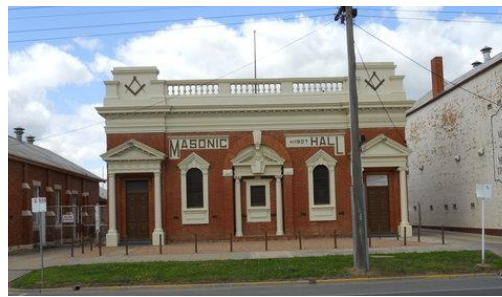
| 426 High Street, Echuca | Place Type | Masonic Lodge |

**Place Description** – an imposing Italianate public building with symmetrical façade to High Street having a central blind archway with elaborate stuccoed broken pediment carried on defaced fluted columns flanked by pavilions emphasised by engaged ionic porticos

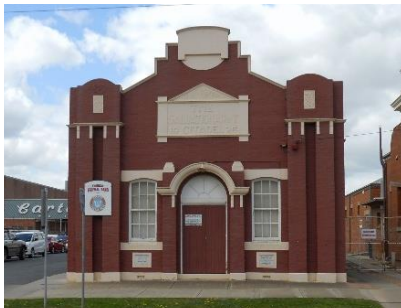
| 432-436 High Street, Echuca | | Place Type | Salvation Army Citadel |

**Place Description** – a brick hall with inter-war classical revival façade in red ochred brick, now overpainted with stuccoed (also overpainted) enrichment. Coupled pilasters, stepped gable, round and segmentally arched openings and semi-circular hood mould to the entry with surmounting cast cement panel are the principle elements. The hall with stage has 4 bays with timber trusses, mostly concealed by the ceiling line and a rear room constituting another bay. This building contributes to the historic and architectural character of the Echuca Central Precinct.

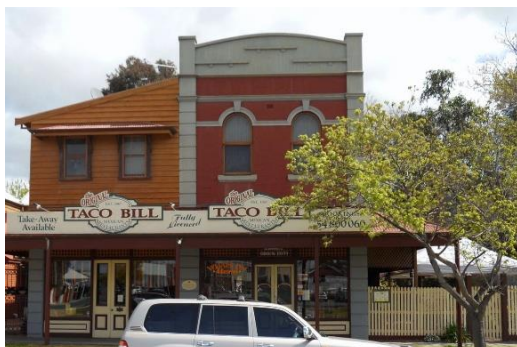
| 433 High Street, Echuca | | Place Type | Former butter factory |

**Place Description** – A two storeyed brick and stuccoed building with additions attached to the south (upper level) and rear, distinguished by reconstructed shop front with verandah, inter-war period parapeted treatment, rusticated pilasters and brick lined basement floor with remnants of stuccoed linings, presumed to related to the buildings former use as a butter factory. This building contributes to the historic and architectural character of the Echuca Central Precinct.

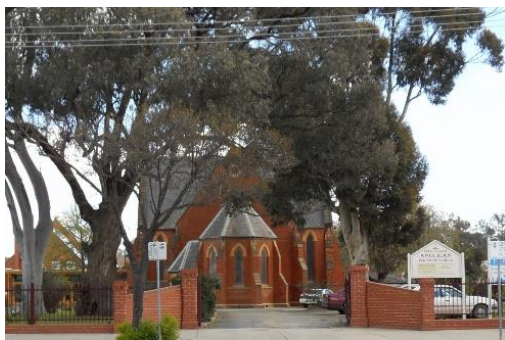
| 500-514 High Street, Echuca (Christ Church Anglican Church) | | Place Type | Church |

**Place Description** – a mid-Victorian gothic revival church with apsidal end, transepts and later stained glass windows to west end. Brickwork is tuckpointed and bi-chromatic and the stuccoed ornamentation is generally limited to the string courses and buttress copings. Inside, the crossing is emphasized by the intersection of four trusses springing from grouped pilasters in the gothic manner.

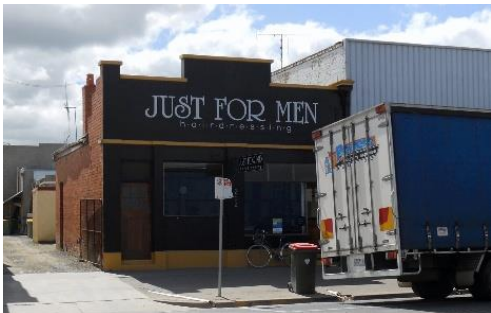
| 252 Pakenham Street, Echuca | Place Type | Commercial |

Place Description – 252 Pakenham Street has an Interwar rendered masonry parapet with capped piers and a capped rectangular pediment. The glazed shop front has been modified. The commercial shop contributes to the historic and architectural character of the Echuca Central Precinct.

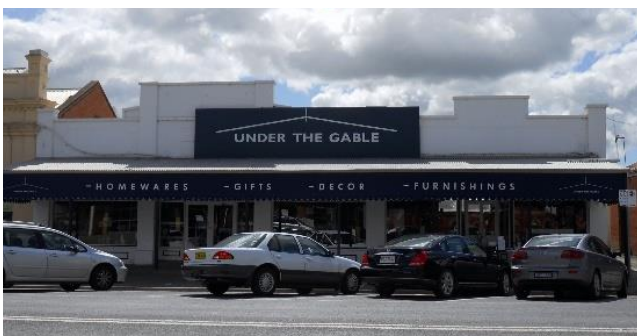
| 254 Pakenham Street, Echuca | Place Type | Commercial |

Place Description – 254 Pakenham Street are Interwar shop fronts with rendered masonry parapets. The parapets have capped piers and capped rectangular pediments. The glazed shop fronts have been modified. The skillion roofed verandah appears to have been modified. The commercial shops contribute to the historic and architectural character of the Echuca Central Precinct.

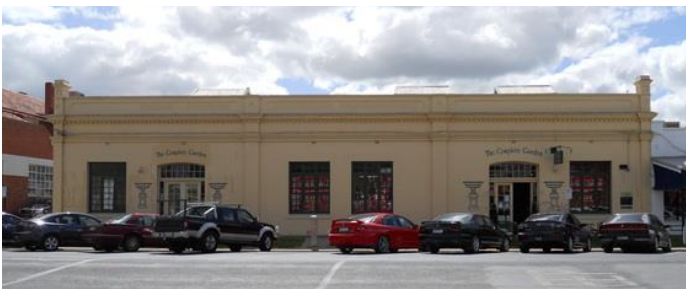
| 258 Pakenham Street, Echuca | Place Type | Commercial |

Place Description – a former tuckpointed brick store with an elegant main façade subdivided into three pilastered bays with frieze and dentillated cornice, the parapet and pilaster terminations having distinctive recessed panels, not seen elsewhere in Echuca, and the corner pilasters being carried up as chimneys. Perimeter walls are brick and the gable roof has glazed lanterns. This commercial building contributes to the historic and architectural character of the Echuca Central Precinct.

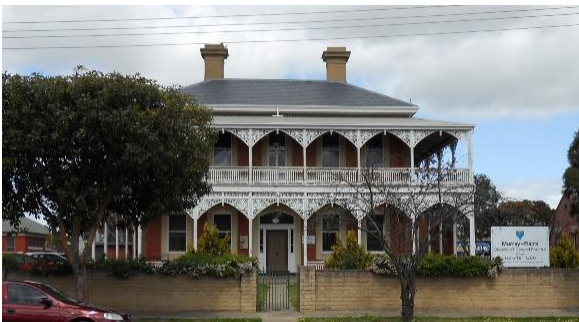
| 13 Percy Street, Echuca | Place Type | St Mary's Catholic Priory |

Place Description – St Mary's Catholic Priory is a late Victorian double storey brick residence. The roof is a hipped slate roof and the rendered chimneys are distinctive elements of the roofline. The verandah roof has been clad with corrugated metal and has a straight profile. The double storey verandah has extensive cast iron lace work with an ecclesiastic theme. Each bay contains a highly decorative and richly patterned cast iron frieze and brackets and these form a pointed arch. The façade is symmetrical with a timber entrance door with side lights and a highlight. The windows have rendered surrounds. This residential building contributes to the historic and architectural character of the Echuca Central Precinct.

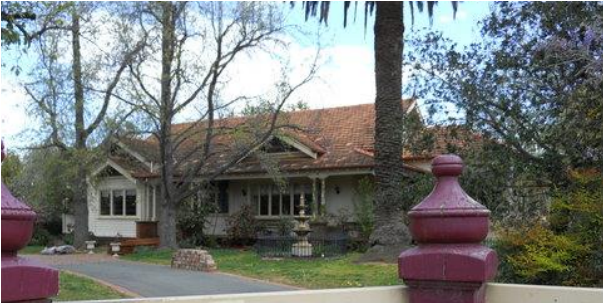
| 41 Francis Street, Echuca | | Place Type | Dwelling |

Place Description - 41 Francis Street is a large Federation era residence in the bungalow style. It is clad with weatherboards and has a terracotta tiled roof. The design is asymmetrical with a particular emphasis on projecting gable roofed sections and recessed verandah. The roof is complex with a number of gables and gablet vents. The windows are generally designed as bands of timber framed casement windows. The verandah includes the entrance and has paired timber posts. The expansive garden setting and timber front fence contribute to the historic character of the house. The house and garden setting

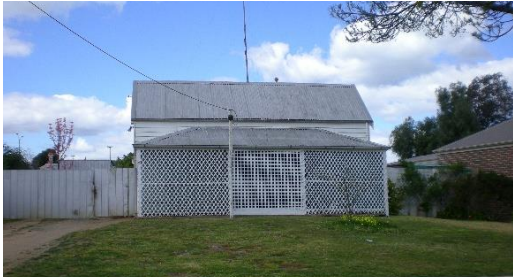
| 42 Francis Street, Echuca | Place Type | Dwelling |

Place Description - 42 Francis Street is a typical late Victorian vernacular timber cottage with a corrugated metal gable roof. The front verandah has a straight profile and is completely enclosed by lattice work. It contributes to the Echuca Central Residential Precinct.

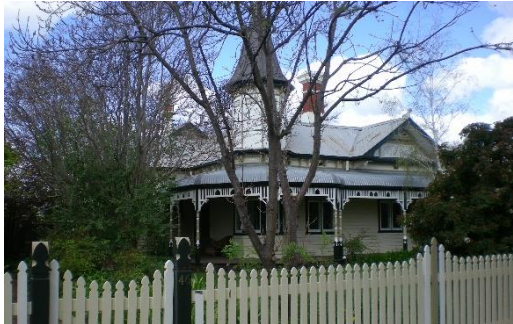
| 46 Francis Street, Echuca | Place Type | Dwelling |

Place Description - 46 Francis Street is a large and finely designed Federation era house. It is a stylish exemplar of its style and demonstrates many of the features associated with this period. This includes the multi gabled roof with gablet vents and the candle snuffer styled roof. The tall and slender chimneys complete the complex roof design. The return verandah has a distinctive timber fretwork. The expansive garden setting and decorative timber fence contributes to its significance. It contributes to the Echuca Central Residential Precinct.

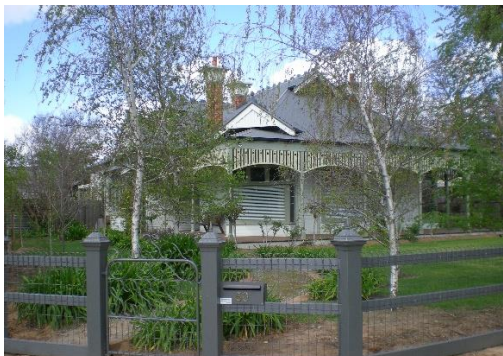
| 50 Francis Street, Echuca | Place Type | Dwelling |

Place Description - 50 Francis Street Echuca is a Federation era house and demonstrates many of the features associated with this period and this includes the multi gabled roof with gablet vents and the decorative ridge capping. The tall and slender chimneys complement the complex roof design. The return verandah has distinctive timber fretwork. The garden setting and the timber post and decorative woven wire fence contributes to its significance. It contributes to the Echuca Central Residential Precinct.

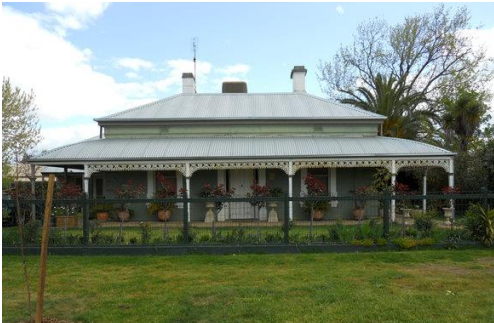
| 53 Francis Street, Echuca | Place Type | Dwelling |

Place Description – a single fronted symmetrical overpainted stuccoed villa with timber posted verandah to north and east elevations, decorative cast iron frieze and quoins. The symmetrical openings have plain stuccoed architraves and there is a later timber room attached to the south wall.

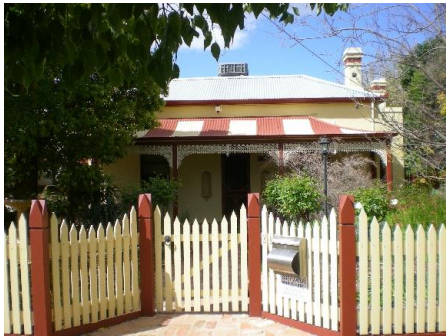
| 54 Francis Street, Echuca | Place Type | Dwelling |

Place Description – an unusual overpainted tuckpointed brick symmetrical villa distinguished by its recessed window spandrels, sill moulds and niches with side of the front door. The verandah has been partially reconstructed and has a concave roof with later iron lace. Symmetrical chimney stacks are chamfered and there is a parapeted wing on the south side.

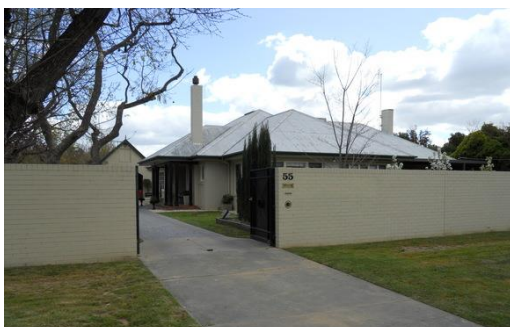
| 55 Francis Street, Echuca | Place Type | Dwelling |

Place Description - 55 Francis Street is a large and somewhat modified residence. It has been constructed from masonry and has a multi hipped corrugated metal roof. The entrance is to the side and has a portico. The front façade has a series of windows. The garden setting contributes to its significance. It contributes to the Echuca Central Residential Precinct.

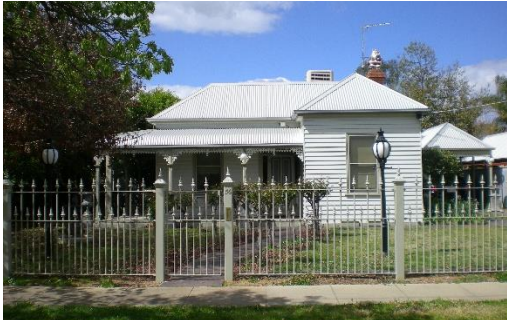
| 56 Francis Street, Echuca | Place Type | Dwelling |

**Place Description** - 56 Francis Street is a timber house with a corrugated metal hipped roof. It demonstrates many of the characteristics associated with Edwardian period. This includes the projecting front with its hipped roof and single timber framed window. The recessed porch has a bullnosed verandah with a cast iron frieze with brackets to the verandah posts. The timber framed door and windows and contribute to its historic character. The garden setting contributes to its significance. The fence is not representative of the period and style. It contributes to the Echuca Central Residential Precinct.

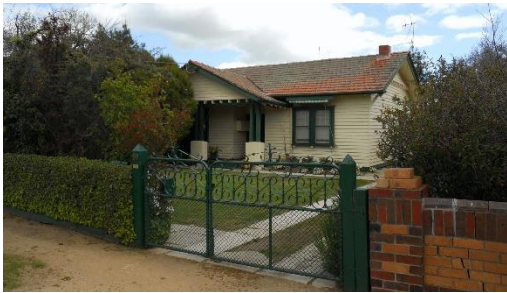
| 59 Francis Street, Echuca | Place Type | Dwelling |

**Place Description** - 59 Francis Street demonstrates many of the characteristics associated with the Interwar Bungalow. It is a weatherboard bungalow with a terracotta tiled roof. Architectural features such as the relatively wide eaves, the opposing gable roofs and the paired timber verandah posts with the masonry plinths are typical for this scale and era of Interwar Bungalow. This particular style is representative of a typical State Savings Bank bungalow design. The timber post and woven wire fence and Cyclone gates are appropriate and complement the garden setting. It contributes to the Echuca Central Residential Precinct.

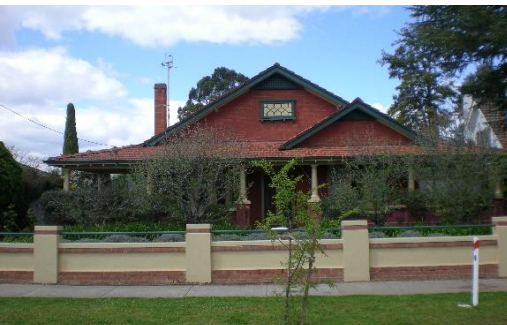
| 62 Francis Street, Echuca | Place Type | Dwelling |

**Place Description** - 62 Francis Street is a fine example of a Federation Bungalow. The styling is more typical of bungalow architecture that developed in response to a search for a national style. These features can be found in the large enveloping gable roof with the return verandah. The main gable has a dominant rectangular motif. The verandah with its masonry piers and low masonry walls are integral to this style. The windows are in bands with a bay window to one side. The low masonry fence and garden setting are complementary elements. It contributes to the Echuca Central Residential Precinct.

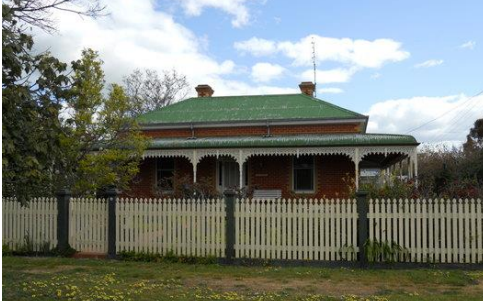
| 63 Francis Street, Echuca | Place Type | Dwelling |

Place Description - 63 Francis Street is a typical late Victorian period residence with a symmetrical façade. The façade has a central door flanked on either side by double hung timber windows. The large hip roof has masonry chimneys and the bullnosed verandah has timber verandah posts with a cast iron frieze and brackets. The return verandah complements the scale of this residence. The timber picket fence and garden setting are complementary elements. It contributes to the Echuca Central Residential Precinct.

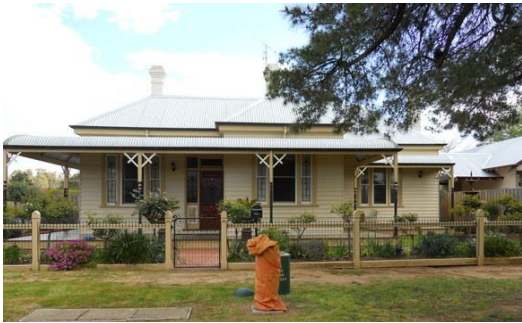
| 65 Francis Street, Echuca | Place Type | Dwelling |

Place Description - 65 Francis Street is clad with weatherboards and has a corrugated metal roof with masonry chimneys. It demonstrates many of the characteristics associated with Edwardian period. This includes the projecting front with its hipped roof, timber framed windows with side lights. The verandah has a minimised bullnose and timber fretwork brackets to the posts. The timber post and woven wire fence and Cyclone gates are appropriate and complement the garden setting. It contributes to the Echuca Central Residential Precinct.

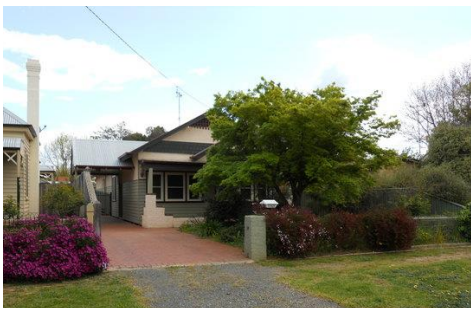
| 67 Francis Street, Echuca | Place Type | Dwelling |

Place Description - 67 Francis Street is a rendered masonry bungalow with a corrugated metal roof. It demonstrates many of the characteristics associated with the Interwar Bungalow. Architectural features such as the relatively wide eaves, the gable roofs and the masonry and the masonry and timber verandah post are typical for this scale and era of Interwar Bungalow. The fence and gates are appropriate and complement the garden setting. It contributes to the Echuca Central Residential Precinct.

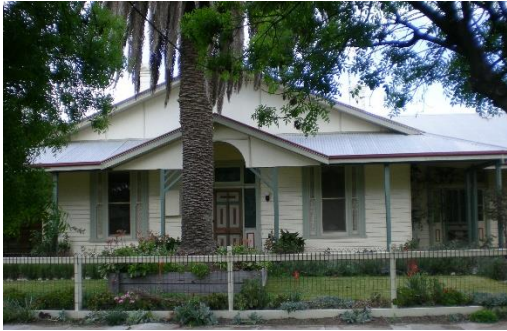
| 68 Francis Street, Echuca | Place Type | Dwelling |

**Place Description** - 68 Francis Street is a bungalow that is clad with weatherboards and has a hipped and gable corrugated metal roof. The front door and the windows have side lights. The timber posted verandah returns to both sides. The woven wire fence and sympathetic gates complement the garden setting. It contributes to the Echuca Central Residential Precinct.

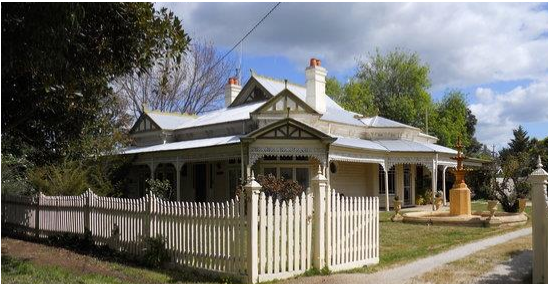
| 71 Francis Street, Echuca | Place Type | Dwelling |

**Place Description** - 71 Francis Street is clad with weatherboards and has a corrugated metal roof. This is an ornate Federation era residence. The design is predicated on the diagonal and this was a common layout (for the period) and for the larger and more ornate residence. The use of the diagonal in the planning was a breakaway from the Victorian symmetry. The diagonal is supported stylistically by the irregularity of the facades; the complex hip and gable roof with gable vents. The facades are distinguished by the use of decorative timber strapping to the gables. The return verandah has a fine frieze and brackets to the verandah posts. The timber picket fence and the garden setting complement this fine residence. It contributes to the Echuca Central Residential Precinct.

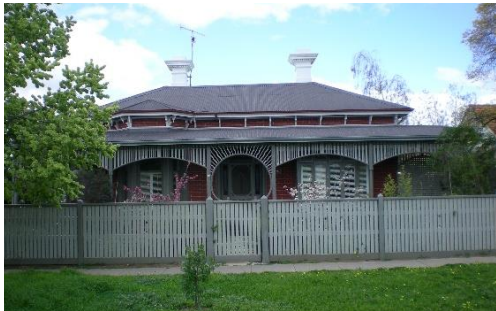
| 74 Francis Street, Echuca | Place Type | Dwelling |

**Place Description** - 74 Francis Street is a stylish masonry residence with a corrugated metal hipped roof with masonry chimneys. Stylistically it demonstrates a change in architecture styling with a move away from the Victorian symmetry and towards a more picturesque and irregular architecture. Features such as the projecting bay and the asymmetry of the front façade contribute to the picturesque historic character. The timber frieze is striking but possibly not original to the date of construction. The timber picket fence and gates and garden setting complement the architecture. It contributes to the Echuca Central Residential Precinct.

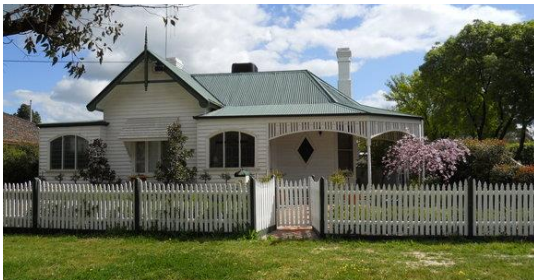
| 75 Francis Street, Echuca | Place Type | Dwelling |

**Place Description** - 75 Francis Street is a weatherboard house with a corrugated metal roof and decorative masonry chimneys. It demonstrates many of the characteristics associated with Edwardian period with some Federation detailing. Architectural characteristics include: the projecting gable front (with its timber finial and collar tie); the timber windows and the window hood. The broken back return verandah is integral to its architectural character and is distinguished by its timber fretwork with timber verandah posts. The picturesque irregularity of this residence has not been compromised by the later modifications and additions. The timber picket fence and gates and garden setting complement the architecture. It contributes to the Echuca Central Residential Precinct.

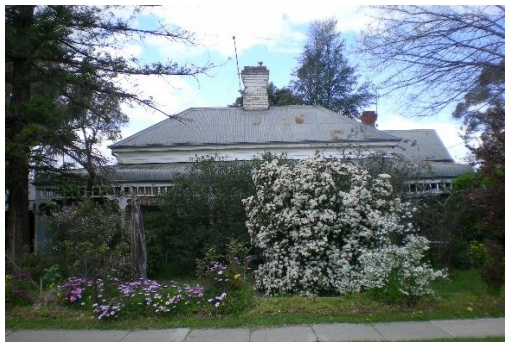
| 80 Francis Street, Echuca | Place Type | Dwelling |

**Place Description** - 80 Francis Street is a typical Victorian period residence with a symmetrical façade. The façade has a central door flanked on either side by double hung windows. The large hip roof has an atypical central masonry chimney. The bullnosed verandah has timber verandah posts with a timber fretwork frieze. The garden setting complements the historic architecture. It contributes to the Echuca Central Residential Precinct.

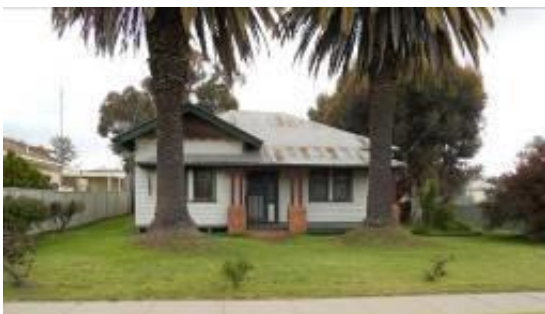
| 323 High Street, Echuca | Place Type | Dwelling |

**Place Description** - 323 High Street is a timber bungalow with a corrugated metal roof. It demonstrates many of the architectural characteristics associated with the Interwar Bungalow. This includes features such as: the relatively wide eaves; the opposing gable roof and hip roof; the decorative finish to the gable. The roof falls to create a verandah roof. The verandah has squat masonry plinths with paired timber verandah posts and these are typical for this scale and era of Interwar Bungalow. This particular style is

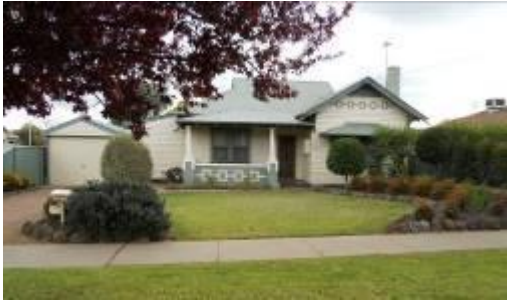
| 325 High Street, Echuca | Place Type | Dwelling |

**Place Description** - 325 High Street is a timber bungalow with a corrugated metal roof and a masonry chimney. It demonstrates many of the characteristics associated with the Interwar Bungalow. It has been modified but these changes have not compromised the stylistic expression of this residence. Architectural features such as the relatively wide eaves, the opposing gable and hip roof (with gable vents), the roof falling to create a verandah roof and the timber and masonry posts are typical for this scale and era of Interwar Bungalow. The garden setting complement the architecture is a timber bungalow with a corrugated metal roof. It contributes to the Echuca Central Residential Precinct.

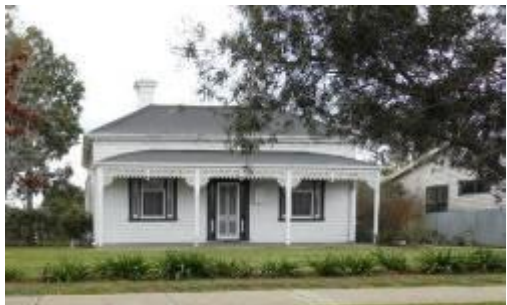
| 329 High Street, Echuca | Place Type | Dwelling |

**Place Description** - 329 High Street is a typical late Victorian period vernacular cottage. It is a timber building with a corrugated metal roof and has masonry chimneys. The styling is dependent on the symmetrical façade with its central door flanked on either side by timber double hung windows with side lights. The verandah is distinguished by a fine cast iron frieze with decorative cast brackets to the verandah posts. The setback provides scope for a sympathetic garden setting. It contributes to the Echuca Central Residential Precinct.

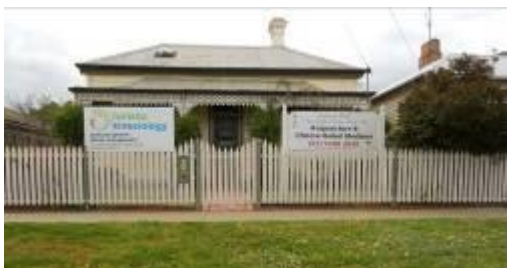
| Photo 337 High Street, Echuca | Place Type | Dwelling |

**Place Description** - 337 High Street is a typical late Victorian period vernacular cottage. It is a timber building with a corrugated metal roof and has one masonry chimney. The styling is dependent on the symmetrical façade with its central door flanked on either side by timber windows. The verandah is distinguished by a fine cast iron frieze and cast brackets to the verandah posts. The timber picket fence and garden setting complements the architecture. It contributes to the Echuca Central Residential Precinct.

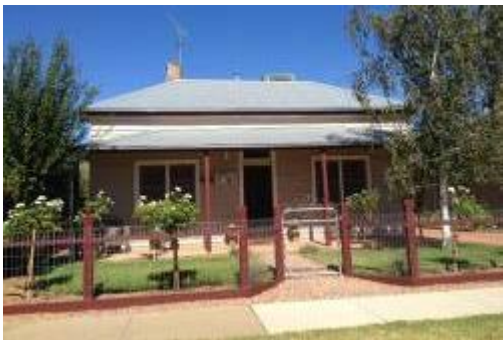
| 339 High Street, Echuca | Place Type | Dwelling |

Place Description - 339 High Street is a typical late Victorian period vernacular cottage. It is a timber building with a corrugated metal roof and it has a masonry chimney. The styling is dependent on the symmetrical façade with its central door flanked on either side by modified paired windows. The verandah and its verandah posts have been modified but are sympathetic. The woven wire fence and sympathetic gates complement the garden setting. It contributes to the Echuca Central Residential Precinct.

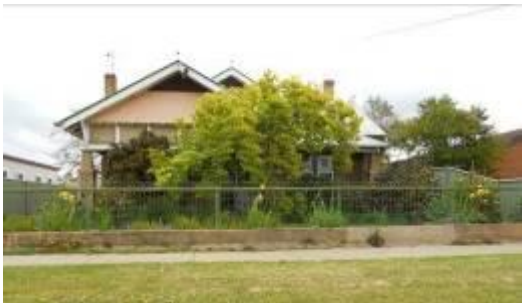
| 341 High Street, Echuca | Place Type | Dwelling |

Place Description - 341 High Street is a good example of a masonry and stucco bungalow with a corrugated metal roof and masonry chimney. Architectural features such as the relatively wide eaves with exposed timber rafters, the double gable roofs, the timber shingled gable fronts and the squat masonry verandah post are typical for this scale and era of Interwar Bungalow. The setback provides scope for a sympathetic garden setting. It contributes to the Echuca Central Residential Precinct.

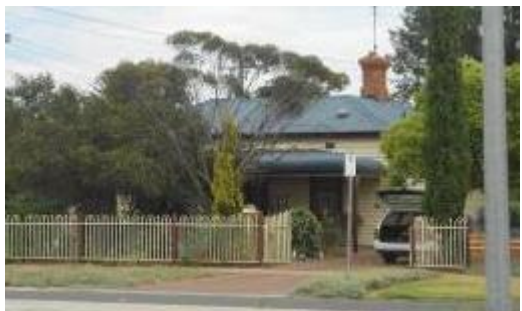
| 347 High Street, Echuca | Place Type | Dwelling |

Place Description - 347 High Street is a typical late Victorian period timber vernacular cottage. It has a corrugated metal hipped roof and a bullnosed verandah. The styling is dependent on the symmetrical façade with its central door flanked on either side by timber windows. The verandah and its verandah posts have been modified but are sympathetic. The setback provides scope for a sympathetic garden setting. It contributes to the Echuca Central Residential Precinct.

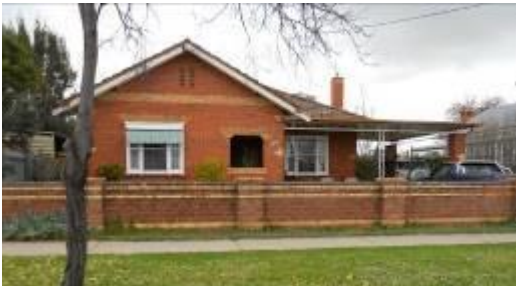
| 349 High Street, Echuca | Place Type | Dwelling |

**Place Description** - 349 High Street is a fine face brick building with a terracotta tiled roof. Its styling has its roots in the bungalow style but it also demonstrates architectural features associated with a later styling. These features can be found in the fully bricked gable front with the contrasting band of cream brick work with its timber framed window and bricked opening (which opens onto the verandah and entrance). The roof falls to create a verandah roof and the entrance is from the side and not the front of the house. The brick fence with its contrasting bands of brickwork complements the architecture and visually frames the building on this site. The setback provides scope for a sympathetic garden setting. It contributes to the Echuca Central Residential Precinct.

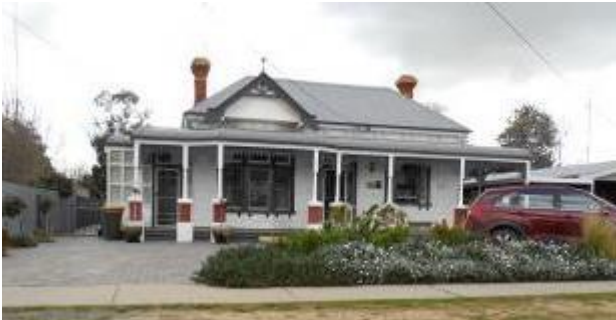
| 351 High Street, Echuca | Place Type | Dwelling |

**Place Description** - 351 High Street is a timber residence with a corrugated metal hipped and gable roof with decorative masonry chimneys. It is a decorative Federation residence with some unusual regional detailing. The design is asymmetrical with its irregular facades and verandah lines. The timber detailing is typical for the period and this includes the window frames, the timber strapwork to the gable. It contributes to the Echuca Central Residential Precinct.

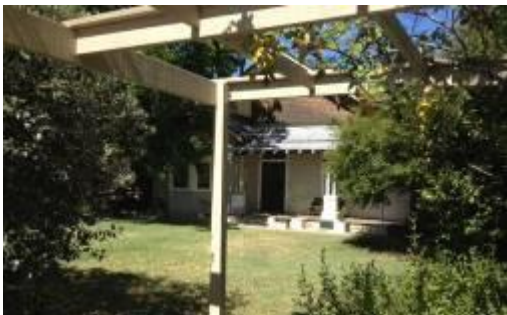
| 355 High Street, Echuca | Place Type | Dwelling |

**Place Description** - 355 High Street is a timber bungalow with a corrugated metal roof. It demonstrates many of the characteristics associated with the Interwar Bungalow. Architectural features such as the relatively wide eaves, the gable roof and the porch with its timber and masonry posts are typical for this scale and era of Interwar Bungalow. The garden setting complement the architecture. It contributes to the Echuca Central Residential Precinct.

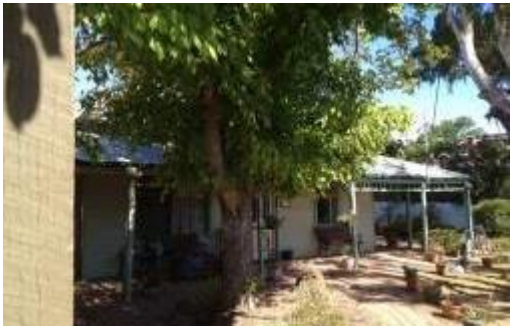
| 357 High Street, Echuca | Place Type | Dwelling |

Place Description - 357 High Street is a late Victorian timber house with a corrugated metal roof. It has a symmetrical façade has a centralized door flanked on either side by timber windows – one of which has been modified. The verandah with its posts and timber fret work frieze complements the architecture of this building. The garden setting complements the architecture. It contributes to the Echuca Central Residential Precinct.

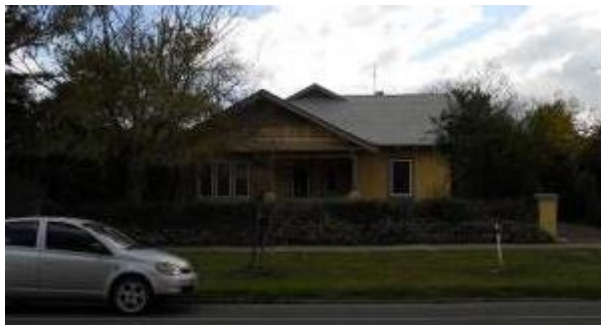
| 359 High Street, Echuca | Place Type | Dwelling |

Place Description - 359 High Street is a good example of a masonry and stucco bungalow with a corrugated metal roof and masonry chimney. Architectural features such as the relatively wide eaves with exposed timber rafters; the double gable roofs and the gablet vent; the timber shingle gable fronts and the timber and masonry verandah post are typical for this scale and era of Interwar Bungalow. The setback provides scope for a sympathetic garden setting. It contributes to the Echuca Central Residential Precinct.

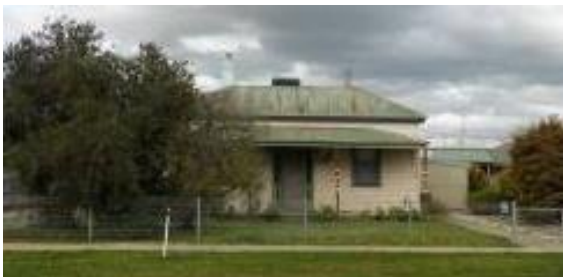
| 366 High Street, Echuca | Place Type | Dwelling |

Place Description - 366 High Street High Street is a typical late Victorian vernacular cottage. It is a timber building with a corrugated metal hipped roof and masonry chimneys. The styling is dependent on the symmetrical façade with its central door flanked on either side by timber double hung windows. The verandah and its timber verandah posts are integral to this style. The setback provides scope for a sympathetic garden setting. It contributes to the Echuca Central Residential Precinct.

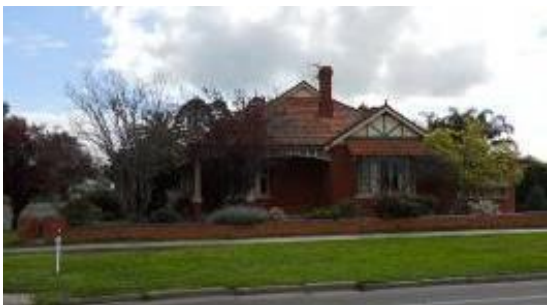
| 381 High Street, Echuca | Place Type | Dwelling |

**Place Description** - 381 High Street is a fine example of a Federation Bungalow. The styling is typical of Federation era bungalow architecture. Qualities such as the simplified elements, the large roof and the deep return verandah hint at the search for a national architecture for the new century. Other features such as the contrasting gable finish with timber strapping; the hip and gablet roof, the decorative masonry chimneys and the wide eaves all demonstrate the main architectural elements associated with this style. The low masonry fence and garden setting are complementary elements. It contributes to the Echuca Central Residential Precinct.

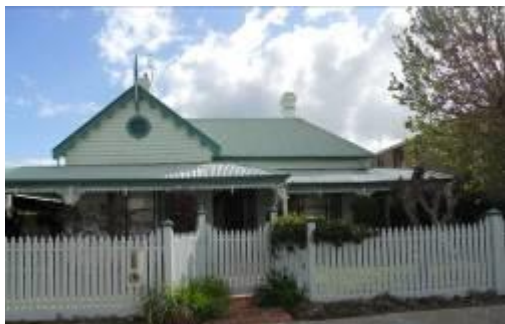
| 383 High Street, Echuca | Place Type | Dwelling |

**Place Description** - 383 High Street is a timber residence with a gable and hipped corrugated metal roof. The styling is picturesque and this is characterized by the projecting gable with its decorative timber barge boards, the timber finial and oculus vent. The later modifications are sympathetic. The timber picket fence and gates and garden setting are sympathetic. It contributes to the Echuca Central Residential Precinct.

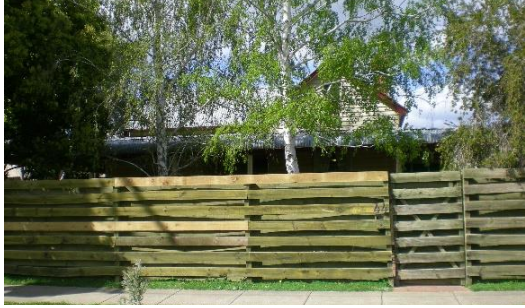
| 44 Hopwood Street, Echuca | Place Type | Dwelling |

**Place Description** - 44 Hopwood Street is an early 20<sup>th</sup> century house. It is clad with weatherboards and has a number of corrugated metal gable roofs and has masonry chimneys. The styling is asymmetrical with a projecting front. The bullnosed verandah extends across the whole of the front. The doors and windows are timber framed. The timber fence is not sympathetic to the period. The setback provides scope for a sympathetic garden setting. It contributes to the Echuca Central Residential Precinct.

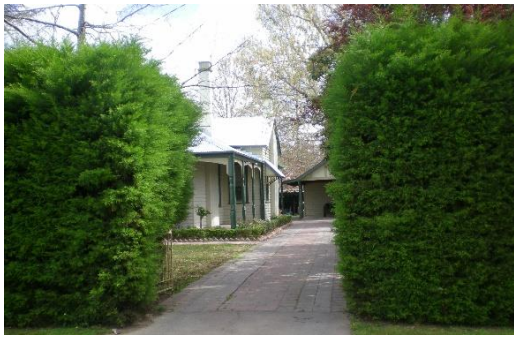
| 47 Hopwood Street, Echuca | Place Type | Dwelling |

**Place Description** – a picturesque timber villa in the federation manner with Dutch gabled corrugated iron clad roof, tall (now painted) chimney stacks with rough cast caps, shingled weatherboard dado, turned timber posted verandah and bay window alongside the front door with lead lit side lights. A projecting wing is shingled and half-timbered with projecting and bracketed gable end and window hood to the bayed window in the Edwardian manner.

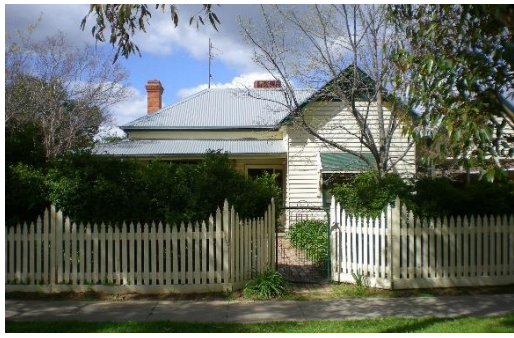
| 50 Hopwood Street, Echuca | Place Type | Dwelling |

**Place Description** - 50 Hopwood Street is a weatherboard clad house with a corrugated hipped and gable corrugated metal roof and decorative masonry chimneys. It demonstrates many of the characteristics associated with Edwardian period. These include: the projecting gable front and the timber window with its window hood. The return verandah has timber verandah posts. The timber picket fence and gates and garden setting complement the architecture. It contributes to the Echuca Central Residential Precinct.

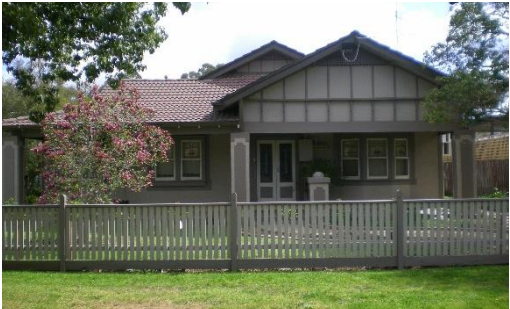
| 53 Hopwood Street, Echuca | Place Type | Dwelling |

Place Description - 53 Hopwood Street is a good example of a masonry and stucco bungalow with a tiled roof and masonry chimney. Architectural features such as the relatively wide eaves with exposed timber rafters, the grouping of the windows, the double gable roofs (with rectangular patterned timber trapping to the gable fronts) and the masonry verandah posts are typical for this scale and era of the Interwar Bungalow. The timber fence and gates and garden setting complement the architecture. It contributes to the Echuca Central Residential Precinct.
