# ***Heritage Review 2014 - Part B***

## ***Heritage Precincts***

**Heritage Review 2014**  
**PART B – Heritage Precincts**

**September 2014**  
**(Amended February 2016)**

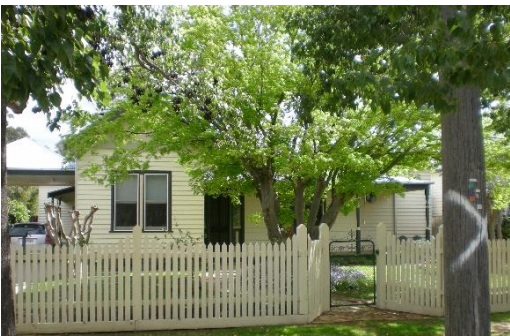
| 55 Hopwood Street, Echuca | Place Type | Dwelling |

Place Description - 55 Hopwood Street is a timber house with a corrugated hipped and gable corrugated metal roof. It demonstrates many of the characteristics associated with Edwardian period. This includes the projecting gable front with its timber windows. The posted verandah contributes to the architectural styling. The timber picket fence and gates and garden setting complement the architecture. It contributes to the Echuca Central Residential Precinct.

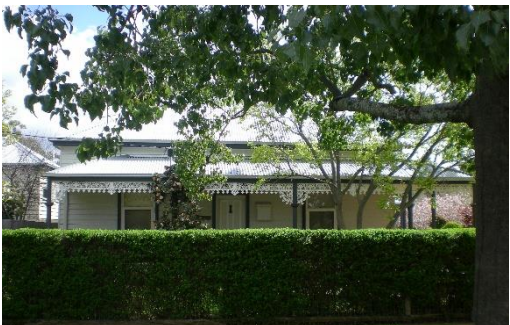
| 57 Hopwood Street, Echuca | Place Type | Dwelling |

Place Description - 57 Hopwood Street is a weatherboard clad building with a corrugated metal roof. The styling is a typical late Victorian period vernacular cottage and this is dependent on the symmetrical façade with its central door flanked on either side by timber double hung window. The slightly convex verandah is distinguished by a fine cast iron frieze and cast brackets to the verandah posts. The hedging to the front fence and the garden setting are complementary to the architectural period. It contributes to the Echuca Central Residential Precinct.

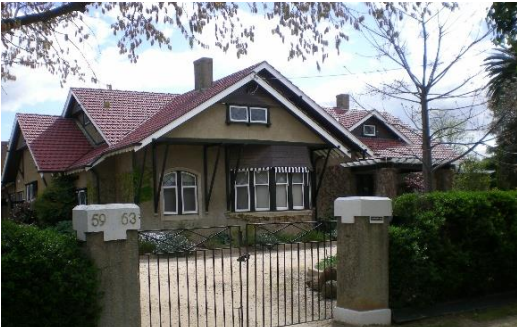
| 59-63 Hopwood Street, Echuca | Place Type | Dwelling |

**Place Description** - 59 – 63 Hopwood Street is one of the finest examples of a masonry and stucco bungalow in Echuca. Its fine unpainted render finish is notable. Other distinctive feature are the bay windows, pairs of timber framed diamond paned windows and the overhanging gable front with its small paired windows. Other architectural features such as grouping of the gable roofs; the masonry chimneys; gablet vents and the relatively wide eaves with exposed timber rafters combine to make this one of the most architecturally distinctive residences in the precinct. The masonry fences with its hedges and gates and garden setting complement this fine residence. It contributes to the Echuca Central Residential Precinct.

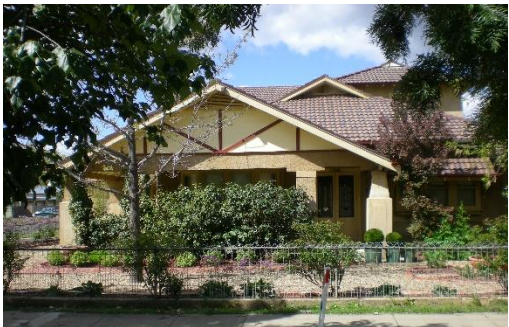
| 62 Hopwood Street, Echuca | Place Type | Dwelling |

**Place Description** - 62 Hopwood Street is constructed from rendered masonry with a terracotta tiled roof. It is a large Federation era Bungalow. The hipped roof with gablet vents and large front gable are typical for the period and scale of this house. The large gable front has timber strapping with generously scaled masonry piers and this creates a distinctive entry. The garden setting is complementary to the architectural period. It contributes to the Echuca Central Residential Precinct.

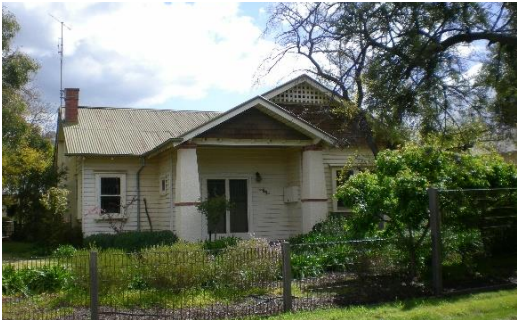
| 65 Hopwood Street, Echuca | Place Type | Dwelling |

**Place Description** - 65 Hopwood Street is a weatherboard clad bungalow with a corrugated metal roof and masonry chimney. The gable roofs combine to create a typical bungalow aesthetic which includes the gable roofed entrance porch with its large masonry piers. The gable fronts have decorative timber shingles with latticework to the gable vents. The garden setting complement the architecture. It contributes to the Echuca Central Residential Precinct.

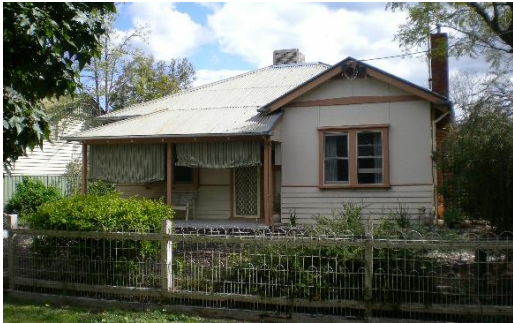
| 67 Hopwood Street, Echuca | Place Type | Dwelling |

Place Description - 67 Hopwood Street is a timber and cement sheet clad house with a corrugated metal hipped and gable roof. There is a timber weatherboard dado panelling. The projecting gable front has a simple timber horizontal timber strap and paired timber windows. The hipped roof falls in an unbroken line to form the verandah. The woven wire fence and garden setting complement the architecture. It contributes to the Echuca Central Residential Precinct.

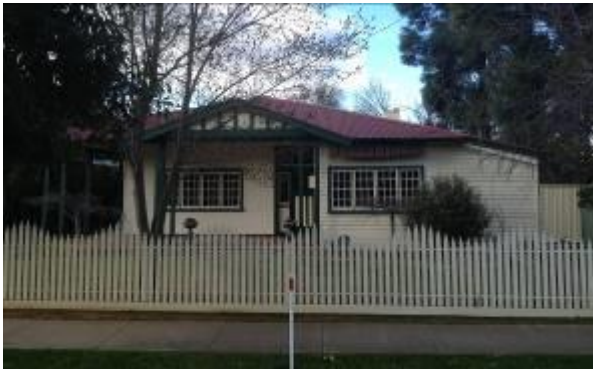
| 68 Hopwood Street, Echuca | Place Type | Dwelling |

Place Description - 68 Hopwood Street is a timber bungalow with a hipped roof with a breakfront gable to the entrance. The façade is distinguished by the rows of small paned windows. The timber picket fence and garden setting complement the architecture. It contributes to the Echuca Central Residential Precinct.

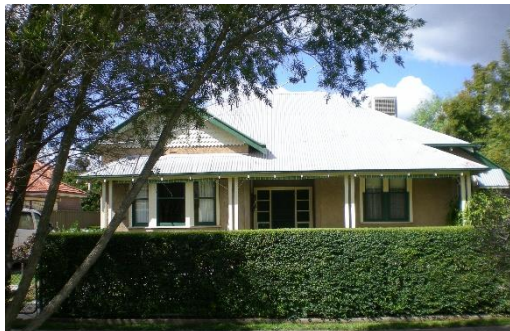
| 70 Hopwood Street, Echuca | Place Type | Dwelling |

Place Description - 70 Hopwood Street is a picturesque house with a corrugated metal hipped and gable roof. The projecting gable front has contrasting timber shingle cladding to its apex and a bay window. The hipped roof falls in an unbroken line to form the verandah. The verandah has paired timber posts with masonry bases. The hedged fence and garden setting complement the architecture. It contributes to the Echuca Central Residential Precinct.

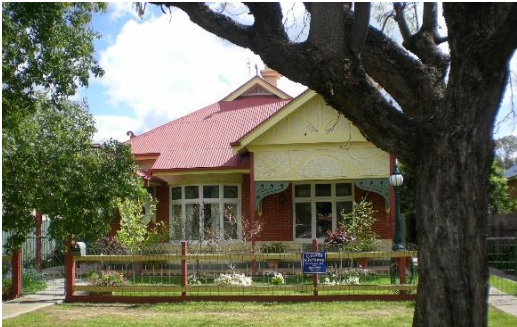
| 73 Hopwood Street, Echuca | Place Type | Dwelling |

Place Description - 73 Hopwood Street is a distinctive Federation era house. It is constructed from masonry has a corrugated metal hipped and gable roof with gablet vents. It demonstrates many fine features and these include the substantial stucco gable front with timber strapping and the decorative timber brackets to the verandah posts. The bands of vertical proportioned windows add to the distinctive character created by its unusual façade. The woven wire fence and garden setting complement the architecture. It contributes to the Echuca Central Residential Precinct.

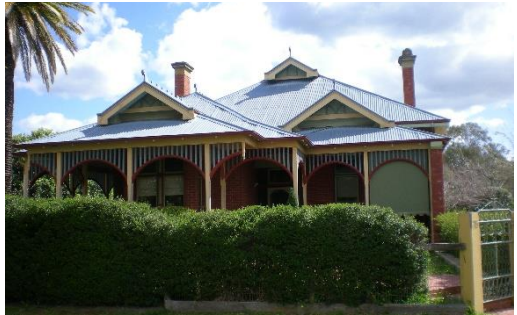
| 75 Hopwood Street, Echuca | Place Type | Dwelling |

Place Description - 75 Hopwood Street is a fine Federation era house. It is constructed from tuck pointed masonry with a corrugated metal hipped and gable roof with gablet vents and finely proportioned masonry chimneys. It demonstrates many of the features associated with the period and these include the decorative gablets and the grouping of the windows. The arched timber fretwork is finely designed. The woven wire fence and garden setting complement the architecture. It contributes to the Echuca Central Residential Precinct.

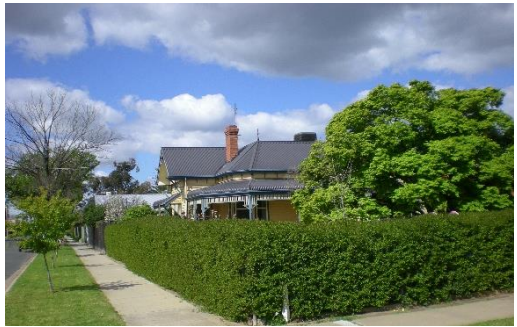
| 76 Hopwood Street, Echuca | Place Type | Dwelling |

Place Description – 76 Hopwood Street is a large late Victorian residence. It is clad with weatherboards and has a hipped and gable corrugated metal roof. The return bullnosed verandah with its decorative timber detailing contributes to its style. Some of the windows have decorative hoods. The hedged fence and garden setting complement the architecture. It contributes to the Echuca Central Residential Precinct.

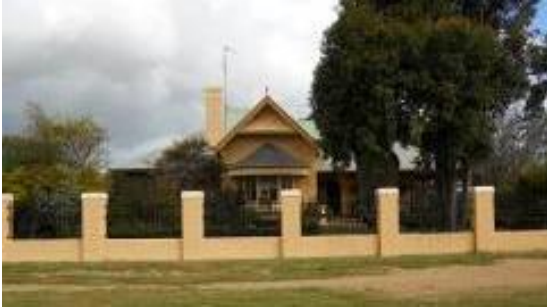
| 221 McKinlay Street, Echuca | Place Type | Dwelling |

Place Description - 221 McKinlay Street is a large masonry Federation era residence. The corrugated metal roof has one large hip with ridge tiles. The rendered façade has vermiculated quoins. The steeply pitched gable front with the bay window provides a counterpoint to the rest of the façade. The verandah is recessed and has fine cast iron frieze with brackets to the verandah posts. The masonry fence and garden setting complement the architecture. It contributes to the Echuca Central Residential Precinct.

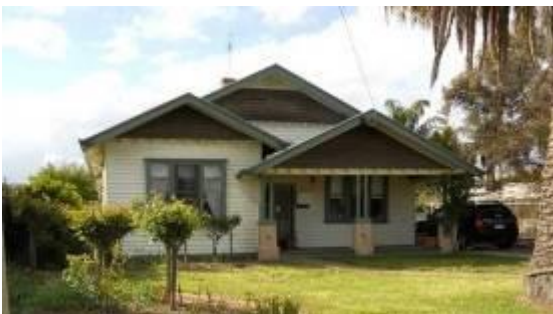
| 2 Tyler Street, Echuca | Place Type | Dwelling |

Place Description - 2 Tyler Street is a timber bungalow with a corrugated metal gable roofs. The gable roofs combine to create a typical bungalow aesthetic which includes the gable roofed entrance porch with its masonry piers and paired timber columns. The gable fronts have decorative timber shingles to the gable vents. The garden setting complement the architecture. It contributes to the Echuca Central Residential Precinct.

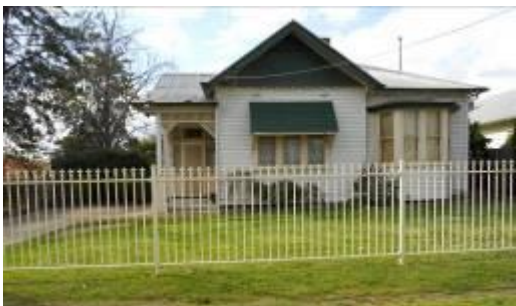
| 4 Tyler Street, Echuca | Place Type | Dwelling |

Place Description - 4 Tyler Street is a timber Interwar residence with a corrugated metal gable and hipped roof. The projecting gable front has a contrasting finishes to the apex of the gable and the triple band of timber framed windows are representative of this period. The entry to one side reinforces the asymmetry of the design and the bay window is integral to its style.. It contributes to the Echuca Central Residential Precinct.

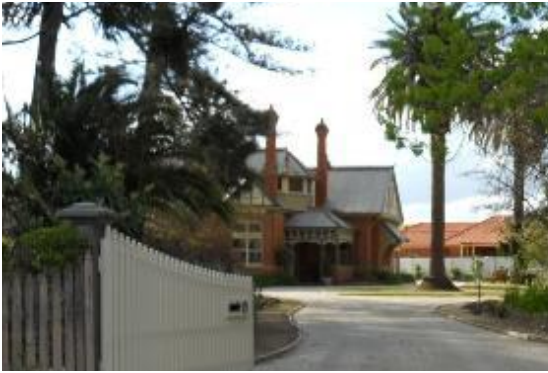
| 12 Tyler Street, Echuca (Cadell) | Place Type | Dwelling |

Place Description - 12 Tyler Street High Street is a fine example of a Federation era bungalow. Its architecture demonstrates a number of other historic themes and these can be found in the Arts and Crafts and the Queen Anne styling. It is constructed from face red brick with rendered contrasting panels such as to the apex of the gable. The complexity of the gable roofs and the fine and slender masonry chimneys contributes to the picturesque character of the building. Features such as the contrasting gable finishes with timber strapping, bands of timber windows and its diagonal placement on the block support its architectural prominence. The timber fence and the garden setting with its large trees support the importance of this building. It contributes to the Echuca Central Residential Precinct.

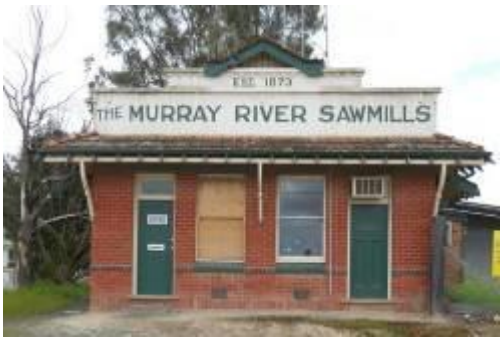
| Murray River Sawmill, Anstruther Street, Echuca | Place Type | Sawmill |

Place Description – the mill complex consists of the following:

Remnants of privately owned rail sidings, including loose chaired rail lengths with cast iron chairs.

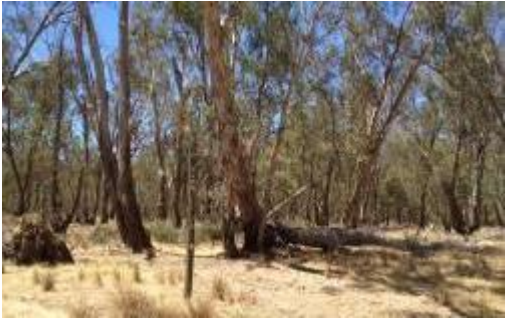
| Shinbone Alley & Reserve, off Anstruther Street, Echuca | Place Type | Former residential area |

Place Description – allotments for Shin Bone Alley shown on 1867 plan. Was a settlement of workers employed in mills and other industries in Echuca. Housing was mostly of a temporary or adhoc nature. It has high local significance as remains of an early settlement of buildings showing how low cost housing was achieved from recycled and inexpensive remains.

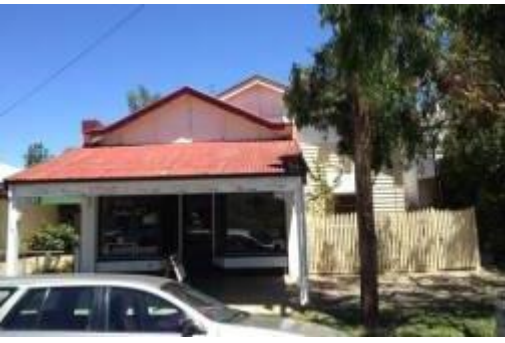
| 127 Pakenham Street, Echuca | Place Type | Dwelling/commercial |

Place Description - 127 Pakenham Street is a shop front with a residence to the rear. The gable forms the parapet and there is a straight profile verandah with timber posts. The glazed shop front has a central entry. The recessed timber residence to the rear has a corrugated gable roof and a timber framed window to the street. There is a timber picket fence. The shop and residence contributes to the Echuca East Precinct.

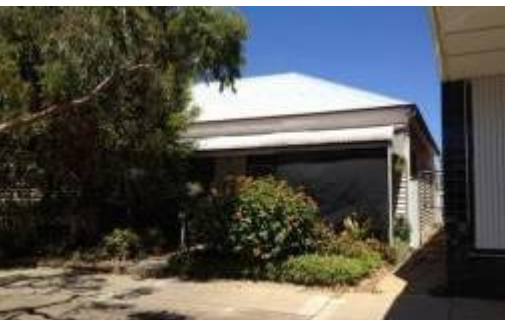
| 129 Pakenham Street, Echuca | Place Type | Dwelling |

Place Description - 129 Pakenham Street is an early 20<sup>th</sup> century house that is constructed from timber and has a corrugated metal roof with a bullnosed verandah. The symmetrical façade has a central door with windows on either side. The residence contributes to the Echuca East Precinct.

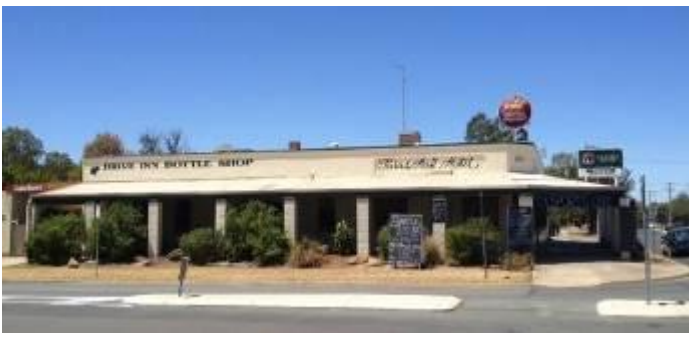
| 130 Pakenham Street, Echuca (Tara's Hall Hotel), | Place Type | Hotel |

Place Description – a single storeyed stuccoed hotel with corner splay and recessed panels above the verandah line. To the north, an extension is in face brick whilst one original window remains in the original portion. Later windows have “Ahern's hotel” in leadlight.

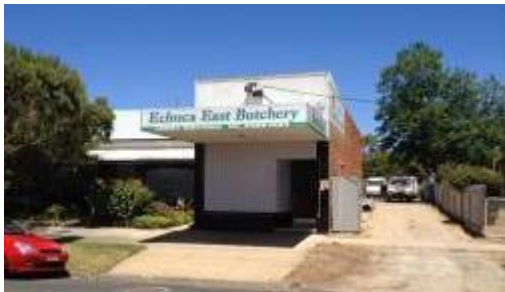
| 131 Pakenham Street, Echuca | Place Type | Commercial |

Place Description - 131 Pakenham Street is a masonry shop with a glazed shop front with an entry to the side of the façade. There is a cantilevered canopy to the full extent of the shop. The shop contributes to the Echuca East Precinct.

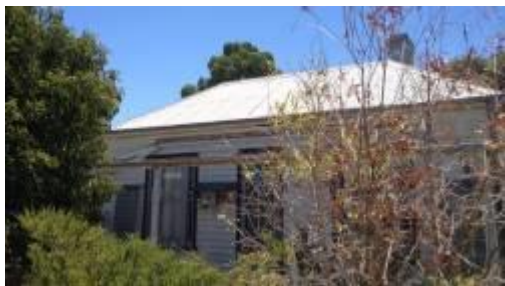
| 134 Pakenham Street, Echuca | Place Type | Dwelling |

Place Description - 134 Pakenham Street is a turn of the century vernacular house with a symmetrical façade. It is clad with timber weatherboards and has a central entrance with timber windows to either side. The corrugated metal roof is hipped. The verandah has been partially demolished. The residence contributes to the Echuca East Precinct.

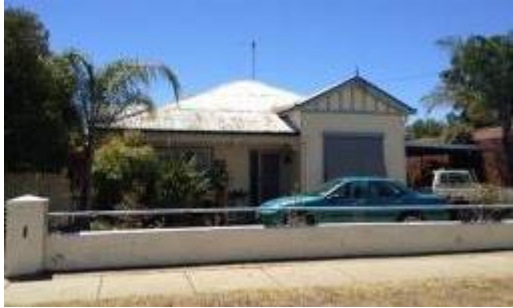
| 138 Pakenham Street, Echuca | Place Type | Dwelling |

Place Description - 138 Pakenham Street is an Interwar house with a hipped and gable corrugated metal roof. It demonstrates many of the vernacular characteristics associated with this period. This includes the projecting front with its gable front and timber strapping. The hipped roof falls in an unbroken line to form the roof of the porch. The entrance is from the porch. The masonry fence complements the style and the garden setting contributes to its significance. The residence contributes to the Echuca East Precinct.

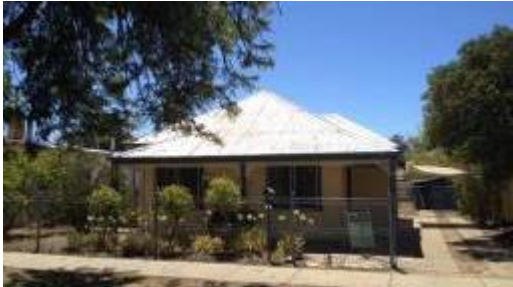
| 140 Pakenham Street, Echuca | Place Type | Dwelling |

Place Description - 140 Pakenham Street demonstrates many of the characteristics from the 20<sup>th</sup> century (pre-World War II). It is a simple design with regularly placed windows to the façade and it has corrugated metal hipped roofs. The setback provides scope for a complementary garden setting. The residence contributes to the Echuca East Precinct.

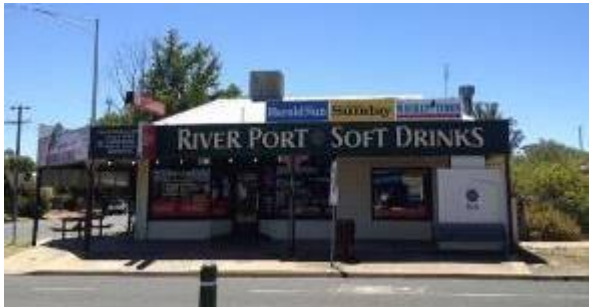
| 142 Pakenham Street, Echuca | Place Type | Dwelling/ commercial |

Place Description - 142 Pakenham Street has been modified but retains sufficient fabric to demonstrate its historic characteristics. The weatherboard corner shop has a glazed shop front with a splayed entry. It has a corrugated metal roof. The shop contributes to the Echuca East Precinct.

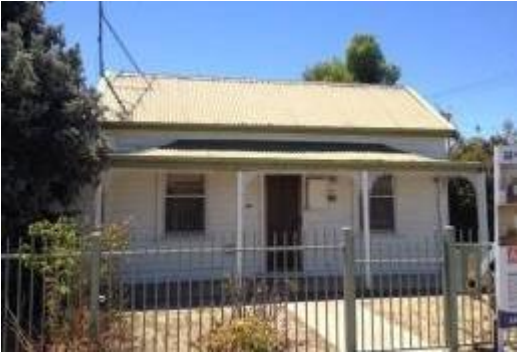
| 144 Pakenham Street, Echuca | Place Type | Dwelling |

Place Description - 144 Pakenham Street is a typical late Victorian period vernacular timber cottage. It has a symmetrical façade with a central door flanked on either side by double hung timber windows. The transverse gable roof has been clad with corrugated metal. The straight profile verandah has verandah posts with cast iron brackets. The setback provides scope for a complementary garden setting. The residence contributes to the Echuca East Precinct.

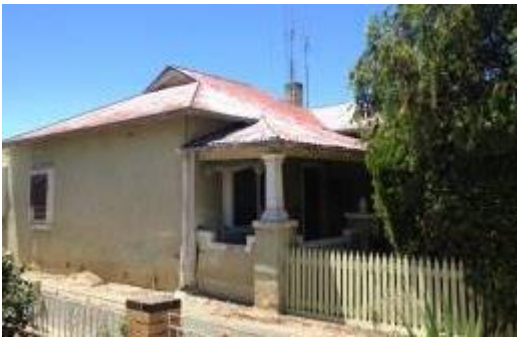
| 148 Pakenham Street, Echuca | Place Type | Dwelling |

Place Description - 148 Pakenham Street is a masonry Interwar bungalow with a corrugated metal hipped and gable roof with gablet vents. The porch is formed by the roof which falls in an unbroken line. The verandah posts are typical in style with a masonry plinth and stylized columns. There is a low masonry wall to the porch and this is contiguous with the columns. The picket fence is complementary. The setback provides scope for a complementary garden setting. The residence contributes to the Echuca East Precinct.

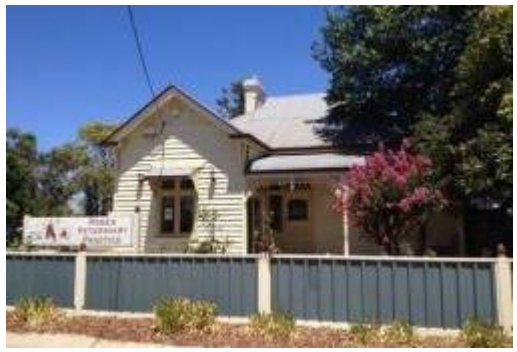
| 149 Pakenham Street, Echuca | Place Type | Dwelling |

Place Description - 149 Pakenham Street is a timber Interwar house with a hipped and gable corrugated metal roof. It demonstrates many of the vernacular characteristics associated with this period. This includes the projecting front with its decorative gable front with timber strapping and the window hoods. The porch has a bullnose profile and decorative cast iron lacework. The entrance is from the porch. The paired timber windows and their timber window frames are typical for the period. The setback provides scope for a complementary garden setting. The residence contributes to the Echuca East Precinct.

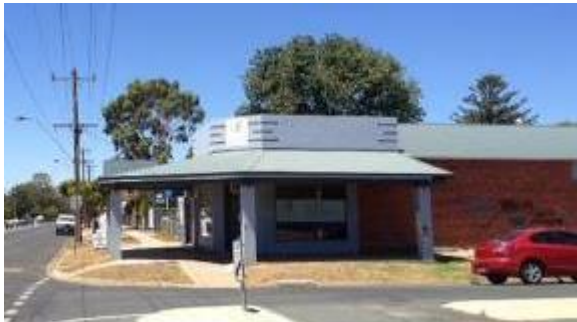
| 151 Pakenham Street, Echuca | Place Type | Commercial |

**Place Description** - 151 Pakenham Street is a masonry corner commercial building. It addresses the corner in the standard manner with a splayed corner entry. The glazed shop front is sympathetic in scale to the building. The verandah returns to both sides. The masonry parapet has horizontal banding typical of the Interwar period and the beginnings of a more functional approach to design. The commercial building contributes to the Echuca East Precinct.

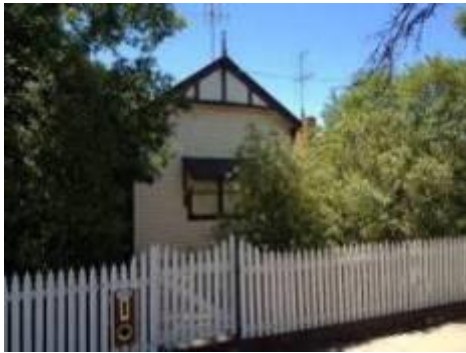
| 154 Pakenham Street, Echuca | Place Type | Dwelling |

**Place Description** - 154 Pakenham Street Echuca is a timber Interwar house with a hipped and gable corrugated metal roof. It demonstrates many of the vernacular characteristics associated with this period. This includes the projecting front with its decorative gable with timber strapping, pressed metal face and the window hoods. The entrance is from a recessed porch and there are timber framed windows. The setback provides scope for a complementary garden setting. The timber picket fence complements the historic character of this building. The residence contributes to the Echuca East Precinct.

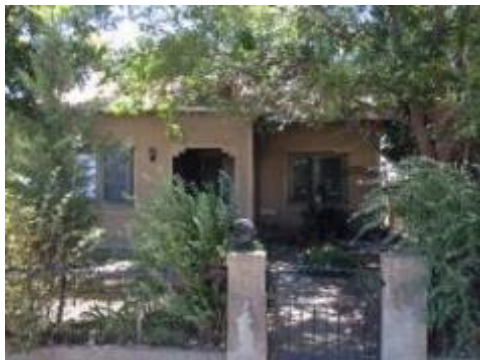
| 156 Pakenham Street, Echuca | Place Type | Dwelling |

**Place Description** - 156 Pakenham Street is a fine example of an Interwar Bungalow. It is rendered in rough cast with contrasting smooth rendered bands to the openings. The roof is a hipped corrugated metal roof. The unpainted render is a fine and distinctive feature of this building. The entry is part of the projecting front section and is articulated by the doorway with smoothly rendered surrounds in contrast to the rough cast render. The fence is of the period and complements the historic character. The setback provides scope for a complementary garden setting. The residence contributes to the Echuca East Precinct.

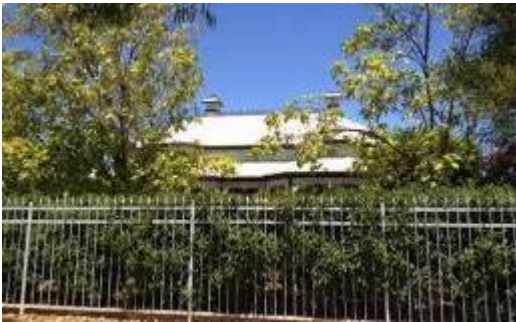
| 163 Pakenham Street, Echuca | Place Type | Dwelling |

**Place Description** - 163 Pakenham Street is a large late Victorian styled house. It is a weatherboard house with a corrugated metal hipped roof. It demonstrates the later stylistic characteristics associated with this period. This includes the stylistic change from a symmetrical façade and towards a more picturesque composition with irregular roof lines and an asymmetrical façade. This is demonstrated by the fine bay window and the commensurate irregularity of the verandah. The timber framed windows complement the character of the building. The setback provides scope for a complementary garden setting. The residence contributes to the Echuca East Precinct.

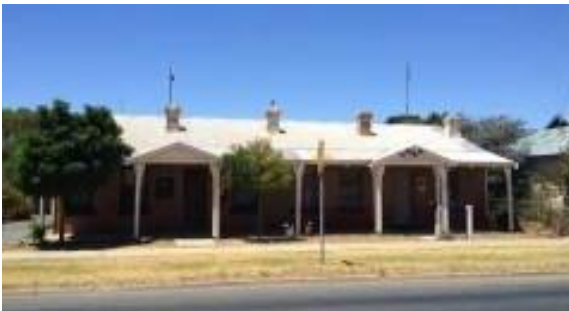
| 138-140 Sturt Street, Echuca | Place Type | Dwelling |

**Place Description** - 138 – 140 Sturt Street Echuca is an atypical terrace for the Echuca township. It is constructed from rendered masonry and has a corrugated metal gable roof which is punctuated by masonry chimneys. The roof falls in an unbroken line to create the verandah. The verandah is distinguished by two breakfront gables. The façade is regular with evenly spaced timber framed windows and doors. The row of terrace housing contributes to the Echuca East Precinct.

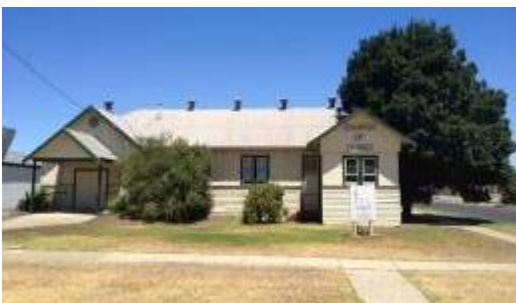
| 128-130 Sturt Street, Echuca (Church of Christ) | Place Type | Church |

**Place Description** - 128 – 130 Sturt Street is a distinctive Interwar ecclesiastic building. It is constructed from timber and has a timber weatherboard dado with the upper section of the wall clad with cement sheeting. The windows are paired with a rectangular form. The roof is a large gable corrugated metal roof with the ridge line punctuated by metal vents. The façade is distinguished at either end by projecting gable fronts. The church contributes to the Echuca East Precinct. The hall located at the rear of the Church building does not demonstrate the same cultural values as the Church due to its significant modifications, particularly the projected

The Church of Christ demonstrates a working class austerity with its unaffected and simple aesthetics and rudimentary external finishes and it is in marked contrast to the elaborate and large scaled ecclesiastic architecture found elsewhere in Echuca. The hall to the rear is not significant.

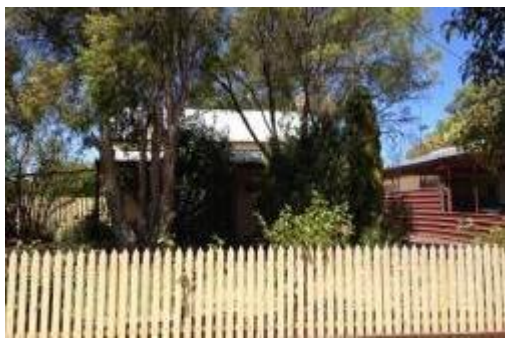
| 112 Hovell Street, Echuca | Place Type | Dwelling |

Place Description - 112 Hovell Street is one of the early vernacular cottages that were typically built as labourers cottages (either for sawmillers or workers associated with port activities). It is relatively diminutive in scale and displays all the characteristics associated with vernacular workers' cottages from the 19<sup>th</sup> century. It has a corrugated metal gable roof with a bullnosed verandah and a centralized door with windows on either side. The timber picket fence complements the historic character of this building. The setback provides scope for a complementary garden setting. The cottage contributes to the Echuca East Precinct.

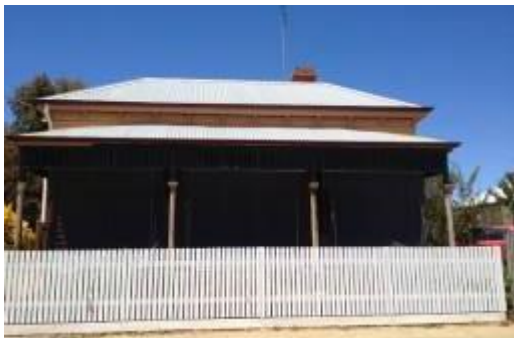
| 116 Hovell Street, Echuca | Place Type | Dwelling |

Place Description - 116 Hovell Street is one of the early vernacular cottages that are found in the East Echuca precinct. It displays all the characteristics associated with a vernacular cottage from the 19<sup>th</sup> century. It has a corrugated metal hipped roof with a convex verandah and a centralized door with windows on either side. The timber picket fence complements the historic character of this building. The setback provides scope for a complementary garden setting. The cottage contributes to the Echuca East Precinct.

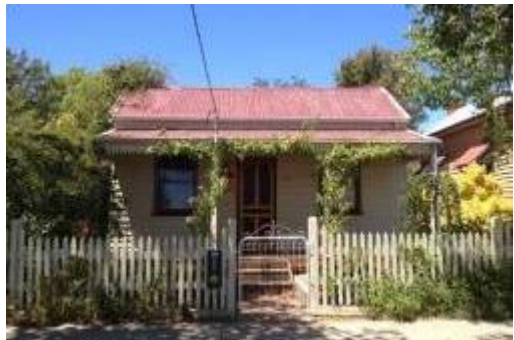
| 118 Hovell Street, Echuca | Place Type | Dwelling |

**Place Description** - 118 Hovell Street is one of the early vernacular cottages that were typically built as labourers cottages (either for sawmillers or workers associated with port activities). It is relatively diminutive in scale and displays all the characteristics associated with vernacular workers' cottages from the 19<sup>th</sup> century. It has a corrugated metal gable roof with a straight verandah with a timber frieze and a centralized door with windows on either side. The timber picket fence complements the historic character of this building. The setback provides scope for a complementary garden setting. The cottage contributes to the Echuca East Precinct.

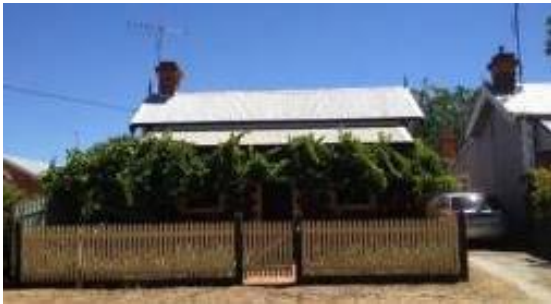
| 119 Hovell Street, Echuca | Place Type | Dwelling |

**Place Description** – 119 Hovell Street is one of the early vernacular cottages that were typically built as labourers cottages (either for sawmillers or workers associated with port activities). It is relatively diminutive in scale and displays all the characteristics associated with vernacular workers' cottages from the 19<sup>th</sup> century. It has a corrugated metal gable roof with a brick chimney. The verandah has a straight profile. It is constructed from brick with quoining to the openings and it has timber fret work to the barge boards. The façade is characterized by a centralized door with windows on either side. The timber picket fence complements the historic character of this building. The setback provides scope for a complementary garden setting. The cottage contributes to the Echuca East Precinct.

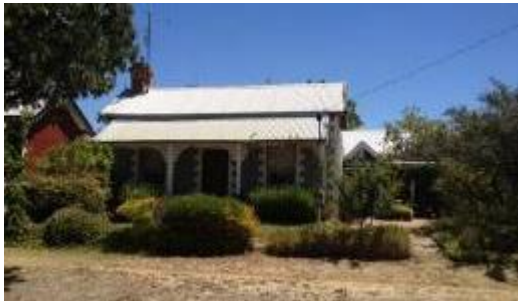
| 121 Hovell Street, Echuca | Place Type | Dwelling |

**Place Description** – 121 Hovell Street is one of the early vernacular cottages that were typically built as labourers cottages (either for sawmillers or workers associated with port activities). It is relatively diminutive in scale and displays all the characteristics associated with vernacular workers' cottages from the 19<sup>th</sup> century. It has a corrugated metal gable roof with a brick chimney. The verandah has a straight profile with decorative brackets to the verandah posts. It is constructed from brick with quoining to the openings and it has timber fret work to the barge boards. The façade is characterized by a centralized door with windows on either side. The setback provides scope for a complementary garden setting. The cottage contributes to the Echuca East Precinct.

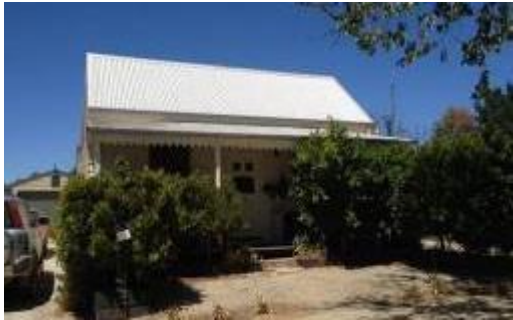
| 130 Hovell Street, Echuca | Place Type | Dwelling |

Place Description - 130 Hovell Street is one of the early vernacular cottages that were typically built as labourers cottages (either for sawmillers or workers associated with port activities). It is relatively diminutive in scale and displays all the characteristics associated with vernacular workers' cottages from the 19<sup>th</sup> century. It has a corrugated metal gable roof with a straight verandah with a timber frieze and a centralized door with windows on either side. The setback provides scope for a complementary garden setting. The cottage contributes to the Echuca East Precinct.

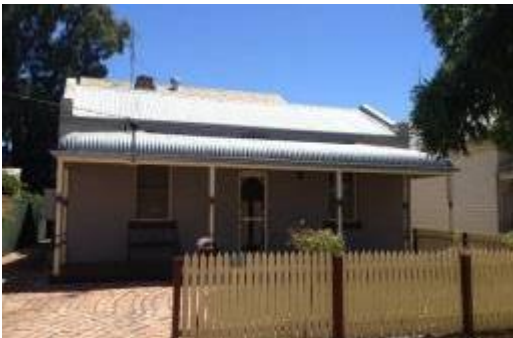
| 131 Hovell Street, Echuca | Place Type | Dwelling |

Place Description - 131 Hovell Street is a vernacular cottage and displays most of the characteristics associated with vernacular workers' cottages from the 19<sup>th</sup> century. It has a corrugated metal gable roof with a bullnosed verandah with timber posts. The centralized door with windows on either side reinforce the symmetrical character of this cottage. The timber picket fence complements the historic character of this building. The setback provides scope for a complementary garden setting. The cottage contributes to the Echuca East Precinct.

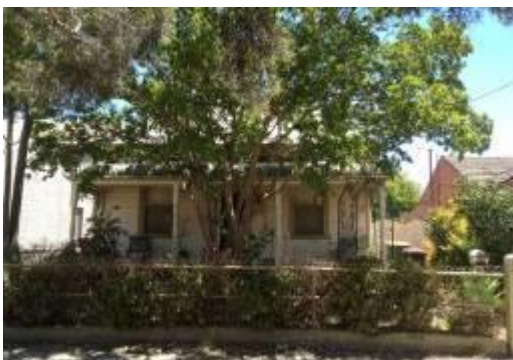
| 133 Hovell Street, Echuca | Place Type | Dwelling |

Place Description - 133 Hovell Street is a vernacular cottage and displays most of the characteristics associated with vernacular workers' cottages from the 19<sup>th</sup> century. It has a corrugated metal gable roof with a bullnosed verandah with timber posts. The centralized door with windows on either side reinforce the symmetrical character of this cottage. The setback provides scope for a complementary garden setting. The cottage contributes to the Echuca East Precinct.

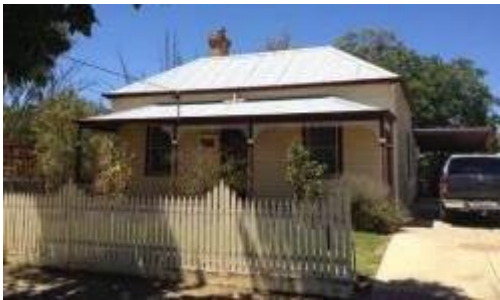
| 134 Hovell Street, Echuca | Place Type | Dwelling |

Place Description – 134 Hovell Street is a vernacular cottage and displays most of the characteristics associated with vernacular workers' cottages from the 19<sup>th</sup> century. It has a corrugated metal gable roof with a straight profile verandah with timber posts and a decorative frieze and brackets. The centralized door with windows on either side reinforce the symmetrical character of this cottage. The timber picket fence complements the historic character of this building. The setback provides scope for a complementary garden setting. The cottage contributes to the Echuca East Precinct.

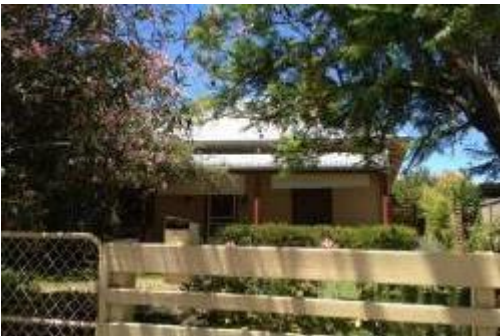
| 132 Hume Street, Echuca | Place Type | Dwelling |

Place Description - 132 Hume Street is a vernacular cottage and displays most of the characteristics associated with vernacular workers' cottages from the 19<sup>th</sup> century. It has a corrugated metal hipped roof with a bullnosed verandah with timber posts. The centralized door with windows on either side reinforce the symmetrical character of this cottage. The setback provides scope for a complementary garden setting. The cottage contributes to the Echuca East Precinct.

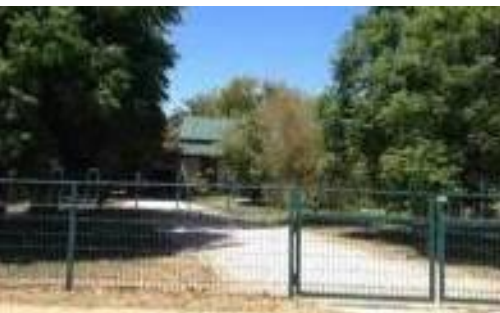
| 136 Hume Street, Echuca | Place Type | Dwelling |

Place Description - 136 Hume Street is an important vernacular cottage within the Echuca East Precinct. It is constructed from timber with some early building techniques including the use of timber slabs. Stylistically it displays most of the characteristics associated with vernacular workers' cottages from the 19<sup>th</sup> century. It has a corrugated metal gable roof with a verandah with timber posts. It has an asymmetrical façade. The setback provides scope for a complementary garden setting. The cottage contributes to the Echuca East Precinct.

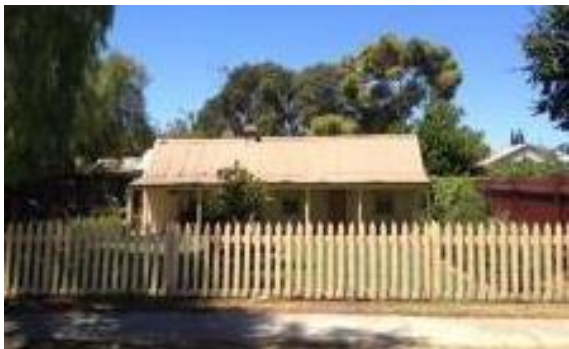
| 140 Hume Street, Echuca | Place Type | Dwelling |

Place Description – a small gable roofed timber house of vertical red gum board and batten construction at least to the front and side walls and with a weatherboard clad lean-to section at the rear. The front elevation has a low timber posted verandah with chamfered posts and the windows have six paned sashes without horns.

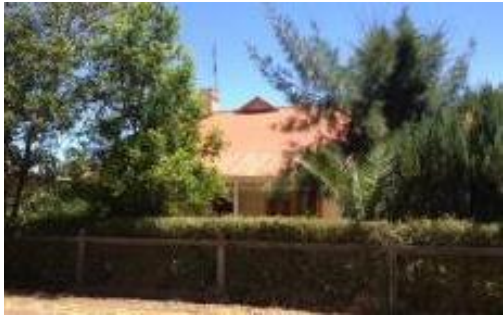
| 141 Hume Street, Echuca | Place Type | Dwelling |

Place Description - 141 Hume Street is an Interwar house weatherboard house with a corrugated metal roof with a gablet vent. The roof falls to form the verandah which has timber posts with a timber frieze. It has a symmetrical façade and the verandah has decorative cast iron frieze.

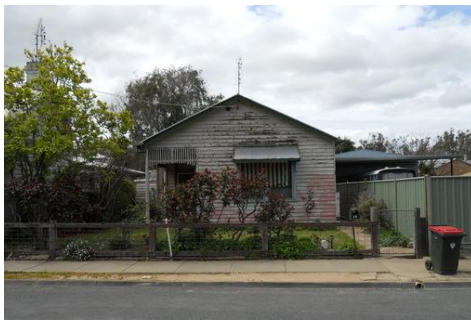
| 16 Bolton Street, Echuca | Place Type | Dwelling |

Place Description - 16 Bolton Street is a modest Interwar Bungalow. It is clad with weatherboards and has a corrugated metal roof. The façade has a paired timber window and the porch is formed by an overhang of the gable roof. The porch entry is distinguished by the timber fretwork. The setback provides scope for a garden setting. It contributes to the historic and aesthetic significance of the Echuca North Precinct.

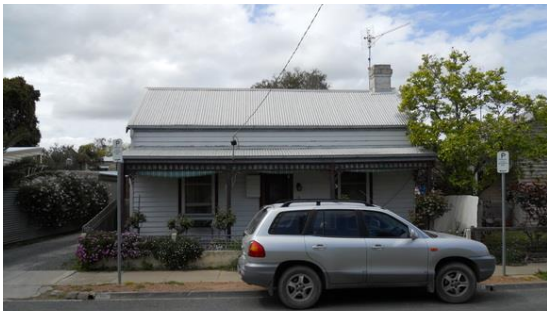
| 18 Bolton Street, Echuca | Place Type | Dwelling |

Place Description - 18 Bolton Street is a late Victorian period styled cottage. It is clad with weatherboards and has a corrugated metal roof with a masonry chimney. The façade is symmetrical with a central door flanked on either side by timber framed windows. The verandah has a straight profile with timber posts and a timber fretwork frieze. It contributes to the historic and aesthetic significance of the Echuca North Precinct.

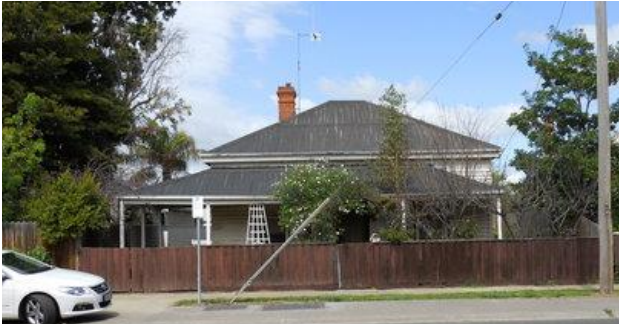
| 1 Connolly Street, Echuca | Place Type | Dwelling |

Place Description – 1 Connolly Street is a late Victorian period styled house. It is clad with weatherboards and has a steeply pitched hipped roof clad with corrugated metal. The façade is symmetrical with a central door flanked on either side by timber framed windows. The verandah has a straight profile that returns to one side. It contributes to the historic and aesthetic significance of the Echuca North Precinct.

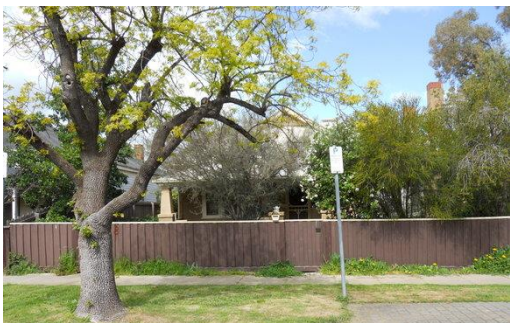
| 3 Connolly Street, Echuca | Place Type | Dwelling |

Place Description - 3 Connolly Street is a rendered masonry Interwar Bungalow. It has a hipped and gable roof form with gablets and is clad with corrugated metal. The brick chimneys are features of the design. The porch which is the dominant feature of the façade contains the entrance. The porch has masonry columns. The windows are banded and timber framed and there is a bay window to the projecting front. The set-back provides scope for a complementary garden setting. It contributes to the historic and aesthetic significance of the Echuca North Precinct.

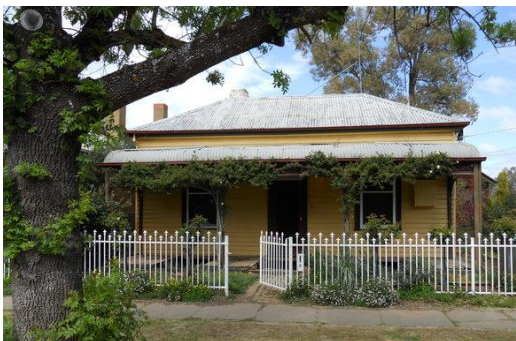
| 5 Connolly Street, Echuca | Place Type | Dwelling |

Place Description - 5 Connolly Street is a late Victorian period styled house. It is clad with weatherboards and has a hipped roof clad with corrugated metal. The façade is symmetrical with a central door flanked on either side by timber framed windows. The verandah has a bull nosed profile. It contributes to the historic and aesthetic significance of the Echuca North Precinct.

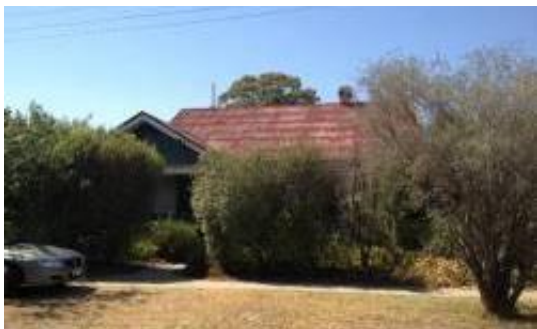
| 9 Connelly Street, Echuca | | Place Type | Dwelling |

Place Description - 9 Connelly Street is a weatherboard clad Interwar Bungalow. It has a transverse gable roof form with an opposing gable front. The roof is clad with corrugated metal. The façade is distinguished by unusual masonry plinths with pyramidal capping. The porch contains the entrance. The windows are banded and timber framed and there is a bay window to the projecting front. The set-back provides scope for a complementary garden setting. It contributes to the historic and aesthetic significance of the Echuca North Precinct.

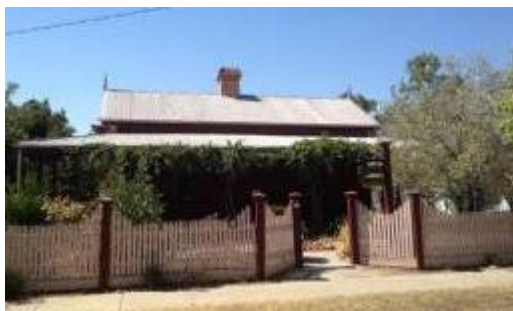
| 11 Connelly Street, Echuca (Etan House) | | Place Type | Dwelling |

Place Description - 11 Connelly Street is a late Victorian period house. It is constructed from masonry and this has been painted. The roof is a gable with timber finials and is clad with corrugated metal. There is a central brick chimney. The verandah has a straight profile that returns to both sides. The façade is asymmetrical and has timber framed windows. The entrance is to one side. It contributes to the historic and aesthetic significance of the Echuca North Precinct.

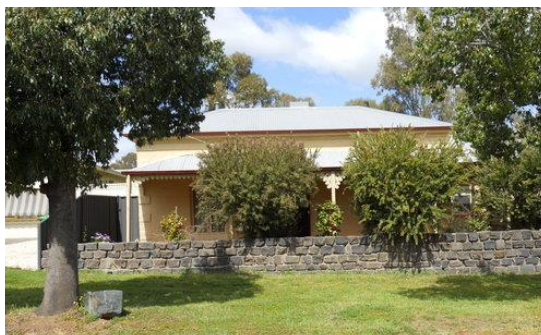
| 15 Connelly Street, Echuca | | Place Type | Dwelling |

Place Description - 15 Connelly Street is a late Victorian cottage. It is constructed from masonry with quoining to the front edges of the façade. The roof is a corrugated metal hip roof and there is a straight profile verandah with a decorative cast iron frieze with cast iron brackets to the verandah posts. It displays many of the characteristics from the period and this includes the central door with French doors to either side. The setback provides scope for a complementary garden setting. It contributes to the historic and aesthetic significance of the Echuca North Precinct.

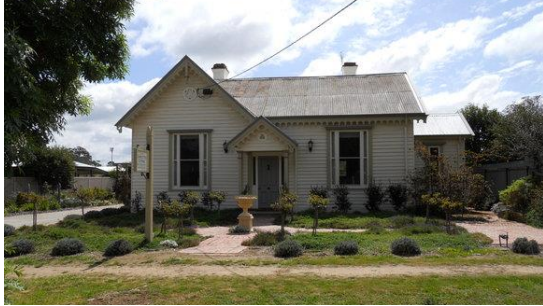
| 16 Connelly Street, Echuca | | Place Type | Dwelling |

Place Description - 16 Connelly Street is a turn of the century house and demonstrates many picturesque qualities. It is clad with weatherboards and there are two steeply pitched corrugated metal roofs. The façade is distinguished by many ornate features and this includes the highly decorative gothic inspired barge boards and the ornate breakfront entrance. The windows and doors are typical for the period with their side lights. Of note are the oculus vents with trefoils. The setback provides scope for a complementary garden setting. It contributes to the historic and aesthetic significance of the Echuca North Precinct.

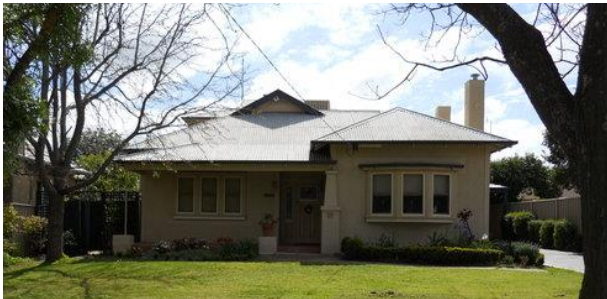
| 18 Connelly Street, Echuca | | Place Type | Dwelling |

Place Description - 18 Connelly Street is an Interwar house with bungalow elements. It is constructed from rendered masonry and has a multi hipped (with gable) corrugated metal roof. The façade has projecting front with curved band of triplet windows. The entrance is recessed and flanked on one side by a masonry plinth and a band of triple windows. The set-back provides scope for a complementary garden setting. It contributes to the historic and aesthetic significance of the Echuca North Precinct.

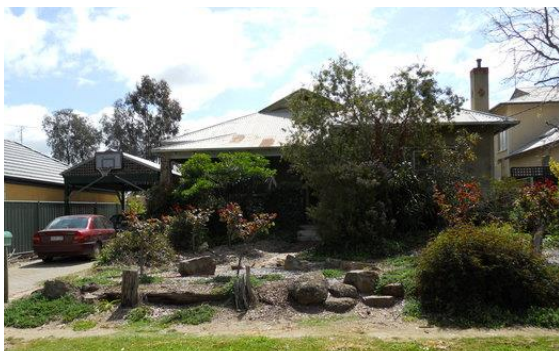
| 20 Connelly Street, Echuca | | Place Type | Dwelling |

Place Description - 20 Connelly Street is an Interwar house with bungalow elements. It is constructed from rendered masonry and has a multi hipped (with gable) corrugated metal roof. The façade has projecting front with a bay window. The porch has masonry plinths and a low masonry wall. The entrance is off the porch. The set-back provides scope for a complementary garden setting. It contributes to the historic and aesthetic significance of the Echuca North Precinct.

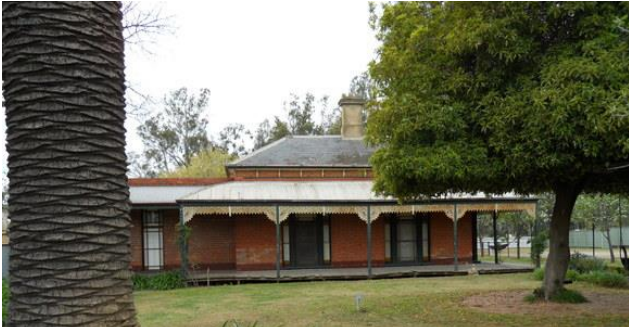
| 10 Dickson Street, Echuca | Place Type | Dwelling |

**Place Description** - 10 Dickson Street is a late Victorian period house. It is constructed from face red brick and has a hipped slate roof with a distinctive masonry chimney. The convex verandah is distinguished by the fine cast iron frieze and cast iron brackets. The timber windows are full height and have side and high lights. The later addition is recessive allowing the historic building to be dominant. The set-back provides scope for a complementary garden setting. It contributes to the historic and aesthetic significance of the Echuca North Precinct.

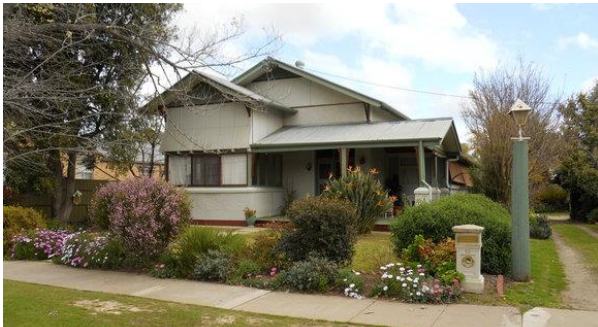
| 13 Dickson Street, Echuca | Place Type | Dwelling |

**Place Description** – 13 Dickson Street is a stylish Interwar Bungalow. It is constructed from rendered masonry and the roof is clad with corrugated metal. There are two main gable roofs with an opposing gable roof to the porch area. The gable fronts are atypical both for their scale and their design. The windows are in bands and are timber framed. The porch has masonry plinths with timber posts. The set-back provides scope for a complementary garden setting. It contributes to the historic and aesthetic significance of the Echuca North Precinct. It is a small bungalow styled residence, incorporating the former Masonic Hall in its present structure which now includes a projecting wing, pierced verandah and later roof to the hall.

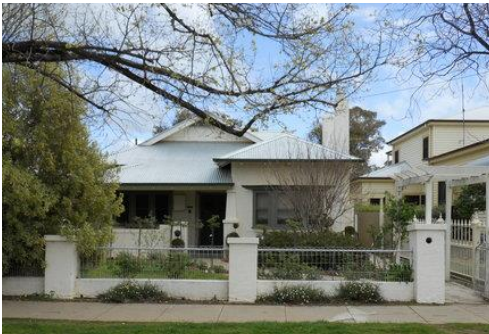
| 15 Dickson Street, Echuca | Place Type | Dwelling |

**Place Description** - 15 Dickson Street is a rendered masonry Interwar Bungalow. It has a hipped and gable roof form with gablets and is clad with corrugated metal. The brick chimneys are features of the design. The porch which is the dominant feature of the façade contains the entrance. The porch has masonry plinths and columns and a low masonry wall. The windows are in bands and

timber framed and the projecting front has a bay window. The front fence contributes to the aesthetic significance. The set-back provides scope for a complementary garden setting. It contributes to the historic and aesthetic significance of the Echuca North Precinct.

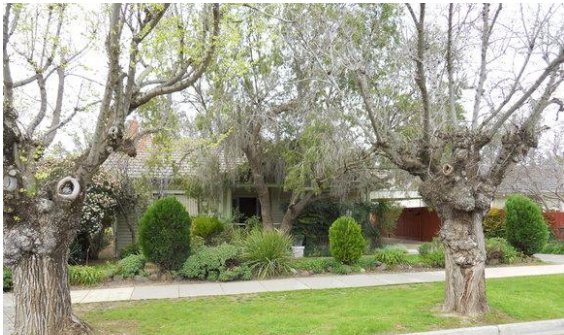
| 16 Dickson Street, Echuca | Place Type | Dwelling |

**Place Description** - 16 Dickson Street is an Interwar Bungalow. It is clad with weatherboards and has a tiled gable roof. The opposing gable front includes the entrance. This bungalow demonstrates many of the features associated with the bungalow style albeit simplified. This includes the paired timber posts to the porch. The set-back provides scope for a complementary garden setting. It contributes to the historic and aesthetic significance of the Echuca North Precinct.

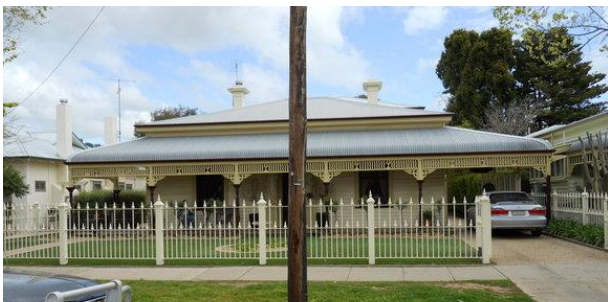
| 17 Dickson Street, Echuca | Place Type | Dwelling |

**Place Description** - is a late Victorian period styled house. It is clad with weatherboards and has a hipped roof clad with corrugated metal. The verandah has a bull nosed profile with decorative timber frieze and timber brackets to the verandah posts. The façade has a central door flanked on either side by timber framed windows. A later modification has extended the verandah to include a carport. The metal palisade fence is a later addition. The set-back provides scope for a complementary garden setting. It contributes to the historic and aesthetic significance of the Echuca North Precinct.

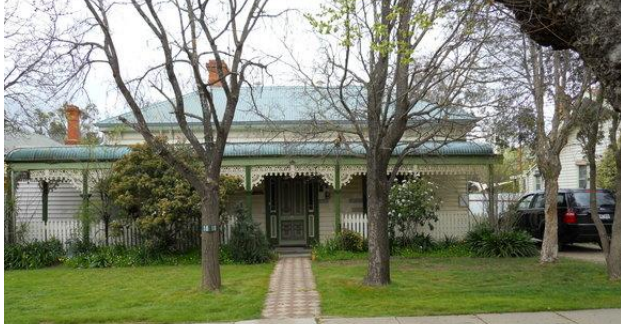
| 18 Dickson Street, Echuca | Place Type | Dwelling |

**Place Description** - 18 Dickson Street is a late Victorian period styled house. It is clad with weatherboards and has a hipped roof clad with corrugated metal. The verandah has a bull nosed profile that returns to one side. The façade is symmetrical with a central door flanked on either side by timber framed windows. The doors and windows have sidelights. The set-back provides scope for a complementary garden setting. It contributes to the historic and aesthetic significance of the Echuca North Precinct.

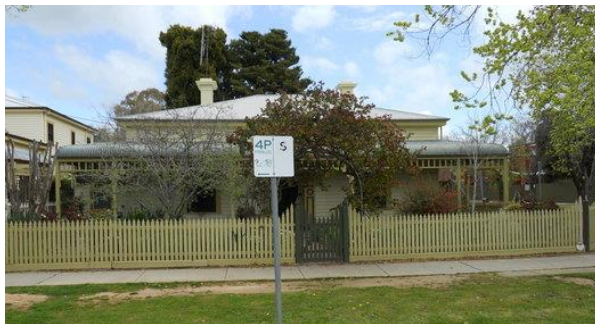
## 19 Dickson Street, Echuca

**Place Description** – is a late Victorian period styled house. It is clad with weatherboards and has a hipped roof clad with corrugated metal. The verandah has a bull nosed profile with decorative timber fretwork frieze and timber brackets to the verandah posts. The façade has a central door flanked on either side by timber framed windows. The set-back provides scope for a complementary garden setting. It contributes to the historic and aesthetic significance of the Echuca North Precinct.

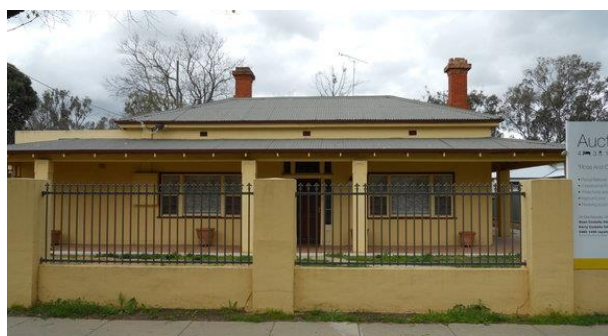
## 20 Dickson Street, Echuca

**Place Description** – 20 Dickson Street is a modified late Victorian period house. It is constructed from masonry and this has been painted. The roof is hipped and clad with corrugated metal there are two distinctive face brick chimneys. The façade is largely symmetrical with a central door with side and top highlights. The windows have been altered but are located on either side of entrance. The front fence is a later addition. The set-back provides scope for a complementary garden setting. It contributes to the historic and aesthetic significance of the Echuca North Precinct.
