# ***Heritage Review 2014 - Part B***

## ***Heritage Precincts***

**Heritage Review 2014**  
**PART B – Heritage Precincts**

**September 2014**  
**(Amended February 2016)**

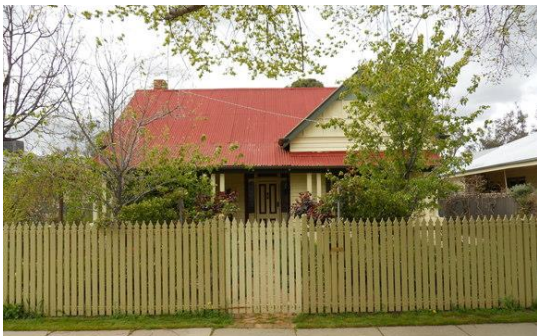
| 24 Dickson Street, Echuca | Place Type | Dwelling |

**Place Description** – 24 Dickson Street is an Interwar Bungalow and its design is similar in form to those designed by the State Savings Bank. It is clad with weatherboards and the gable roofs are clad with corrugated metal. The projecting front gable has timber strapping to the gable area. The roof of the transverse gable falls to create the porch roof. This roof extends across the whole front façade. The entrance door has side and high lights and is located off the recessed porch area. The porch posts have a masonry plinth with paired timber posts. The timber picket fence is complementary. The set-back provides scope for a complementary garden setting. It contributes to the historic and aesthetic significance of the Echuca North Precinct.

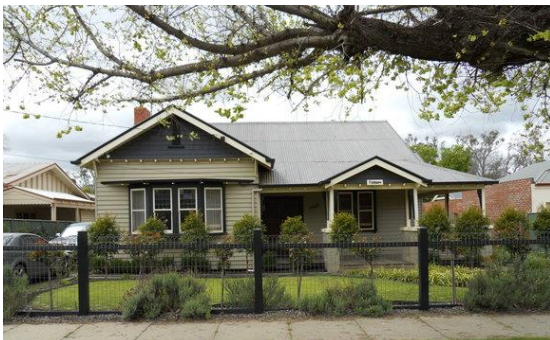
| 28 Dickson Street, Echuca | Place Type | Dwelling |

**Place Description** – 28 Dickson Street is an Interwar Bungalow. It is clad with weatherboards and the gable roofs are clad with corrugated metal. The projecting front gable has timber shingles to the gable area and a fine bay window. The roof of the transverse gable falls to create the porch roof. The porch roof is distinguished by the breakfront and the masonry piers with timber posts. The porch returns to one side. The timber and woven wire fence is complementary. The set-back provides scope for a complementary garden setting. It contributes to the historic and aesthetic significance of the Echuca North Precinct.

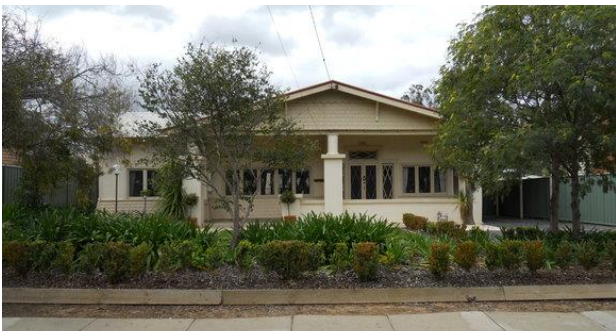
| 30 Dickson Street, Echuca | Place Type | Dwelling |

**Place Description** – 30 Dickson Street is a rendered masonry Interwar Bungalow. It has a transverse gable with the opposing gable (with its timber shingle cladding) creating a large entrance and porch area. The porch which is the dominant feature of the façade contains the entrance. The porch has unusually high masonry plinths and columns. The bands of diamond pane windows and the timber shingling to the external walls contributes to the aesthetic significance. The set-back provides scope for a complementary garden setting. It contributes to the historic and aesthetic significance of the Echuca North Precinct.

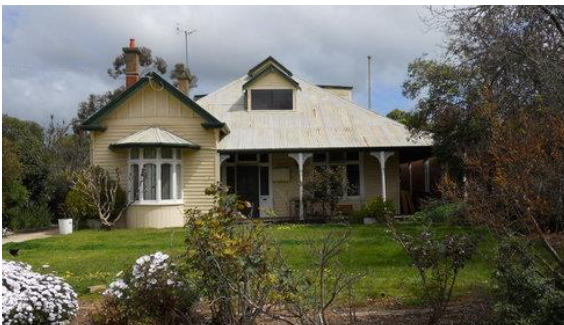
| 33 Dickson Street, Echuca | Place Type | Dwelling |

**Place Description** - 33 Dickson Street is a large early 20<sup>th</sup> century house. It is clad with weatherboards with elements of contrasting external cladding. The roof has a steeply pitched pyramidal roof with dormer windows. The projecting gable with its diminutive bay and rendered and strapped gable adds to the picturesque character of the building. The hipped roof falls in an unbroken line to form the verandah and the return. The entrance is from the verandah and the door has side and high lights. The triple bands of windows complement the aesthetic character. The set-back provides scope for a complementary garden setting. It contributes to the historic and aesthetic significance of the Echuca North Precinct.

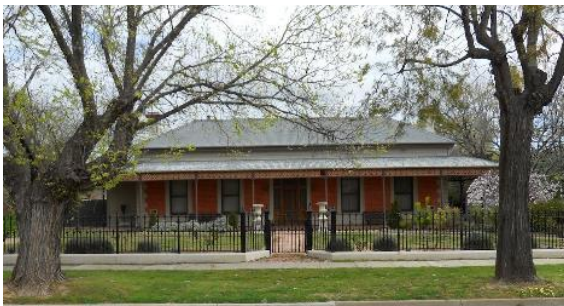
| 35 Dickson Street, Echuca | Place Type | Dwelling |

**Place Description** - 35 Dickson Street is a large Victorian styled house. It is constructed from face red brick work and has a hipped slate roof. The verandah has a straight profile that returns to one side. The cast iron frieze is particularly fine and the cast iron columns complement the design. The façade is symmetrical with a central door flanked on either side by two sets of double hung windows. The scale and setbacks for this house give it a prominence in the streetscape. The set-back provides scope for a complementary garden setting. It contributes to the historic and aesthetic significance of the Echuca North Precinct.

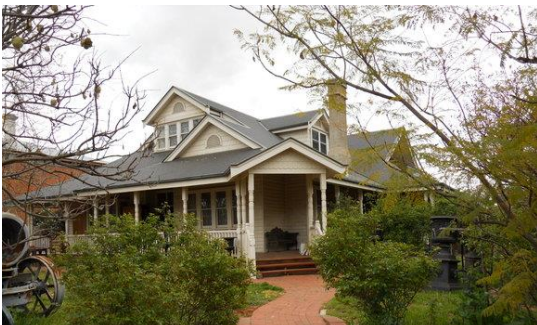
| 2 Law Court Place, Echuca | Place Type | Dwelling |

**Place Description** - 2 Law Court Place is a modified Federation Bungalow. It is clad with weatherboards and has a corrugated metal roof. The roof is complex with gables, gablet vents and dormers. Some of which are later modifications. The entrance is from the corner and this diagonal approach is typical for the period. The verandah is to both sides. The windows are in bands and contribute to the architectural significance. The set-back provides scope for a complementary garden setting. It contributes to the historic and aesthetic significance of the Echuca North Precinct.

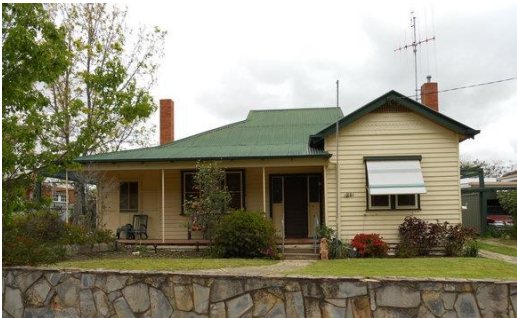
| 21 Watson Street, Echuca | Place Type | Dwelling |

Place Description - 21 Watson Street is a typical Interwar house. It is clad with weatherboards and has a gable and hipped roof (with gable vents) clad with corrugated metal. The hip roof falls in an unbroken line to create the porch. The projecting gable front has a decorative scalloped board and timber lattice to the apex and paired timber windows. The entrance is off the recessed porch. There are a triple band of timber framed windows. The set-back provides scope for a complementary garden setting. It contributes to the historic and aesthetic significance of the Echuca North Precinct.

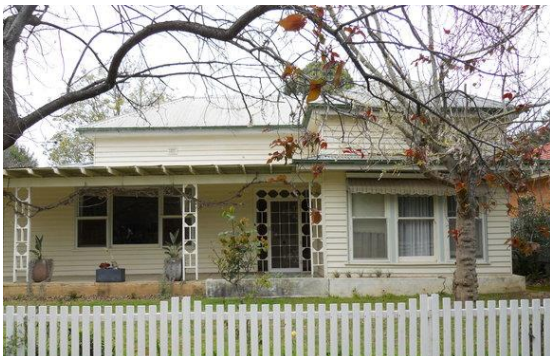
| 27 Watson Street, Echuca | Place Type | Dwelling |

Place Description - 27 Watson Street is a modified Interwar house. It is clad with timber weatherboards and has a corrugated metal hipped roof. The projecting section with its hipped roof has a band of three windows and the same type of window is found on the recessed area with porch. The distinctive cut out metal decorations are later additions. The set-back provides scope for a complementary garden setting. It contributes to the historic and aesthetic significance of the Echuca North Precinct.

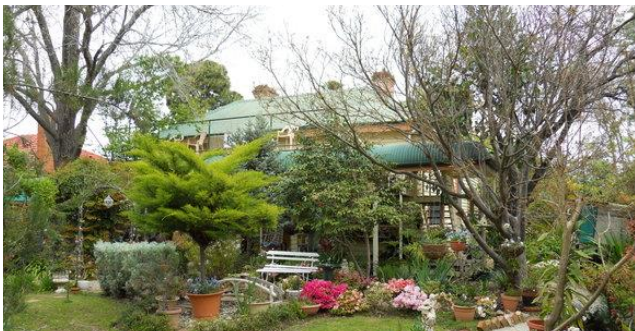
| 31 Watson Street, Echuca | Place Type | Dwelling |

Place Description - 31 Watson Street is a late Victorian period styled house. It is clad with weatherboards and has a hipped roof clad with corrugated metal. The verandah has a bull nosed profile with returns. The façade is symmetrical with a central door flanked on either side by modified windows. The upper deck is a later modification. The set-back provides scope for a complementary garden setting. It contributes to the historic and aesthetic significance of the Echuca North Precinct.

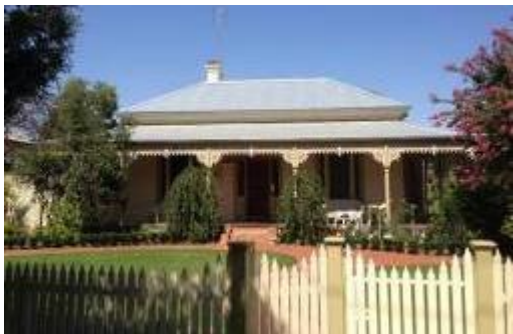
| 33 Watson Street, Echuca | Place Type | Dwelling |

Place Description - 33 Watson Street is late Victorian period styled house. It is clad with weatherboards and has a hipped roof clad with corrugated metal. The verandah has a straight profile. It has a decorative cast iron frieze with cast iron brackets to the verandah posts. The façade is symmetrical with a central door flanked on either side by timber framed windows. The doors and windows have sidelights. The set-back provides scope for a complementary garden setting. It contributes to the historic and aesthetic significance of the Echuca North Precinct.

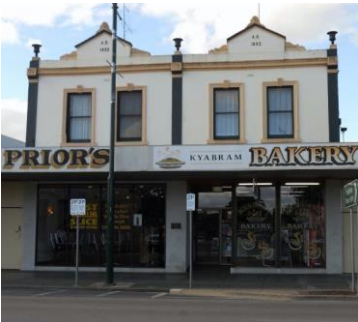
| 133 & 135 Allan Street, Kyabram | Place Type | Commercial |

Place Description – a pair of late Victorian shopfronts constructed from rendered masonry. The shop fronts are distinguished by their pedimented parapets with acroteria and console brackets. The pilasters are topped with urns and have vermiculated impost styled

blocks. There is a strong cornice line and the windows have decorative moulded surrounds. The glazed shop fronts have been modified. The shop fronts contribute to the historic and architectural character of the commercial precinct.

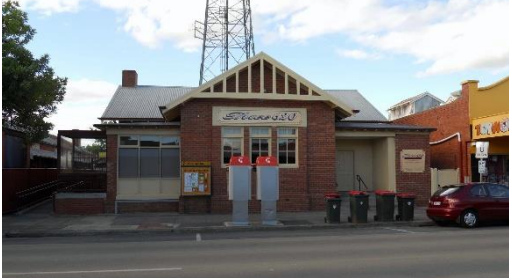
| 139 Allan Street, Kyabram | Place Type | Former post office (current Café) |

Place Description – the former post office demonstrates Public Works Department post office architecture from the early 20<sup>th</sup> century. It is constructed from face red brickwork and it has opposing corrugated metal gable roofs. The projecting gable front has decorative timber fret work and a band of three timber framed sash windows. The former Post Office contributes to the historic and architectural character of the commercial precinct.

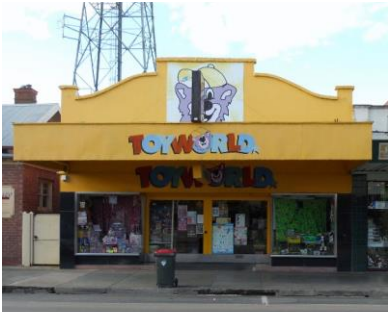
| 141 Allan Street, Kyabram | Place Type | Commercial |

Place Description – 141 Allan Street demonstrates typical Interwar shopfront architectural characteristics. These are found in the parapet with its squared central area and its curved sides falling to capped pilasters. There is a cantilevered canopy and the glazed shop fronts have been modified. The shop front contributes to the historic and architectural character of the commercial precinct.

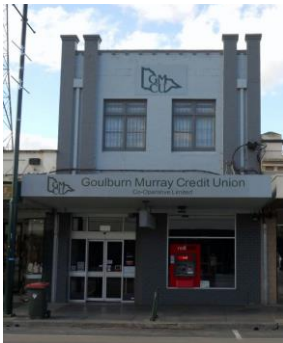
| 145 Allan Street, Kyabram | Place Type | Commercial |

Place Description – The Interwar shopfront at 145 Allan Street Kyabram has a squared rectangular rendered parapet with a pair of windows. The parapet has paired and capped pilasters at either end of the parapet. The cantilevered canopy is a later modification and the glazed shopfront is not original. The shop front contributes to the historic and architectural character of the commercial precinct.

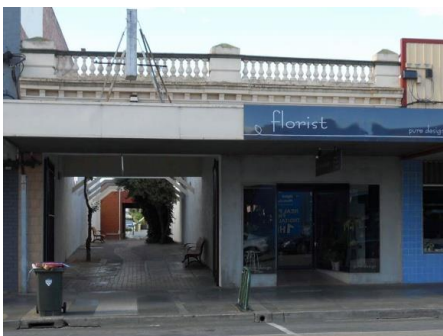
| 147 & 149 Allan Street, Kyabram | Place Type | Commercial (& current walkway) |

Place Description – 147 & 149 Allan Street Kyabram is an altered double shop front. One ground floor shop front has been removed and is a thoroughfare. The second shop front has an altered glazed ground floor. The rendered balustrade parapet extends along the full length of the two shop fronts. The balustrade is bisected by a pier and there are piers at either end. The cantilevered canopy is a later addition. The shop fronts contribute to the historic and architectural character of the commercial precinct.

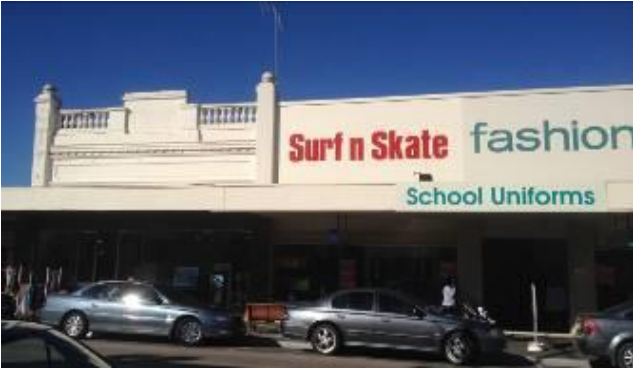
| 156-160 Allan Street, Kyabram | Place Type | Commercial |

**Place Description** – 156-160 Allan Street is an early 20<sup>th</sup> century shop front with a distinctive parapet. The parapet has a centralised rectangular section in the style of a pediment – albeit flat - with a strong cornice line. It is flanked with a balustrade parapet with piers on either end that rise up and are surmounted by masonry orbs. The cantilevered canopy is a later addition. The shop fronts contribute to the historic and architectural character of the commercial precinct.

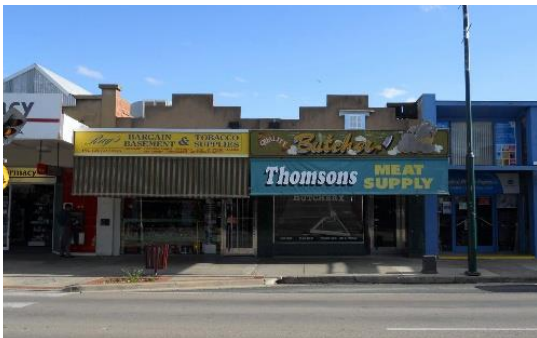
| 170-172 Allan Street, Kyabram | Place Type | Commercial |

**Place Description** – 170-172 Allan Street Kyabram is an Interwar double shopfront. The masonry parapet over each individual shop front has a centralised stepped section. The glazed shop fronts have been modified. The cantilevered canopy is a later addition. The shop fronts contribute to the historic and architectural character of the commercial precinct.

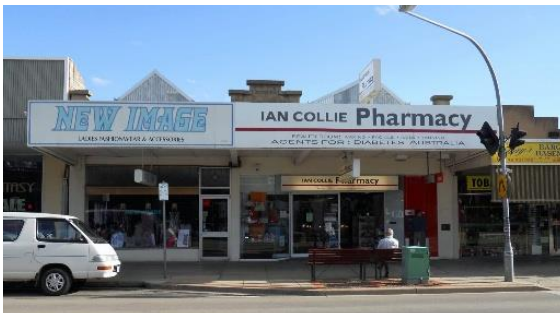
| 174-176 Allan Street, Kyabram | Place Type | Commercial |

**Place Description** – The double shopfront at 174-176 Allan Street is a simple Interwar building. At its centre there is a stepped parapet with pronounced capping. Much of the parapet is obscured by the deep fascia of the canopy. At either end there are capped piers. The glazed shop fronts have been modified. The cantilevered canopy is a later addition. The shop front contributes to the historic and architectural character of the commercial precinct.

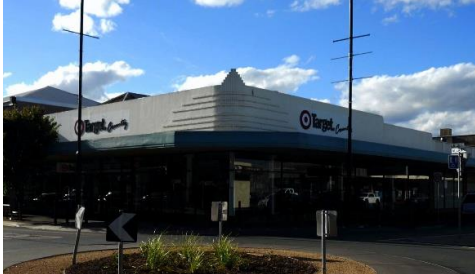
| 179-185 Allan Street, Kyabram | Place Type | Commercial |

**Place Description** – The large corner commercial building at 179-185 Allan Street is a simple Interwar building with Art Deco styling. The parapet is a plain rendered parapet to both sides of the shop. The corner is addressed with horizontal banding continues around to both sides and rises to a peak at the corner. The canopy is cantilevered. This corner shopfront contributes to the historic and architectural character of the commercial precinct.

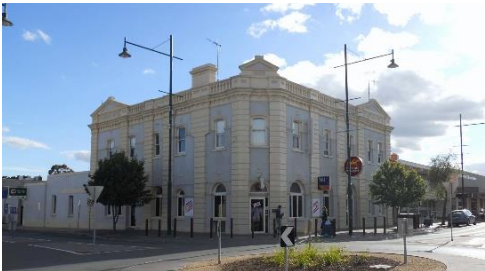
| 188-192 Allan Street, Kyabram | Place Type | Hotel |

**Place Description** – 188 - 192 Allan Street is a large two storey rendered masonry commercial building. It is highly decorative and this includes the contrasting finishes such as tooled ashlar masonry and smooth render. The parapet is distinguished by the corner pediment as well as the pediments to the bays at the each end. The windows are regularly placed across the facade and this is accentuated by the pilasters. The cornice line is a dominant horizontal feature within the composition of the facade. It contributes to the historic and aesthetic significance of the Kyabram Commercial Precinct.

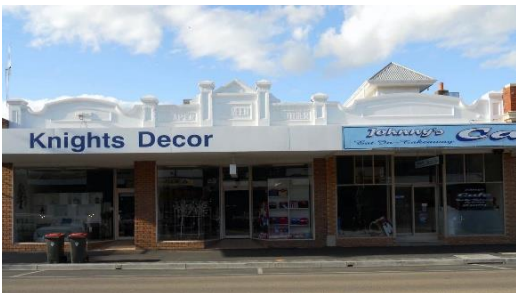
| 193-197 Allan Street, Kyabram | Place Type | Commercial |

**Place Description** – The commercial building at 193–197 Allan Street includes three shops. The parapet is symmetrical with a centralised pediment. The flanking parapets have curved pediment like features with capped pilasters. The cement rendered mouldings are a feature of this parapet. Of note is the lantern these features were once common and were a natural source of light and ventilation prior to mechanical means. The glazed shop fronts are a later modification although the splayed entryways have been retained. The canopy is cantilevered and a later addition. These three shopfront contribute to the historic and architectural character of the commercial precinct.

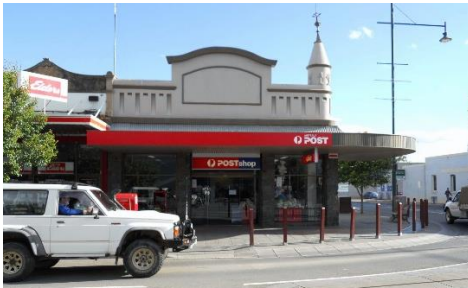
| 194-196 Allan Street, Kyabram | Place Type | Commercial (Kyabram Post Office), |

**Place Description** – The commercial building at 194–196 Allan Street is a distinctive addition at this prominent intersection. The decorative elements are essentially an Arts And Crafts synthesis of architectural features from Art Nouveau, Romanesque and to a lesser degree Queen Anne. There is no overall evocation of any specific style. The projecting corner tower with its metal spire and the curved rendered parapet are fine examples from this period. The indented features to the full extent of the parapet create a subtle but distinctive pattern within the rendered finish. The canopy is cantilevered and a later addition. The glazed shop fronts are not original. This corner shopfront contributes to the historic and architectural character of the commercial precinct.

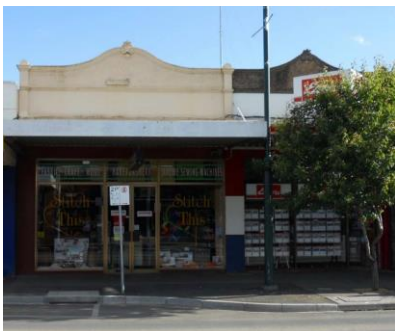
| 198 & 200 Allan Street, Kyabram | Place Type | Commercial |

**Place Description** – The commercial building at 198 & 200 Allan Street are typical examples of shop fronts from the Interwar Period. The curvilinear parapet feature is emphasised by the projecting cornice and the central projecting moulding. The capped pilasters to either side of the parapet are subtle additions. 198 Allan Street has been painted but it is of particular note that 200 Allan Street has retained its original cement render finish. This is a rare surviving example of an original finish in the Kyabram Commercial Precinct. The canopy is cantilevered and a later addition. The glazed shop fronts are not original. These two shop fronts contribute to the historic and architectural character of the commercial precinct.

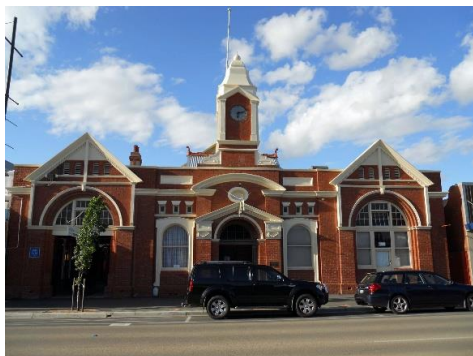
| 199-207 Allan Street, Kyabram | Place Type | Mechanics Institute |

**Place Description** –The Kyabram Mechanics Institute has a classical styled symmetrical façade with a central clock tower with flanking pavilions. Its features and use of materials such as red brick and cement render demonstrates many of the features associated with the Federation era of public building. This is a striking building and the contrast of cement rendered mouldings, pediment to the entry

doorway and the Diocletian windows contribute to its architectural presence. It has retained a high degree of integrity. It contributes to the historic and architectural character of the commercial precinct.

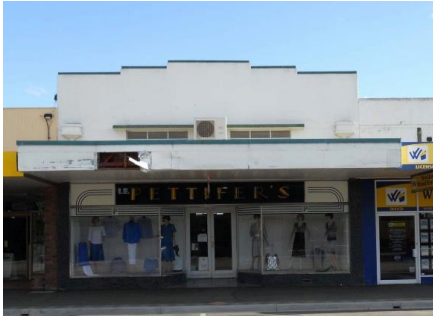
| 204 Allan Street, Kyabram | Place Type | Commercial |

**Place Description** – The commercial building at 204 Allan Street has a simplified Art Deco styling. The parapet has a shallow stepped façade with a band of horizontal glazing its base (light and ventilation for the shop). The canopy is cantilevered. The glazed shop front appears to have retained some of its original fabric and appearance. It contributes to the historic and architectural character of the commercial precinct.

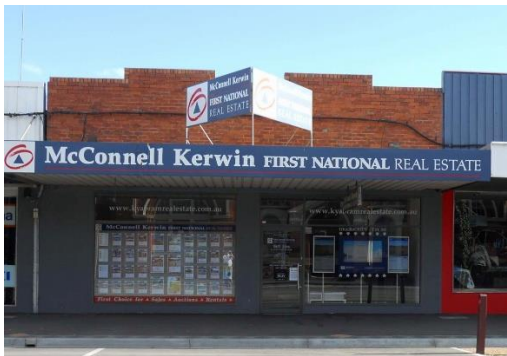
| 214 Allan Street, Kyabram | Place Type | Commercial |

**Place Description** – The commercial building at 214 Allan Street has a restrained red face brick parapet. The parapet has a shallow step with a capping of contrasting cream soldier course. The canopy is cantilevered and a later addition. The glazed shop fronts have been modified. It contributes to the historic and architectural character of the commercial precinct.

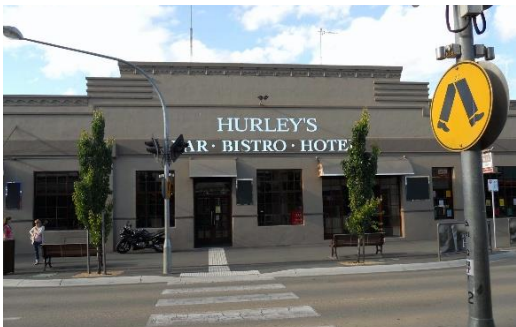
| 217-231 Allan Street, Kyabram (Hurley's Hotel) | Place Type | Hotel |

**Place Description**- The hotel at 217-231 Allan Street was formerly a face brick building but has been rendered. A number of the original architectural characteristics have been retained and its original architecture is discernable. The horizontal banding and the bracketed cornice contribute to the architectural character of this building. The symmetry of the façade and the stylised central panel is an elemental feature and is supported by the architectural detailing. It contributes to the historic and architectural character of the commercial precinct.

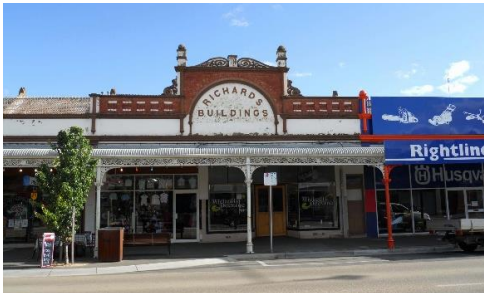
| 222-232 Allan Street, Kyabram (Richards Building) | Place Type | Commercial |

Place Description – 222-232 is a symmetrical group of single storey shops built in 1907. The façade is symmetrical and the central panel with its console brackets (at the top of the panel) and the capped columns on either side of the panel is very distinctive. On either side of the central panel is an unusual cast iron balustrade. The verandah is bullnosed and there is a decorative cast iron frieze with brackets to the metal verandah posts. The shop front has been modified with some retaining more original features than others. It contributes to the historic and architectural character of the commercial precinct.

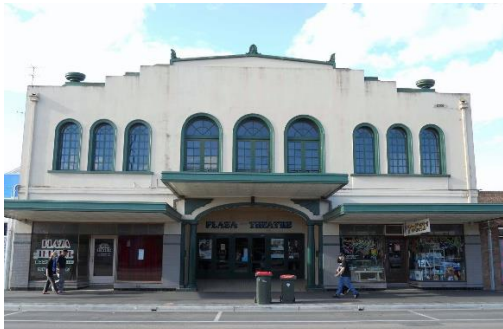
| 241 Allan Street, Kyabram (Plaza Theatre Complex) | Place Type | Theatre |

Place Description – The theatre was built in 1929 from load bearing brickwork. The two storey front façade is rendered and the arched and multi paned windows provide a pleasing contrast to the smooth walls. The canopy to the entrance is at a higher level than the canopy to either side. The entrance is recessed. It contributes to the historic and architectural character of the commercial precinct.

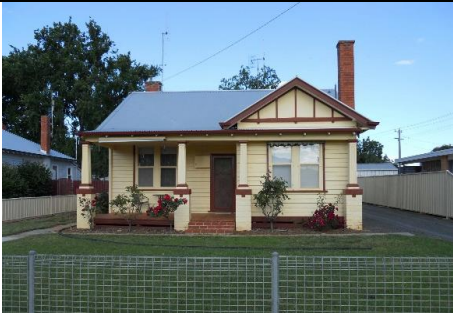
| 3 Union Street, Kyabram | | Place Type | Dwelling |

Place Description – 3 Union Street is a typical timber Interwar Bungalow with a corrugated metal roof. The design is typical for a State Savings Bank design. It has a projecting gable roofed section with a recessive transverse gable. The façade is distinguished by the gable end with its decorative timber strapping. The verandah posts are squat masonry plinths with columns. The paired timber framed windows are double hung. The chimneys are tall and slender brick chimneys with a subtle brick capping. It contributes to the architectural character of Union Street Kyabram.

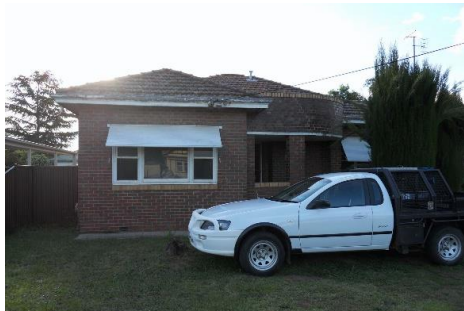
| 4 Union Street, Kyabram | | Place Type | Dwelling |

Place Description – 4 Union Street is a face brick building with two hipped and terracotta tiled roofs. The facade is triple fronted and has a distinctive curved brick entrance porch. Of note is the contrasting brick work and this is found on the brick sills and the brick porch (upper and lower levels). The windows are in band of three and are timber framed. It contributes to the architectural character of Union Street Kyabram.

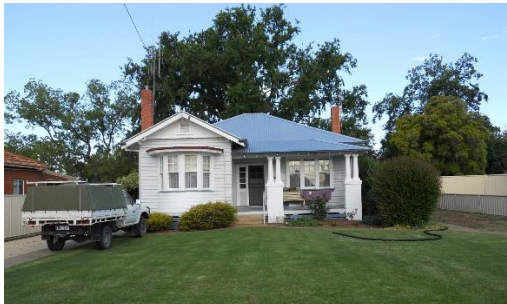
| 5 Union Street, Kyabram | Place Type | Dwelling |

Place Description – 5 Union Street is a good representative example of a timber Interwar Bungalow with a corrugated metal roof. The roof line is a combination of gable roofs and a hipped roof falling in a contiguous line to create the porch roof. The gable end has decorative timber shingles to the apex of the gable. The recessive section has a porch with distinctive masonry plinths and paired columns. The entrance has a side light with small panes of glass and there is a triple band of timber framed windows with small panes of glass to the upper sash. The segmented bay window is of particular note. There are two brick chimneys. It contributes to the architectural character of Union Street Kyabram.

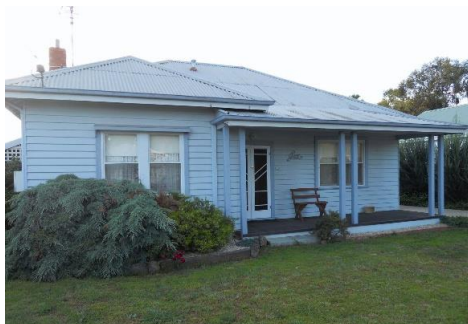
| 6 Union Street, Kyabram | Place Type | Dwelling |

Place Description – 6 Union Street is a timber weatherboard villa with a double hipped roof clad with corrugated metal. The façade consists of paired timber windows and a recessed porch with paired timber posts. It contributes to the architectural character of Union Street Kyabram.

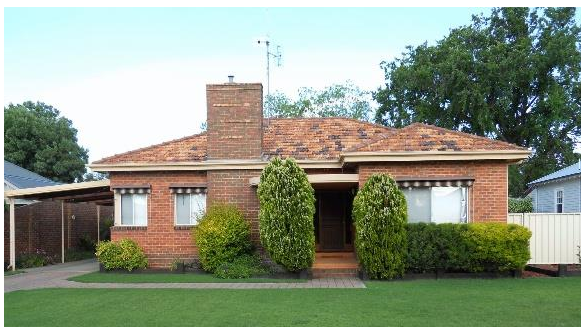
| 7 Union Street, Kyabram | Place Type | Dwelling |

Place Description – 7 Union Street is a face brick building with two hipped and terracotta tiled roofs. The facade is distinguished by the large brick chimney (constructed from a contrasting coloured brick) with contrasting cream brick horizontal strips. The entrance porch has a curved canopy. It contributes to the architectural character of Union Street Kyabram.

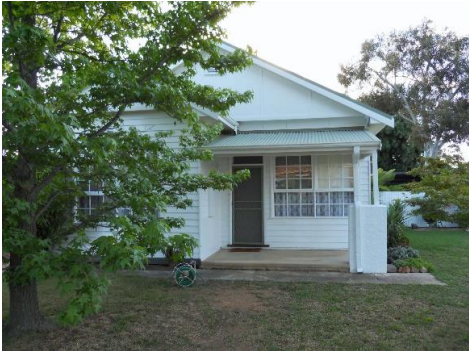
| 8 Union Street, Kyabram | Place Type | Dwelling |

Place Description – 8 Union Street is a representative timber Interwar Bungalow with a corrugated metal roof. It has two corrugated metal gable roofs with the smaller gable roofed section to the front and the larger to the rear. The gable fronts have decorative timber strapping. The verandah posts consist of a masonry plinth and posts. The windows are not original. It contributes to the architectural character of Union Street Kyabram.

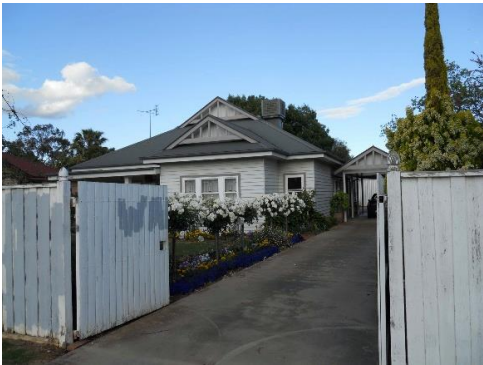
| 9 Union Street, Kyabram | Place Type | Dwelling |

Place Description – 9 Union Street is a representative timber Interwar Bungalow – albeit with some modifications to the original structure. The corrugated metal roof line is a combination of gable roofs and a hipped roof falling in a contiguous line to create the porch roof. The gable end has decorative timber fretwork. It contributes to the architectural character of Union Street Kyabram.

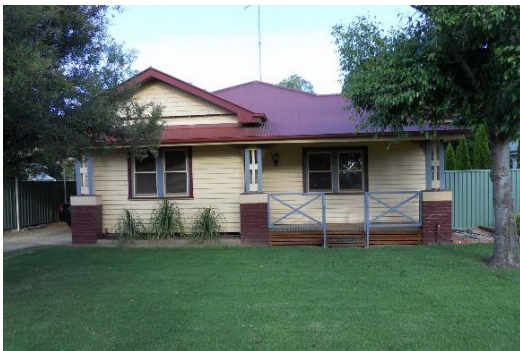
| 11 Union Street, Kyabram | Place Type | Dwelling |

Place Description – 11 Union Street is a good representative example of a timber Interwar Bungalow – albeit with some later modifications. The original design is typical for a State Savings Bank design. The corrugated metal roof line is a combination of gable roof and a hipped roof falling in a contiguous line to create the porch roof. The projecting gable roofed section has decorative timber shingles to the apex of the gable. The recessive section has a porch with distinctive masonry plinths and paired columns. The facade consists of two pairs of double hung timber framed sash windows. It contributes to the architectural character of Union Street Kyabram.

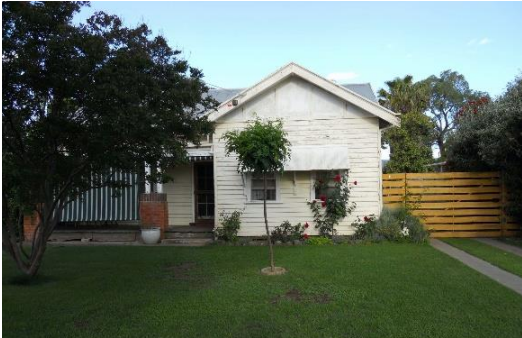
| 13 Union Street, Kyabram | Place Type | Dwelling |

Place Description – 13 Union Street is a good representative example of a timber Interwar Bungalow. The corrugated metal gable roofs contribute to its character. The front of the gable has decorative timber strapping to the apex of the gable. The recessive section has a porch with distinctive masonry plinths and paired timber columns. It contributes to the architectural character of Union Street Kyabram.

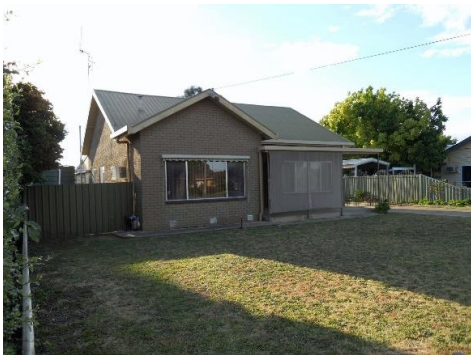
| 14 Union Street, Kyabram | Place Type | Dwelling |

Place Description – 14 Union Street is a good representative example of an Interwar Bungalow –albeit modified. The modifications consist of faux brick cladding and the aluminium framed windows. The opposing gable roofs contribute to its character. The recessive section has a porch with later metal posts. It contributes to the architectural character of Union Street Kyabram.

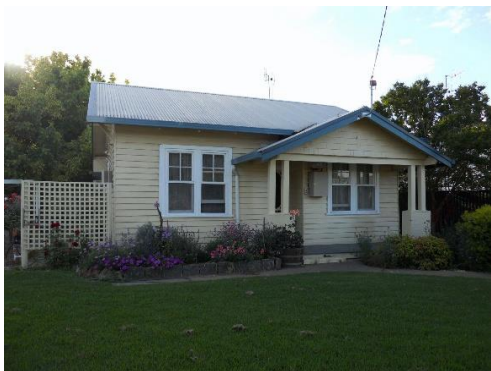
| 16 Union Street, Kyabram | Place Type | Dwelling |

Place Description – 16 Union Street is a good representative example of a timber Interwar Bungalow. The design is typical of a standard State Savings Bank design. The corrugated metal gable roofs contribute to its character. The front of the gable has decorative timber shingles to the apex of the gable. The porch has distinctive masonry plinths and paired timber columns. It contributes to the architectural character of Union Street Kyabram.

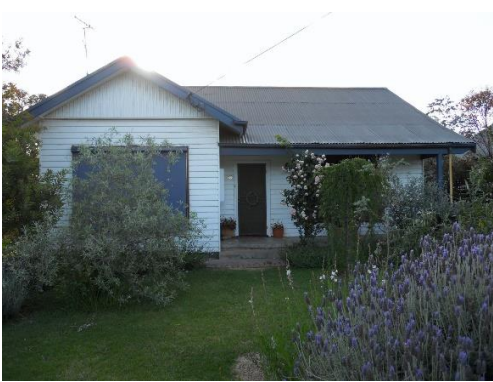
| 18 Union Street, Kyabram | Place Type | Dwelling |

Place Description – 18 Union Street is a good representative example of an Interwar Bungalow –albeit modified. The modifications include changes to the original windows, the gable front and the porch. The opposing gable roofs contribute to its character. The recessive section has a porch with later posts. It contributes to the architectural character of Union Street Kyabram.

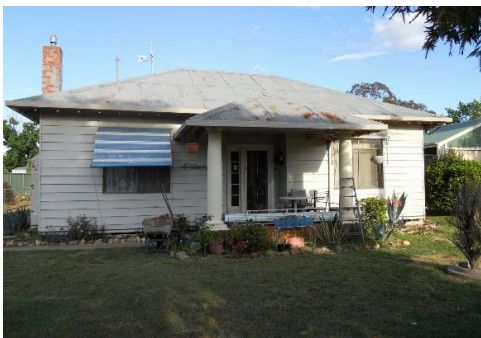
| 19 Union Street, Kyabram | Place Type | Dwelling |

Place Description – 19 Union Street is an atypical example of an Interwar Bungalow. It has a symmetrical façade with a pronounced hipped roof porch with classically inspired columns. The main roof is a single hipped corrugated metal roof. The windows have been modified. It contributes to the architectural character of Union Street Kyabram.

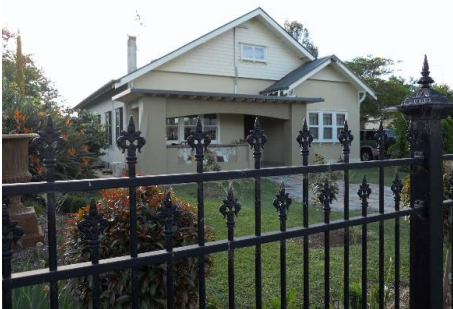
| 20 Union Street, Kyabram | Place Type | Dwelling |

Place Description – 20 Union Street is a representative example of an Interwar Bungalow – albeit modified. It is constructed from masonry and timber and has a corrugated metal roof. The façade is asymmetrical and it has a distinctive masonry porch. The ground floor windows are in bands of three and are timber framed sash windows. It contributes to the architectural character of Union Street Kyabram.

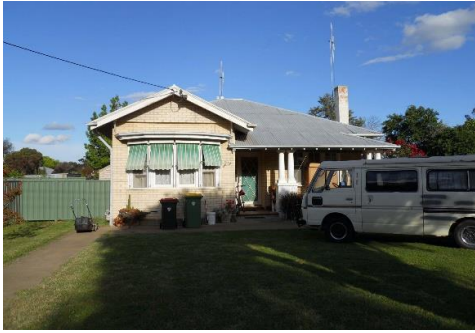
| 21 Union Street, Kyabram | Place Type | Dwelling |

**Place Description** – 21 Union Street is a good representative example of an Interwar Bungalow. It has been clad with a faux brick cladding. The design is typical for a State Savings Bank standard design. The roof line is a combination of gable roof and a hipped roof falling in a contiguous line to create the porch roof. The recessive section has a porch with distinctive masonry plinths and paired masonry classically styled columns.. The segmented bay window is of particular note. There is one brick chimney. It contributes to the architectural character of Union Street Kyabram.

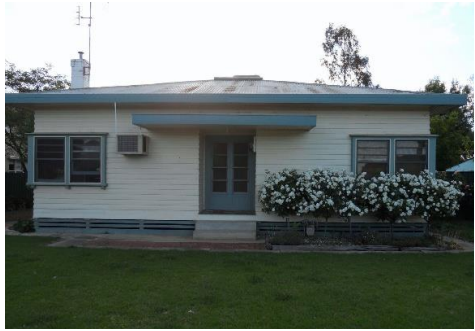
| 22 Union Street, Kyabram | Place Type | Dwelling |

**Place Description** – 22 Union Street is a distinctive modern styled post war house. It is clad with ship lap weatherboards and has a relatively flat pitched corrugated metal hip roof. It has a symmetrical façade with a recessed front entrance and paired corner windows. Despite its modernist features the timber framed windows have small brackets to the sill. These windows are possibly recycled windows from an Interwar house. The use of recycled building materials was common during the immediate post war period as there was rationing of building materials.

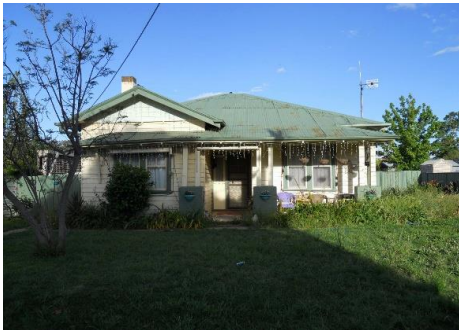
| 23 Union Street, Kyabram | Place Type | Dwelling |

**Place Description** – 23 Union Street is a good representative example of a timber Interwar Bungalow. The design is typical for a State Savings Bank design. The corrugated metal roof line is a combination of gable roof and a hipped roof falling in a contiguous line to create the porch roof. The projecting gable roofed section has decorative timber shingles to the apex of the gable. The recessive section has a porch with masonry plinths and paired columns. The facade consists of two pairs of double hung timber framed sash windows... It contributes to the architectural character of Union Street Kyabram.

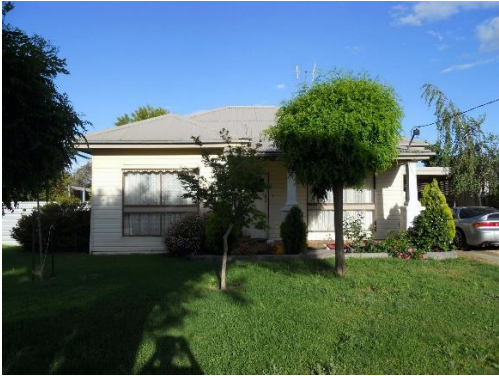
| 25 Union Street, Kyabram | Place Type | Dwelling |

Place Description – 25 Union Street is a representative example of an Interwar Bungalow – albeit modified. It has two hipped corrugated metal roofs. The façade is asymmetrical and the porch has posts constructed from masonry plinths with masonry columns. The windows are not original. It contributes to the architectural character of Union Street Kyabram.

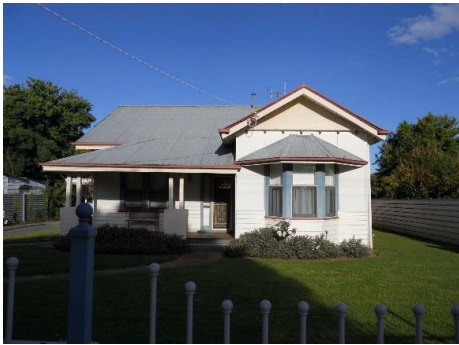
| 27 Union Street, Kyabram | Place Type | Dwelling |

Place Description – 27 Union Street is a good representative example of an Interwar Bungalow. The design is typical for a State Savings Bank standard design. The roof line is a combination of gable roofs and a hipped roof falling in a contiguous line to create the porch roof. The gable front has a timber strap with timber brackets. The recessive section has a porch with distinctive masonry plinths and paired timber posts. It contributes to the architectural character of Union Street Kyabram.

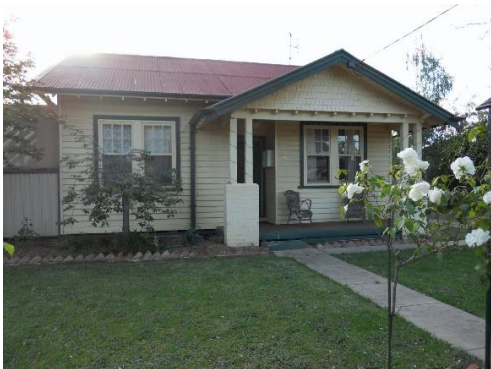
| 28 Union Street, Kyabram | Place Type | Dwelling |

Place Description – 28 Union Street is a typical Interwar Bungalow. The design is typical for a State Savings Bank standard design. It has a projecting gable roofed section with a recessive transverse gable. The façade is distinguished by the gable end with its decorative timber shingles and timber brackets. The verandah posts are squat masonry plinths with paired timber columns. The paired timber framed windows are double hung and the upper sash is divided into six small panes. It contributes to the architectural character of Union Street Kyabram.

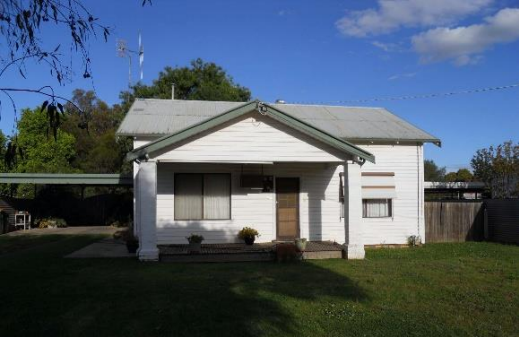
| 29 Union Street, Kyabram | Place Type | Dwelling |

Place Description – 29 Union Street is a typical Interwar Bungalow. The design is typical for a State Savings Bank standard design. It has a projecting gable roofed section that includes the entrance and porch area. There is a rear transverse gable section. The façade is distinguished by the gable roofed porch. The verandah posts are masonry columns. The windows are not original. It contributes to the architectural character of Union Street Kyabram.

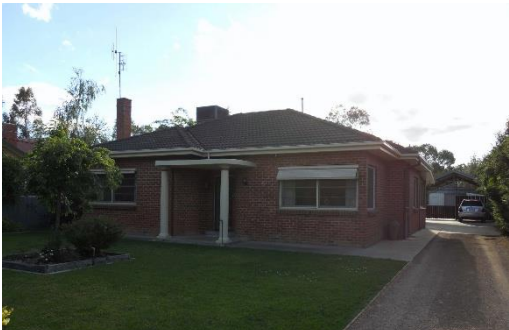
| 30 Union Street, Kyabram | Place Type | Dwelling |

Place Description – 30 Union Street is a distinctive modern styled post war house. It is constructed from face red brick and it has a double hipped roof with terracotta tiles. The façade is distinguished by the curved canopy with classically styled columns. The windows are horizontal in proportion and complement the styling of the building. It contributes to the architectural character of Union Street Kyabram.

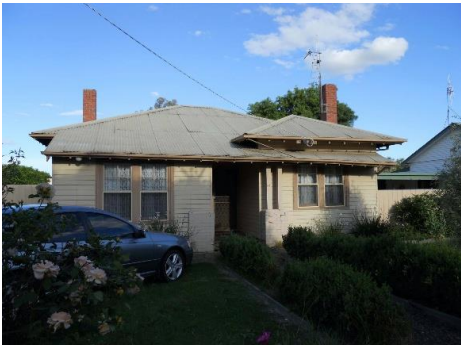
| 31 Union Street, Kyabram | Place Type | Dwelling |

Place Description – 31 Union Street is a good representative example of an Interwar Bungalow – albeit modified. The roof line is a combination of hipped roofs with the main hipped roof falling in a contiguous line to create the recessed entrance. The façade features paired timber sash windows with the upper panes divided into four small panes. It contributes to the architectural character of Union Street Kyabram.

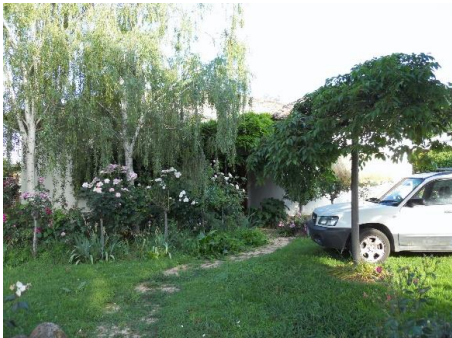
| 33 Union Street, Kyabram | Place Type | Dwelling |

Place Description – 33 Union Street has an asymmetrical façade and porch area. It is a rendered masonry façade and a double hipped terracotta roof. It contributes to the architectural character of Union Street Kyabram.

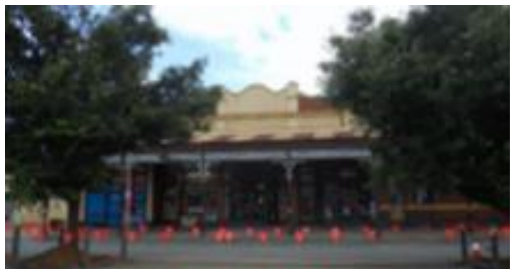
| 5-9 Gillies Street, Rochester | Place Type | Commercial |

Place Description – The shop front at 5-9 Gillies Street Rochester is a good representative example of early 20th century commercial architecture. The rendered masonry parapet demonstrates typical features and these include the centralised arch with capped pilasters to either side. The straight verandah has a decorative cast iron frieze with brackets to the verandah posts. The shop front has retained its integrity and is relatively intact. The architectural character contributes to the streetscape.

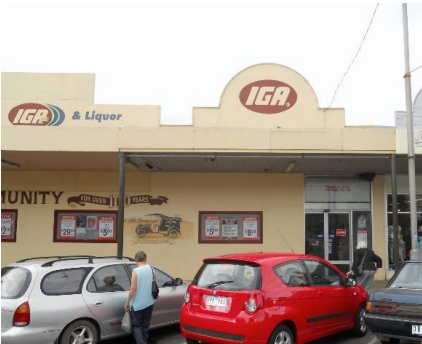
| 10-20 Gillies Street, Rochester | Place Type | Commercial |

Place Description – The shop fronts at 10-20 Gillies Street Rochester demonstrate a number of historic characteristics typical of commercial architecture. There are two parapets one has a central arch and the other has a rectangular centralised pediment. The verandah has metal verandah posts. The shop front has been substantially altered and this includes changes to the shopfront windows/walls and changes to the parapet. The architectural character contributes to the streetscape.

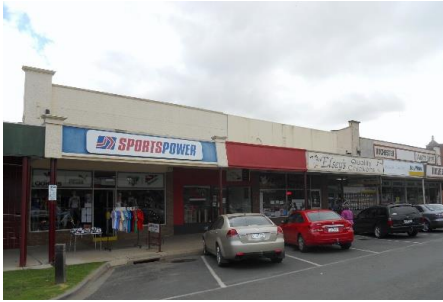
| 11-23 Gillies Street, Rochester | Place Type | Commercial |

**Place Description** – The shop front at 11-23 Gillies Street Rochester demonstrates a number of historic characteristics typical of commercial architecture from the Interwar period. The rendered masonry parapet is distinguished by the capped pilasters at either end. The glazed shop front has been substantially altered. The verandah has metal verandah posts. The shop front contributes to the historic character of the streetscape.

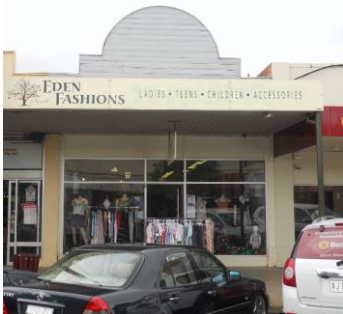
| 22 Gillies Street, Rochester | Place Type | Commercial |

**Place Description** – The shop front at 22 Gillies Street Rochester demonstrates a number of historic characteristics typical of commercial architecture. The parapet has a central arch and the verandah has metal posts. The shop front has been substantially altered and this includes changes to the shopfront windows/walls and changes to the parapet. The architectural character contributes to the streetscape.

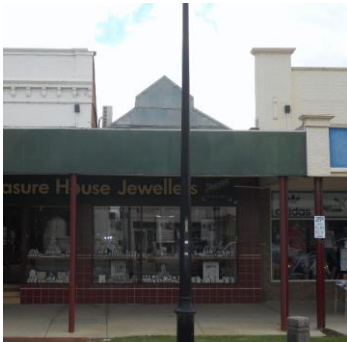
| 25 Gillies Street, Rochester | Place Type | Commercial |

**Place Description** – The shop front at 25 Gillies Street Rochester demonstrates a number of historic characteristics typical of commercial architecture. The parapet has an atypical pediment – it is a pointed parapet with a stepped design. The shop front has been substantially altered and this includes changes to the shopfront windows/walls and changes to the parapet. The architectural character contributes to the streetscape.

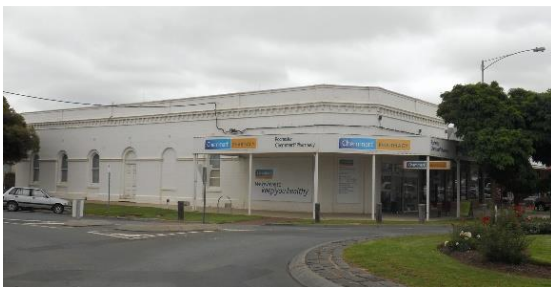
| 27 Gillies Street, Rochester | Place Type | Commercial |

**Place Description** – 27 Gillies Street demonstrates many architectural characteristics typical of the 19th century and the region. It is a relatively large single storey masonry building that is located on a corner. The building is wedge shaped and both facades would have had a similar prominence. The string coursing is a continuation of the drip mould to the top of the arched openings. The parapet consists of a simple rectangular section with regular divisions created by pilasters. The cornice is distinguished by the bracketing. Only one facade has retained the regularly placed arched openings typical of the period and style. Other modifications include: the construction of large glazed shopfronts; the building in of some of the original openings; the construction of a flat verandah with metal posts and the painting of the original face brickwork.

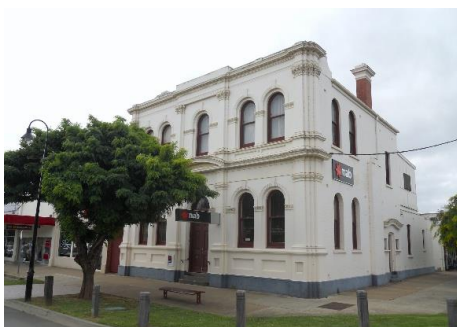
| 28 Gillies Street, Rochester | Place Type | Bank |

**Place Description** – 28 Gillies Street is a very fine example of bank architecture from the 19th century. It is a large rendered masonry building with classically inspired features. This includes the three bay division of the façade. The centralised entrance with has a large arched opening and this is flanked by paired arched windows. The window sill continues across the front of the building and the underside of the windows is coffered and there is a rusticated stone plinth. The division of floors is marked by a stylised cornice. The upper floor largely replicates the design of the ground floor with a centralised shallow breakfront. The façade has been designed to address the change of hierarchy between the commercial front entrance and the residential side entrance. The main commercial façade with the public access is quite decorative and detailed. This is in contrast to the side residential entrance with its simpler façade and decreased scale. This building is notable for its integrity including the retention of the original timber hoods for the external blinds.

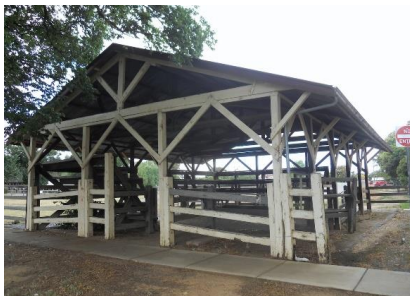
| Bull Saleyard Ring, Gillies Street, Rochester | Place Type | Live stock saleyard |

**Place Description** – The construction and layout of the bull saleyard ring is typical for this type of use. It is a timber framed structure with an expressed structural system with vertical timber posts with diagonal timber bracing. The sides of the structure have timber rails.

The interior still retains its raked timber seating. This structure has retained a high degree of integrity and it is relatively intact. This is a rare surviving structure of its type and use.

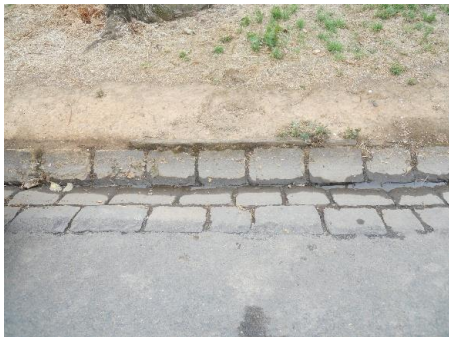
| Basalt gutters, Gillies Street, Rochester | Place Type | Gutters |

**Place Description** – The gutters have been constructed from basalt (bluestone) pitches. Basalt was plentiful, relatively easy to work with and stronger than many other materials available during the 19th and 20th century. Large amounts of the stone were quarried in Melbourne and surrounding areas. The stones for these gutters were most likely railed to Rochester. The gutters have been laid in a typical manner with a single stone for the back of the gutter and a raked bed for drainage.

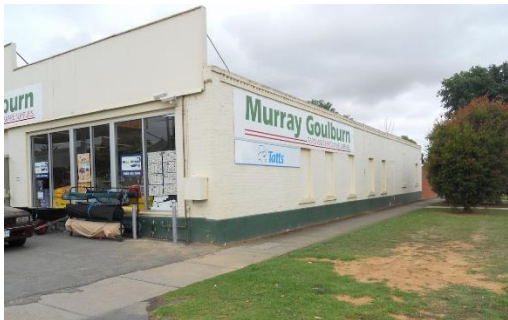
| 31-33 Moore Street, Rochester | Place Type | Commercial |

**Place Description** – The integrity of this building at 31 – 33 Moore Street Rochester has been compromised with the modifications to the front façade. The side façade demonstrates the original architecture with the regularly spaced windows and the decorative brickwork to the upper brick walling. The brickwork has been painted.

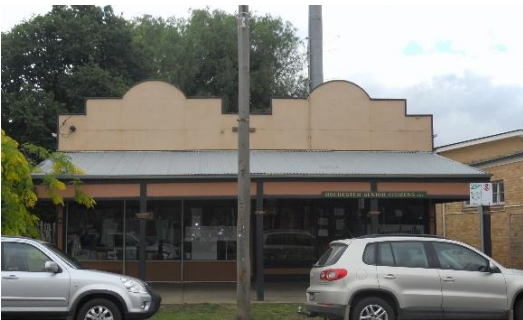
| 32-34 Moore Street, Rochester | Place Type | Commercial (Senior Citizens Opp Shop) |

**Place Description** – The double shop front at 32 – 34 Moore Street Rochester demonstrates a number of historic characteristics typical of commercial architecture from the late 19th/early 20th century. The parapet is divided into two to reflect the double shop front and there is an identical stepped pediment with an arched cap. The straight verandah has timber verandah posts and a deep fascia. The architectural character contributes to the streetscape.

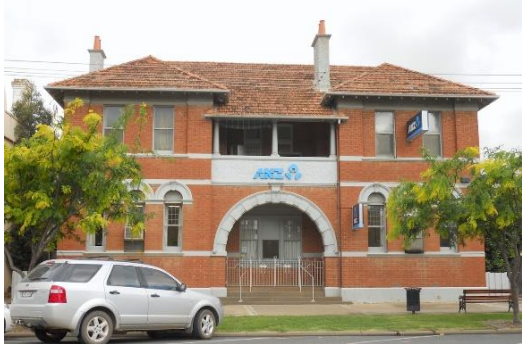
| 35 Moore Street, Rochester (ANZ Bank) | Place Type | Bank |

**Place Description** – The bank building at 35 Moore Street Rochester is a large two storey face brick building. The façade is distinguished by a centralised archway entrance and this is flanked on either side by three narrow arch headed windows. The upper floor has a central recessed porch and is flanked by two hipped roofed sections with rectangular windows. The roof is tiled with terracotta tiles. The face brick has contrasting cement dressings. The chimneys provide further architectural features. The architectural character contributes to the streetscape.

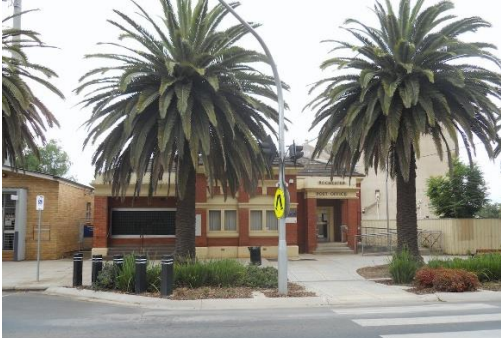
| 38 Moore Street, Rochester (Post Office) | Place Type | Post Office |

**Place Description** – This Post Office building at 38 Moore Street Rochester is typical post office design from the Public Works Office during the Interwar Period. The design is asymmetrical with a varied façade and roof configurations. It is constructed from face brickwork with contrasting cement rendered details. The façade is broken up into three sections with post boxes located on one section, a formalised central panel with paired windows and the third section has a pillared entrance to the post office. This building has retained its integrity and intactness. The architectural character contributes to the streetscape.

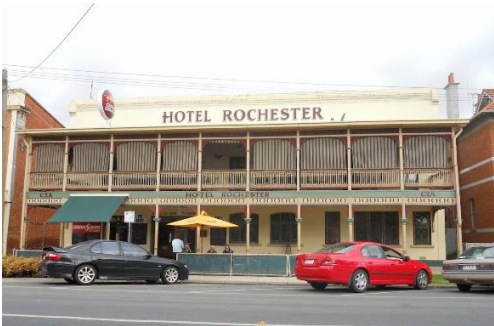
| 39 Moore Street, Rochester (Hotel Rochester) | Place Type | Hotel |

**Place Description** – The Hotel Rochester at 39 Moore Street Rochester is a good representative example of a late 19th/early 20th century two storey hotel. It is constructed from masonry and this has been painted. The parapet is a rectangular section and the signage is a feature of the façade. The storey verandah is a quintessential feature and is a significant architectural element. This building has largely retained its integrity and intactness. The architectural character contributes to the streetscape.

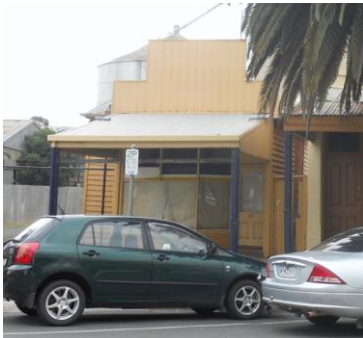
| 40 Moore Street, Rochester | Place Type | Commercial |

**Place Description** – 40 Moore Street is a good representative example of a simple timber vernacular shop front. It has a stepped metal clad parapet with a straight profile verandah. The glazed shop front has a recessed splay walled entry. This building has largely retained its integrity and intactness. The architectural character contributes to the streetscape.

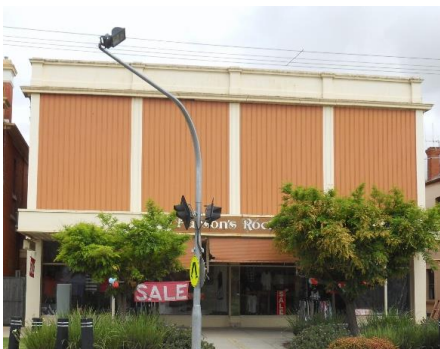
| 41 Moore Street, Rochester | Place Type | Commercial |

**Place Description** – 41 Moore Street is a large two storey commercial building. The ground floor has a modern glazed shop front with a cantilevered canopy. The upper floor has a metal infill panelling. The original rendered cornice and parapet is extant. This building has retained its integrity and intactness. The architectural character contributes to the streetscape.
