# ***Heritage Review 2014 - Part B***

## ***Heritage Precincts***

**Heritage Review 2014**  
**PART B – Heritage Precincts**

**September 2014**  
**(Amended February 2016)**

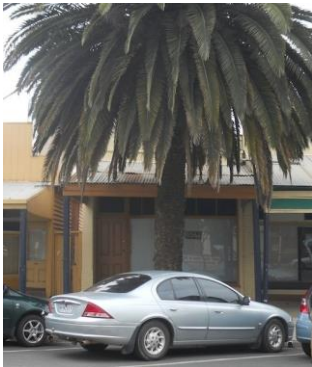
| 42 Moore Street, Rochester | Place Type | Commercial |

Place Description – 42 Moore Street is a good representative example of a simple timber vernacular shop front. It has a stepped and arched timber clad parapet with a straight profile verandah. The glazed shop has a recessed splay walled entry. This building has largely retained its integrity and intactness. The architectural character contributes to the streetscape.

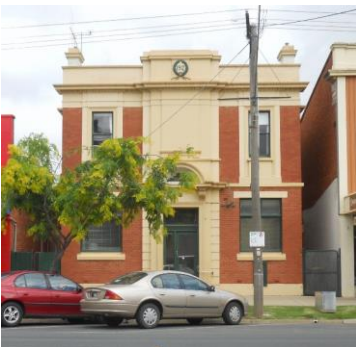
| 43 Moore Street, Rochester | Place Type | Commercial |

Place Description – 43 Moore Street is fine example of a two storey Interwar commercial building. The façade is classically styled and demonstrates some fine architectural features. The central front bay is rendered and is flanked by stylised ashlar pilasters, reeded pilasters and this door surround is surmounted by a moulded archway. The upper floor continues with this thematic composition – albeit simplified and rises up through the parapet. Other features of this façade include a finely detailed cornice with dentil mouldings; rendered window panels and render and brick chimneys with rendered cornices. This building has retained its integrity and intactness. The architectural character contributes to the streetscape.

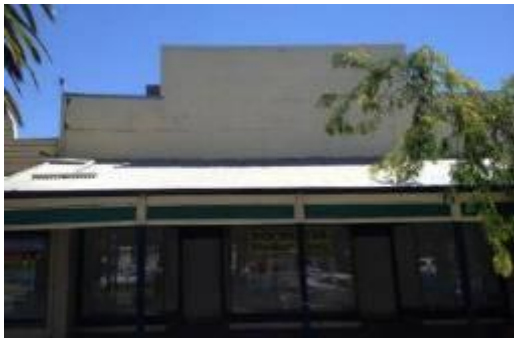
| 44 Moore Street, Rochester | Place Type | Commercial |

Place Description – 44 Moore Street is a large shop complex. The glazed shop front includes recessed entrances the parapet is a stepped parapet and is lined with metal sheeting. The verandah has a straight profile and a deep timber fascia. This building has largely retained its integrity and intactness. The architectural character contributes to the streetscape.

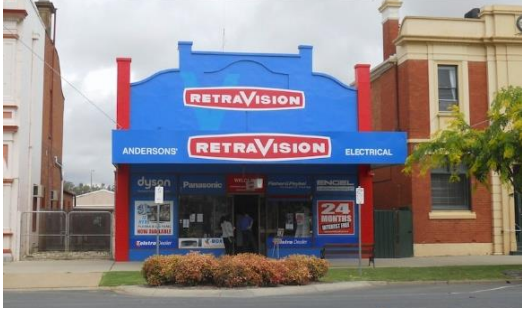
| 45 Moore Street, Rochester | Place Type | Commercial |

**Place Description** – 45 Moore Street is a single storey commercial building. Its architecture is typical of the Interwar period. It has a large glazed shop front with a cantilevered canopy. The parapet has a central rectangular feature with a recessed panel with a decorative curved top. This curvature is echoed on the parapet. The parapet has four capped pilasters. This building has retained its integrity and intactness – albeit with an inappropriate colours scheme. This building has largely retained its integrity and intactness. The architectural character contributes to the streetscape.

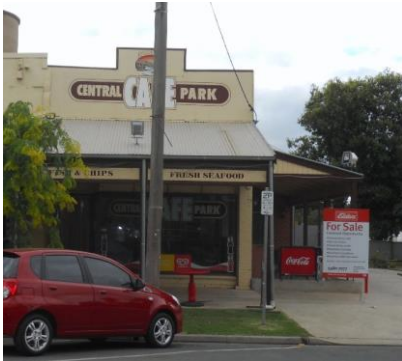
| 46 Moore Street, Rochester | Place Type | Commercial (café) |

**Place Description** – 46 Moore Street is a good representative example of a simple timber vernacular shop front. It has a stepped parapet with a straight profile verandah. The glazed shop has a recessed entry. There is a verandah to the side of the building. This building has largely retained its integrity and intactness. The architectural character contributes to the streetscape.

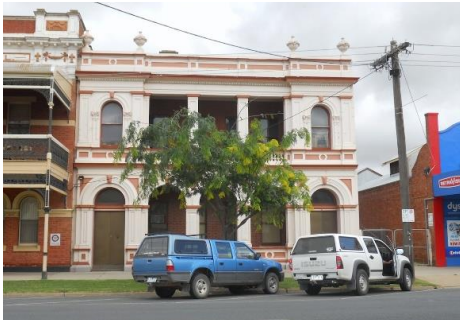
| 47 Moore Street, Rochester | Place Type | Bank |

**Place Description** – 47 Moore Street is a very fine example of bank architecture from the 19th century. It is a large rendered masonry building with classically inspired features. This includes the three bay division of the façade. The centralised section has three arches and this is flanked on either side by an arched window/doorway. The upper floor largely replicates the design of the ground floor but instead of three arches to the central portion there is a loggia with columns and balustrade. The cornice is a fine feature and this includes the dentil mouldings. The parapet includes decorative urns. This building has retained its integrity and intactness. The architectural character contributes to the streetscape.

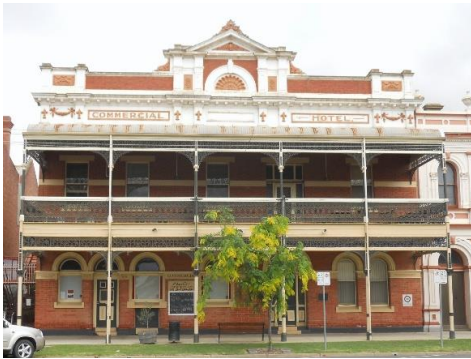
| 49 Moore Street, Rochester (Commercial Hotel) | Place Type | Hotel |

**Place Description** – 49 Moore Street is a particularly fine two storey Federation era hotel. It is constructed from red face brick and has contrasting cement rendered mouldings. The parapet is of particular note for its Federation inspired architectural detailing. This includes the pediment with its paired columns, arched detailing and the acroteria. The contrasting horizontal cement banding is often referred to as 'blood and bandages.' The ground floor has arched openings with cement rendered detailing and the upper floor has rectangular window openings with flat lintel banding. The two storey verandah has decorative cast iron balustrading and a cast iron frieze with cast iron brackets to both levels. This building has retained its integrity and intactness. The architectural character contributes to the streetscape.

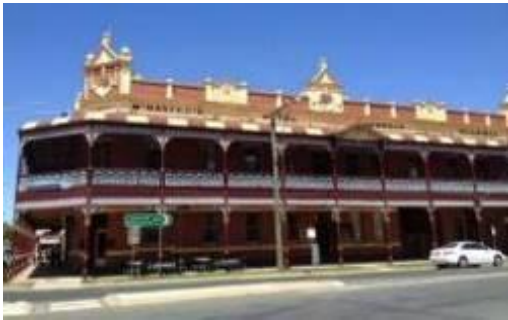
| 55 Moore Street, Rochester (Shamrock building) | Place Type | Hotel & shops |

**Place Description** – 55 Moore Street is a very fine face brick Federation era hotel. It is distinguished by its scale and its degree of decorative details. Its distinctive architecture dominates this main intersection of Rochester. Its styling is informed by its parapet detailing with pediments, oculus, arched pediments and capped pilasters. The two storey verandah is elaborate with its cast iron balustrading, cast iron frieze and brackets and bullnosed verandah. This building has retained its integrity and intactness. The architectural character contributes to the streetscape.

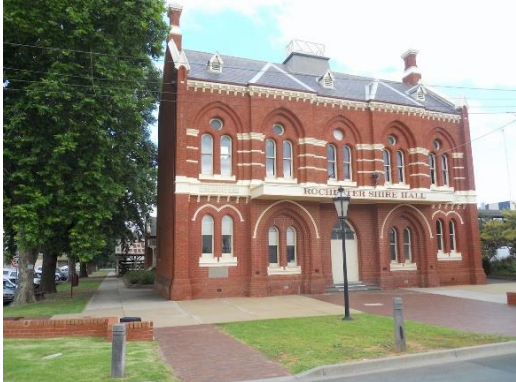
| 45 Mackay Street, Rochester, (Rochester Shire Hall) | Place Type | Former Shire Hall |

Place Description – 45 Mackay Street Rochester (former Shire Hall) is a two-storey symmetrical brick building erected in 1892 with coupled windows with gothic style characteristics. The gothic styling is complimented by the contrasting rendered features. The slate roof has a widow's walk on the ridge line. This building has retained its integrity and intactness. The architectural character contributes to the streetscape.

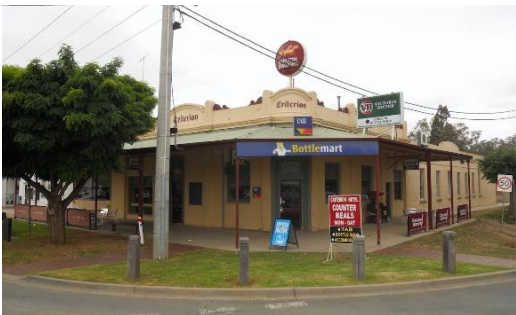
| 49 Mackay Street, Rochester (Criterion Hotel) | Place Type | Hotel |

Place Description – 49 Mackay Street is a single storey corner hotel. It demonstrates the principal characteristics of the period and the building type and this includes the verandah to both sides of the building and the simple parapet with its arched pediments. This building has largely retained its integrity and intactness. The architectural character contributes to the streetscape.

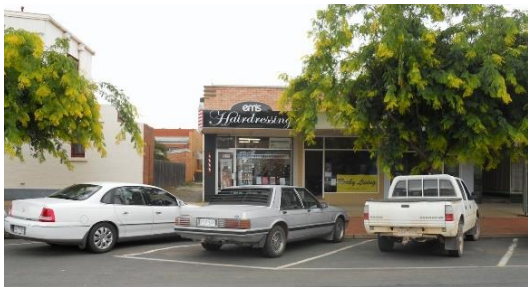
| 50-54 Mackay Street, Rochester | Place Type | Commercial |

Place Description – 50 – 54 Mackay Street has a simple post-war parapet and shop front. It is constructed from face cream brick and has a cantilevered canopy. This building has largely retained its integrity and intactness. The architectural character contributes to the streetscape.

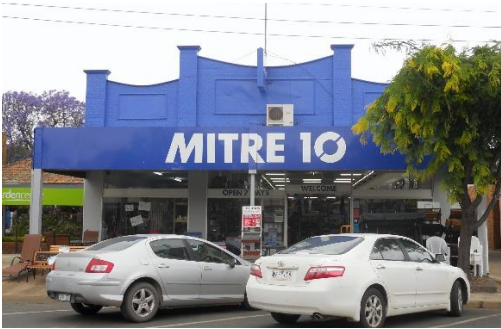
| 55 Mackay Street, Rochester | Place Type | Commercial |

Place Description – 55 Mackay Street is a commercial shop front from the Interwar period. The parapet is divided into three sections by capped pilasters. The profile of the parapet is concave. The glazed shop front has been modified. . This building has retained most of its integrity and intactness. The architectural character contributes to the streetscape.

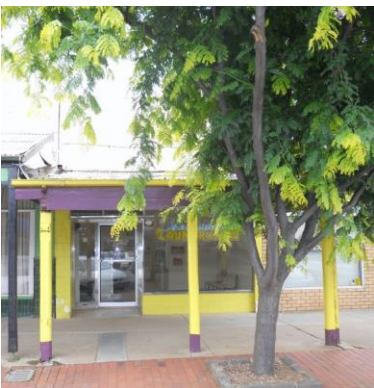
| 58 Mackay Street, Rochester | Place Type | Commercial |

Place Description – 58 Mackay Street is a simple vernacular shop front. It has a rectangular parapet with a straight profile verandah and a deep timber fascia. The shop front is glazed and is a later addition. This building has largely retained its integrity and intactness. The architectural character contributes to the streetscape.

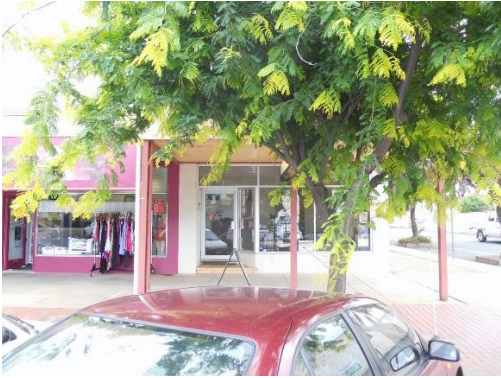
| 68 Mackay Street, Rochester | Place Type | Commercial |

Place Description – 68 Mackay Street is a simple vernacular shop front. The shop front is glazed and is a later addition. This building has retained much of its integrity and intactness. The architectural character contributes to the streetscape.

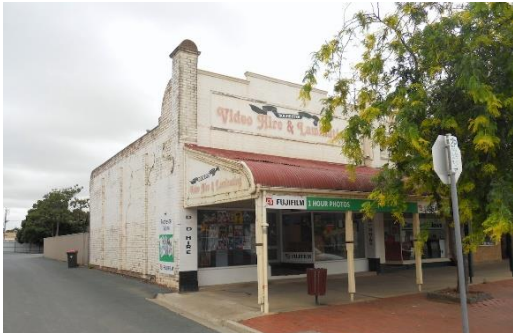
| 72 Mackay Street, Rochester | Place Type | Commercial |

Place Description – 72 Mackay Street has a masonry shop front. It has a rectangular parapet with capping and capped pilasters. The verandah has a bullnose and a deep timber fascia. The shop front is glazed. This building has largely retained its integrity and intactness. The architectural character contributes to the streetscape.

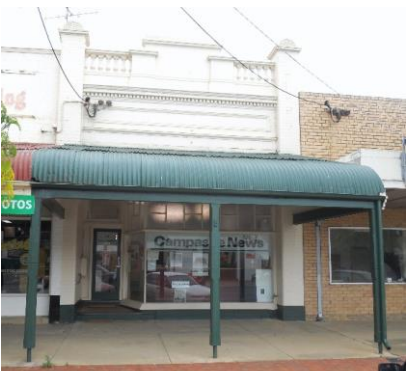
| 74 Mackay Street, Rochester | Place Type | Commercial |

Place Description – 74 Mackay Street has a masonry shop front. It has a balustrade parapet with a solid central section. The parapet has capped pilasters. The verandah has a bullnose and a timber fascia. The shop front is glazed and has a splayed recessed entrance. This building has largely retained its integrity and intactness. The architectural character contributes to the streetscape.

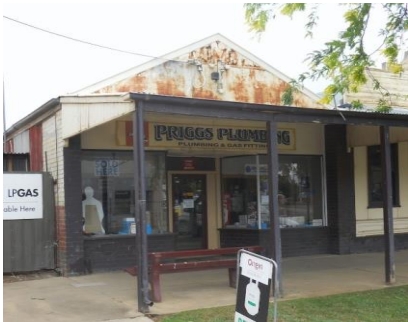
| 78 Mackay Street, Rochester | Place Type | Commercial |

Place Description – 78 Mackay Street is a gable fronted shop with a straight profile verandah. The shop front is glazed and it has a recessed entry. This building has largely retained its integrity and intactness. The architectural character contributes to the streetscape.

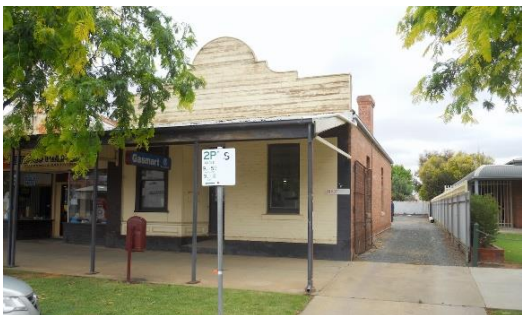
| 80 Mackay Street, Rochester | Place Type | Commercial |

Place Description – 80 Mackay Street is a masonry commercial building. It has an arched and stepped parapet and a straight profile verandah and a timber fascia. The street frontage has a recessed entrance with windows to either side of the doorway. This building has largely retained its integrity and intactness. The architectural character contributes to the streetscape.

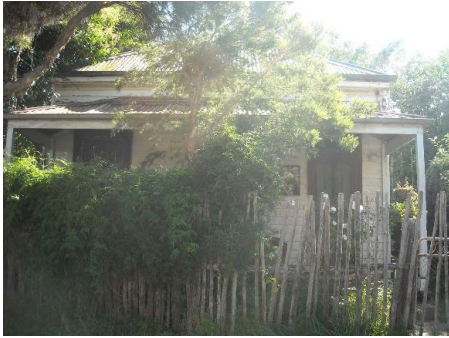
| 5 Esmonde Street, Rushworth | Place Type | Dwelling |

Place Description - 5 Esmonde Street is a single storey miner's cottage with a corrugated galvanised hipped roof with roll top ridge cappings. There is a straight profile verandah to the full extent of the front facade. The front door is located to one side with two timber sash windows to the other side. The house has retained much of its 19th century character. The design of this house with a door to one side is not typical for Rushworth. This cottage is potentially one of the earliest surviving cottages in Rushworth.

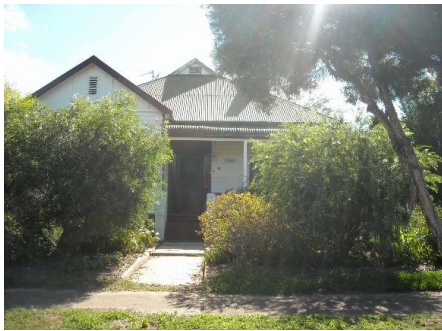
| 11 Esmonde Street, Rushworth | Place Type | Dwelling |

Place Description - 11 Esmonde Street is a single storey Edwardian Villa with a hipped roof clad in corrugated galvanised metal and a return verandah terminated by a projecting gabled bay. The hipped roof has gablet with a timber louvred vent. The gable front has vent to the gable and timber strapping. This contributory place is atypical representative example for its scale, era and region.

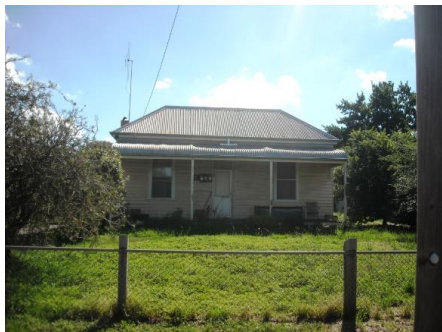
| 13 Esmonde Street, Rushworth | Place Type | Dwelling |

Place Description - 13 Esmonde Street is a single storey weatherboard clad cottage with a corrugated galvanised hipped roof with roll top ridge cappings. A bull nosed verandah extends across the front facade. The facade is symmetrical with a central front door flanked on either side by timber sash windows. Its design is typical for the 19th century and can be considered a vernacular response to local conditions. On the gold fields these cottages are often referred to as miner's cottages and this type of domestic architecture contributes to the quintessential 19th century mining character of Rushworth.

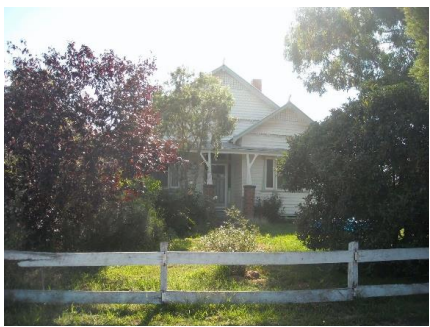
| 15 Esmonde Street, Rushworth | Place Type | Dwelling |

Place Description - 15 Esmonde Street is a single storey Interwar Bungalow with Arts and Crafts derived timber detailing. The design is asymmetric and the main body of the house has a large gable roof with a smaller projecting gable to the front. Each gable has stylised timber shingle cladding with a timber trellis to the apex of the gable. The gable fronts have paired timber brackets to the full extent of the gable base. The windows have a stylised splayed timber detail - which was a typical detail found on door and window surrounds c1920s. The front porch has brick half columns with slender timber posts that taper off as they approach the porch roof. Each of the timber posts have a timber support and this detail contributes to the decorative timber work found on the facade. The extent and types of decorative timber detailing is typical for the Arts And Crafts movement and demonstrates the move away from the Victorian cast iron detailing.

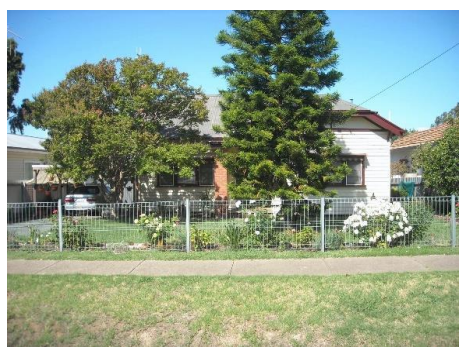
| 18 Esmonde Street, Rushworth | Place Type | Dwelling |

Place Description – 18 Esmonde Street is a weatherboard Interwar Bungalow with an entry porch. Its architectural character is informed by its asymmetry; timber weatherboards, simple group of timber framed triple windows. The roof is a hipped corrugated galvanised metal roof with a projecting gable front with a Jurkinhead gable.

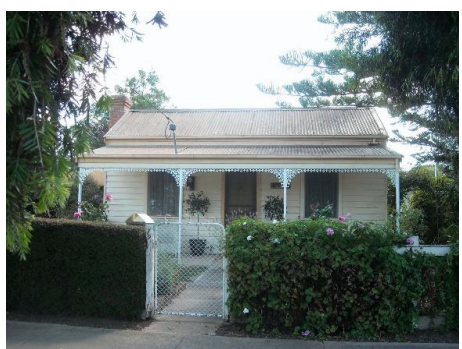
| 19 Esmonde Street, Rushworth | Place Type | Dwelling |

Place Description – 19 Esmonde Street is a single storey weatherboard clad cottage with a corrugated galvanised gable roof with roll top ridge cappings. A straight profile verandah extends across the front facade. The brick chimney contributes to the 19th century character and is a typical feature for this type of cottage. The facade is symmetrical with a central front door flanked on either side by timber sash windows. The verandah posts are not original. The front fence, hedging and gate complement the architecture of this house. Its design is typical for the 19th century and can be considered a vernacular response to local conditions. On the gold fields

these cottages are often referred to as miner's cottages and this type of domestic architecture contributes to the quintessential 19th century mining character of Rushworth.

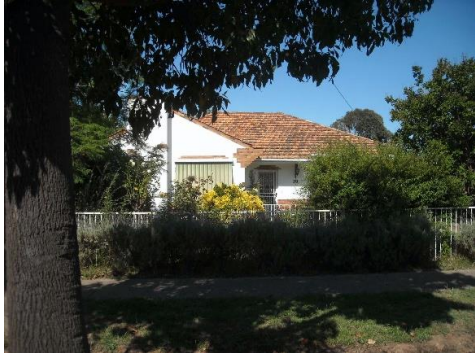
| 20 Esmonde Street, Rushworth | | Place Type | Dwelling |

Place Description – 20 Esmonde Street displays many of the characteristics associated with wartime and the immediate post war period architecture. It is a brick house with smooth rendered walling and decorative face brick detailing such as the corbelled face brickwork to the gable ends. The textural qualities of the face brickwork are echoed in the terracotta tiled roofing. The asymmetry of the design with the projecting gable front and recessed hipped roof body of the house is typical for the period.

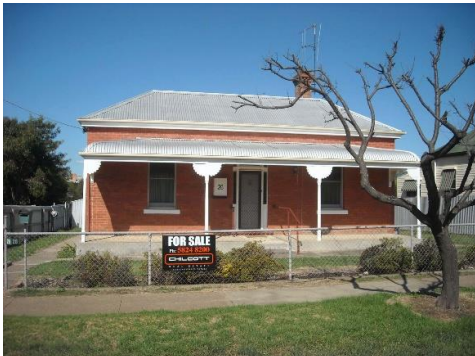
| 26 Esmonde Street, Rushworth | | Place Type | Dwelling |

Place Description – 26 Esmonde Street is a single storey face red brick cottage with a corrugated galvanised gable roof with roll top ridge cappings and a bullnosed verandah that extends across the front facade. The brick chimney contributes to the 19th century character and is a typical feature for this type of cottage. The facade is symmetrical with a central front door flanked on either side by timber sash windows. The verandah posts have timber 'capitals' and these are not original. Its overall design is typical for the 19th century and can be considered a vernacular response to local conditions. Its use of face brick gives this building additional stature as most of the cottages in Rushworth and of this scale tend to be constructed from timber with timber weatherboards. On the gold fields these cottages are often referred to as miner's cottages and this type of domestic architecture contributes to the quintessential 19th century mining character of Rushworth.

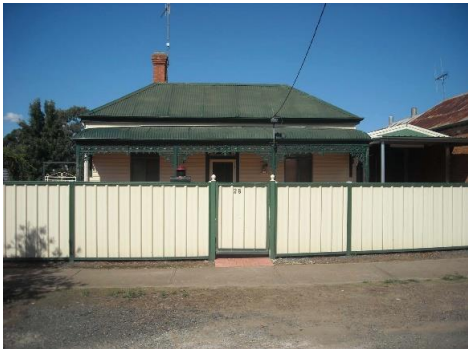
| 28 Esmonde Street, Rushworth | Place Type | Dwelling |

**Place Description** – 28 Esmonde Street is a single storey weatherboard clad cottage with a corrugated galvanised gable roof with roll top ridge cappings. A straight profile verandah extends across the front facade. The brick chimney contributes to the 19th century character and is a typical feature for this type of cottage. The facade is symmetrical with a central front door flanked on either side by timber sash windows. The verandah posts are not original. The front fence, hedging and gate complement the architecture of this house. Its design is typical for the 19th century and can be considered a vernacular response to local conditions. On the gold fields these cottages are often referred to as miner's cottages and this type of domestic architecture contributes to the quintessential 19th century mining character of Rushworth.

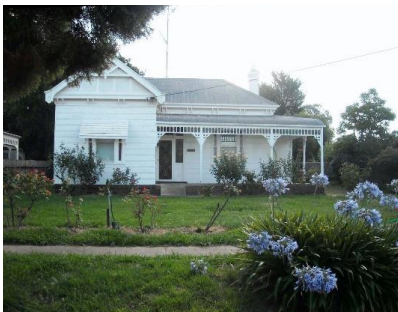
| 29 Esmonde Street, Rushworth | Place Type | Dwelling |

**Place Description** – 29 Esmonde Street is a stylish weatherboard Edwardian villa with a corrugated galvanised metal hipped roof with a return verandah terminated on one side by a projecting gable bay and on the other side it returns to the side of the house. The gable has decorative timber strapping and timber brackets to its base. The return verandah has timber fretwork frieze and brackets. The windows and front door have decorative side lights. The window to the gable has decorative hood.

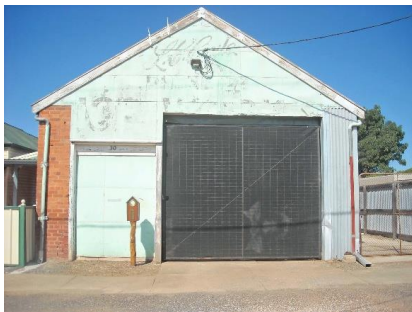
| 30 Esmonde Street, Rushworth | Place Type | Rushworth Dairy |

**Place Description** – 30 Esmonde Street is a utilitarian rectangular brick building with a gable roof clad with corrugated galvanised metal. The façade has a double garage door with a metal grille clad door. The gable is clad with metal sheeting and there is evidence of the former signage. The side panel was corrugated metal but this has been replaced by Rushworth Iron bark (*Eucalyptus sideroxylon*).

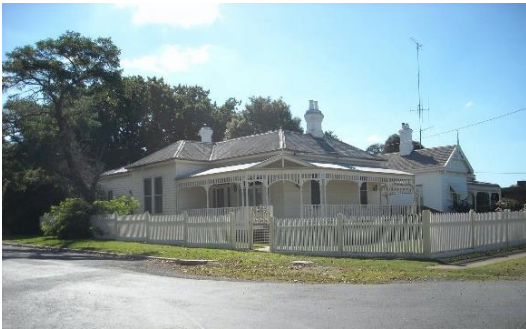
| 31 Esmonde Street, Rushworth | Place Type | Dwelling |

**Place Description** – 31 Esmonde Street occupies a corner site and is a feature of the streetscape. It is a large weatherboard house with hipped roofs, brick chimneys and timber framed double hung windows. The front door has highlights and sidelights and there is a bank of windows adjacent to the entrance. The timber picket fence and wrought cyclone gate complements the architecture.

The style is typical for a regional Federation/Edwardian era house. It addresses the corner with a splayed breakfront to the verandah with a side entrance. This use of diagonals (splayed breakfront, side entry) is a feature of architecture from this period. Other decorative features that contribute to its architecture include the turned timber verandah posts, the timber fretwork and the fine detailing found within the arched fretwork to the break front. This detail is reminiscent of Desbrowe-Anneer's 1903 house and is a stylish embellishment and contributes to the overall finesse of this building.

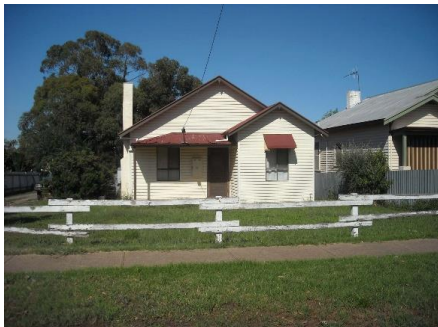
| 36 Esmonde Street, Rushworth | Place Type | Dwelling |

**Place Description** – 36 Esmonde Street is an Interwar Bungalow. The architecture is typical for the period and region with a large gable front/roof to the main section of the building with an entrance porch and a smaller gable front/roofed projection. Both fronts have windows that have been modified and the cladding is also not original.

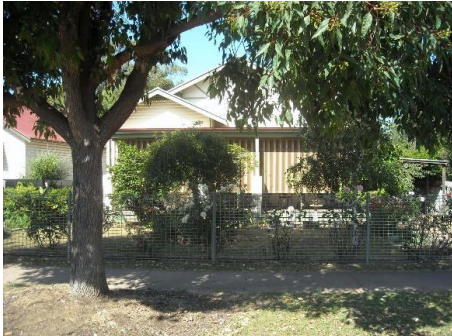
| 38 Esmonde Street, Rushworth | Place Type | Dwelling |

**Place Description** – 38 Esmonde Street is a relatively intact Interwar Bungalow. The architecture is typical for the period and region with a large gable front/roof to the main section of the building with an entrance porch and a smaller gable front/roofed projection. The porch extends across the front of both sections and has masonry half columns with timber posts. The smaller gable front has a

timber fretwork vent and stylised scalloped boards to the gable front. The large gable front has a timber fret work vent and radial timber battens to the gable front. There is a lean-to carport to one side.

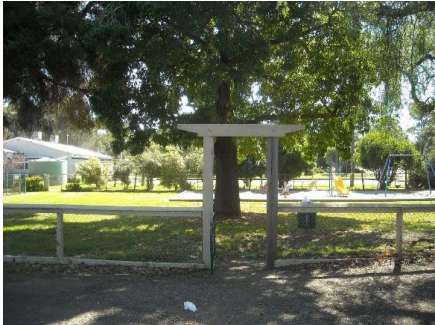
| Geyle Reserve, Esmonde Street, Rushworth | Place Type | Recreation reserve/Play ground |

Place Description – Geyle Reserve is a recreation area with a timber and cyclone wire fence with a decorative timber frame to the main entrance. The park has a number of large trees, and grassed area with a playground.

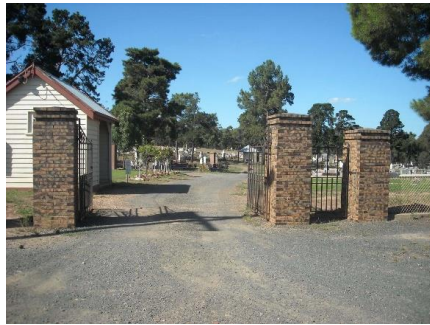
| Rushworth Cemetery, Heily Street, Rushworth | Place Type | Cemetery |

Place Description – Rushworth Cemetery is located on a hillside overlooking Rushworth and surrounding bushland. It has a large number of 19th and 20th century burial areas with some having substantial headstones. The rotundas and shelter sheds add to the picturesque character of the place. The front gates are a 20th century addition with brick plinths and wrought iron gates. There are a number of significant trees within the site. The gravelled paths contribute to its character.

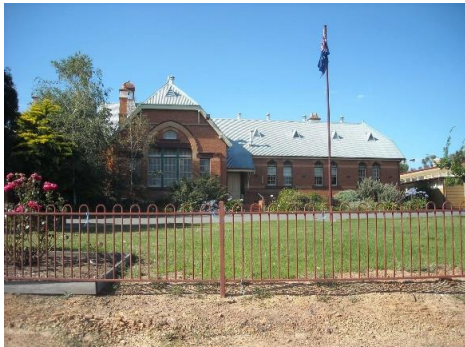
| Rushworth Primary School, 49-65 Heily Street, Rushworth | Place Type | School |

Place Description – The Rushworth Primary School is a very fine 19th century Victorian school building. It is a large brick building with a prominent projecting façade.

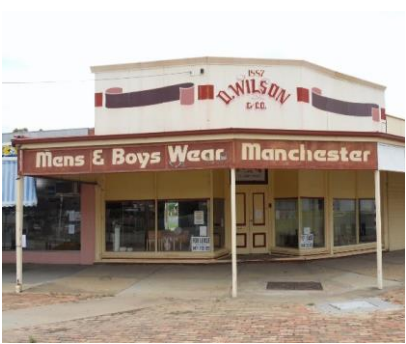
| 1 High Street, Rushworth | Place Type | Commercial |

Place Description – 1 High Street is a typical splayed shop front with glazed shop windows and a parapet with a cornice top. The verandah posts are not original as they are painted galvanised pipes.

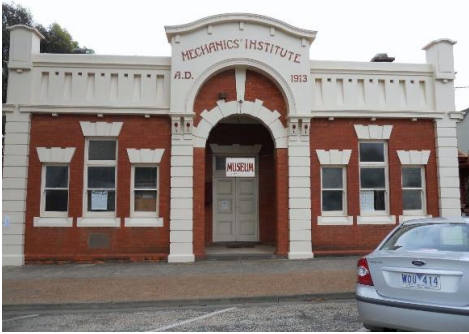
| 2-4 High Street, Rushworth | Place Type | Mechanics Institute (current museum) |

Place Description – The Mechanics Institute is a fine early 20th building. The foundation stone of the Rushworth Mechanics Institute was laid by William Gunn Esq the President in July 1913. The architect was A J Inches and the builder, D Brothers. The façade has many elements of the Baroque revival.

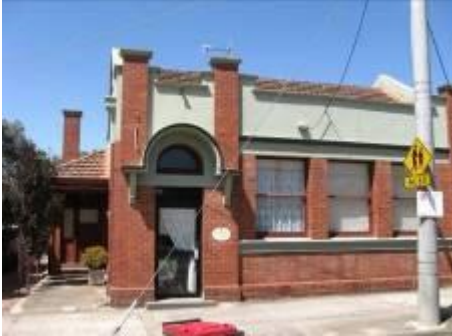
| 6 High Street, Rushworth | Place Type | Former State Savings & then Commonwealth Bank (current dwelling) |

**Place Description** – Former State Savings Bank (SSB) dates from c1920. Built in face red brickwork with stucco mouldings in the style of the Baroque revival as illustrated by the flanking pilasters that rise up above the parapet and the cantilevered arched canopy. The door has been replaced and glazing altered. The roof is clad with Marseilles pattern terra cotta. The horizontal lines of the rendered parapet are echoed with a group of three double hung windows. To the rear of the former bank building there is a residence with a recessed side entrance which is visible from High Street. The design is typical for SSB country branches c1920.

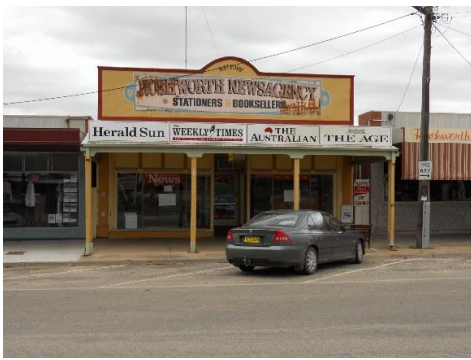
| 7 High Street, Rushworth | Place Type | Commercial |

**Place Description** – This simple shop front demonstrates many of the characteristics associated with 19<sup>th</sup> and early 20<sup>th</sup> century regional commercial architecture. The parapet has a centralised arch which relieves the relative utility of the façade. The posted verandah has a vertical signage board which is possibly not original but it is a typical feature from the period. The shop front has large glazed panels with segmented highlights.

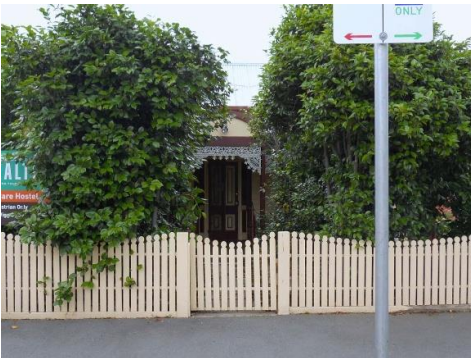
| 8 High Street, Rushworth | Place Type | Dwelling |

**Place Description** – 8 High Street Rushworth has a symmetrical facade with a central front door flanked on either side by timber sash windows. It has a hipped roof and convex profile verandah. Its design is typical for the 19th century and can be considered a vernacular response to local conditions. On the gold fields these cottages are often referred to as miner's cottages and this type of

domestic architecture contributes to the quintessential 19th century mining character of Rushworth. The verandah has a decorative cast iron frieze and brackets and this adds to the distinction of the place as befits its location in High Street.

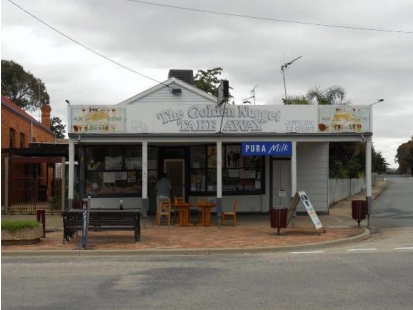
| 15 High Street, Rushworth | Place Type | Commercial |

**Place Description** – This simple shop front demonstrates many of the characteristics associated with 19<sup>th</sup> and early 20<sup>th</sup> century regional commercial architecture. The gable roof of the shop protrudes above the rectangular parapet and acts as a defacto pediment. The large glazed shop fronts are typical if somewhat altered. The posted verandah contributes to the historic character of this building.

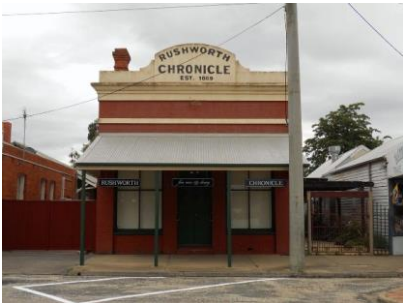
| 17 High Street, Rushworth | Place Type | Former Rushworth Chronicle Steam Printing Office |

**Place Description** – The Rushworth Chronicle Steam Printing was built in 1888 to house the new steam powered presses, this intact simple double brick office and dwelling was built to a Cornish design popular on the Burra copper fields. The façade; is distinguished by the string course, the cornice line and arched pediment to the parapet with raised lettering. The relatively intact interior together with the unusual cooling design through the ventilated hollow brick piers, the water pipes under the floor, the overhead belting system and collection of printing equipment related to this small town printery all combine to make this building notable.

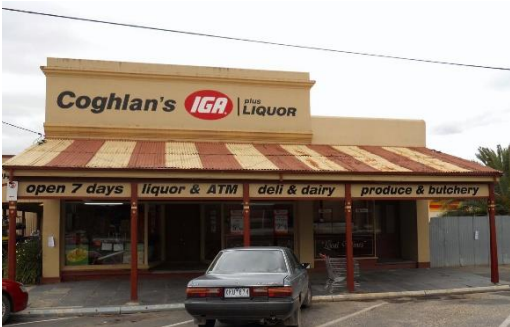
| 18 High Street, Rushworth | Place Type | Commercial |

**Place Description** – The shop front at 18 High Street demonstrates many of the characteristics associated with 19<sup>th</sup> and early 20<sup>th</sup> century regional commercial architecture. The cornice to the parapet contributes to its historic architectural character. The large glazed shop fronts are typical. The posted verandah with the timber fascia (used for signage) contributes to the historic character of this building. The later addition is sympathetic to the historic and aesthetic significance of this building.

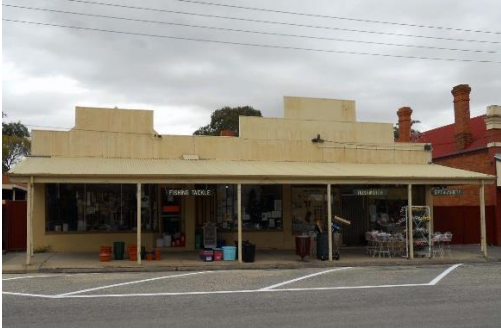
| 19-21 High Street, Rushworth | Place Type | Commercial |

**Place Description** – These two simple shop fronts demonstrates many of the characteristics associated with 20<sup>th</sup> century regional commercial architecture. Both of the sheet metal clad parapets have centralised rectangular pediments. The posted verandahs and glazed shop fronts contribute to the historic character of these shops. The metal clad parapets are an important feature of these shops as it demonstrates the changing fortunes of Rushworth.

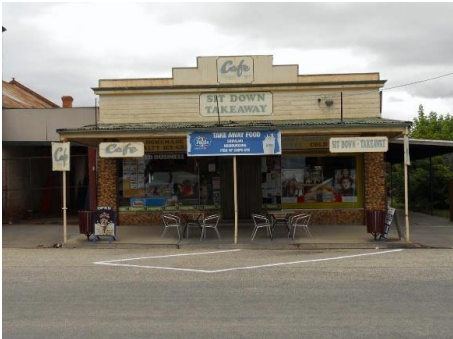
| 25 High Street, Rushworth | Place Type | Commercial |

**Place Description** – The shop front at 25 High Street demonstrates many of the characteristics associated with 19<sup>th</sup> and early 20<sup>th</sup> century regional commercial architecture. The cornice to the parapet contributes to its historic architectural character. The large glazed shop fronts are typical. The posted verandah while not original does contribute to the historic character of this building. The façade has been modified and is constructed from 20<sup>th</sup> century brickwork.

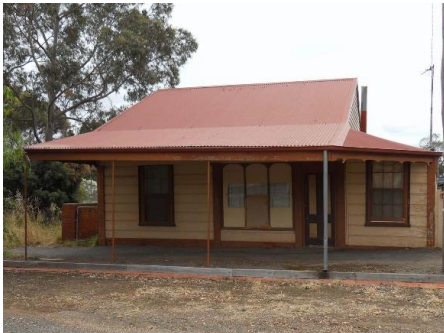
| 26 High Street, Rushworth | Place Type | Former Cracknell's Bakery Shop and Residence |

**Place Description** – A simple gabled weatherboarded former baker's shop and residence, with a timber ashlar pattern facade and remnant verandah showing scalloped fascia. The shop front has an arcaded timber glazed shop window, four-panelled doors and 12 pane windows (possibly Crown Glass).

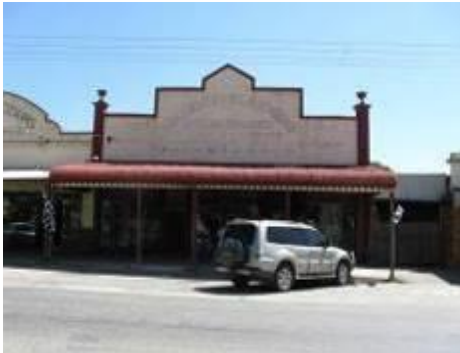
| 27 High Street, Rushworth | | Place Type | Commercial |

Place Description – Large double-fronted shop with generous glazed shopfront windows and glazed entry doors. There is a high stepped parapet with austere pediment at the centre. There are parapet urns to the tall piers at either end and the verandah has a bullnosed profile.

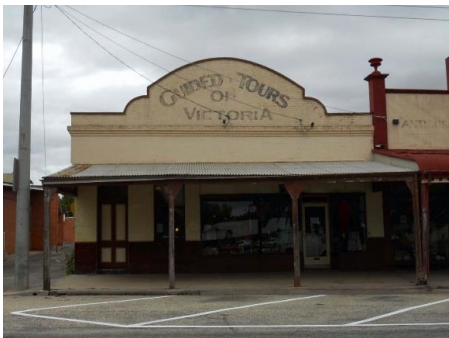
| 29-31 High Street, Rushworth | | Place Type | Commercial |

Place Description – Brick shop and office (and residence) with original shopfront tiling and verandah. The shop front has an asymmetric design with irregularly spaced doors and one large glazed shopfront window. The parapet with its face brick high segmented arch (now painted) contributes to the distinctive profile.

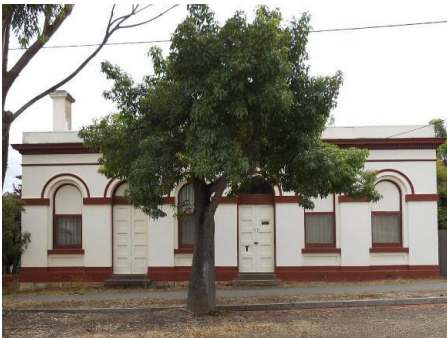
| 30-32 High Street, Rushworth | | Place Type | Former Bank of Victoria |

Place Description – 30 – 32 High Street is a brick and render commercial building with a parapeted and rendered main façade. The styling is Renaissance Revival and is similar to the work of the 19<sup>th</sup> century Melbourne architect Leonard Terry. It has a dentilated cornice line and arcuated facade. There are subtle impost mouldings that link with the arched window and these are panelled beneath the sills to imply the arcade principle. Two entrance doors (5- panelled pairs) have arched high lights. The render finish is ruled as for ashlar masonry and the footings are of stone with basalt steps to each door. The side yard has an exotic garden.

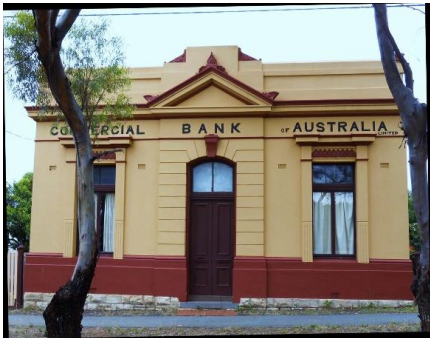
| 34-36, High Street, Rushworth | Place Type | Former Commercial Bank |

Place Description – Distinctive former Bank of Victoria owes much to the Renaissance Revival. The breakfront has a tooled and rusticated render with a pediment and double four-panel entrance doors with a bisected top light and flanking (altered) windows set between pilasters in the aedicule format above which is a delicate palmette pattern. Other details includes acroterion at the parapet corners and pediment apices plus subtle scrolling at the raised entablature central to the parapet where the bank name can still be distinguished.

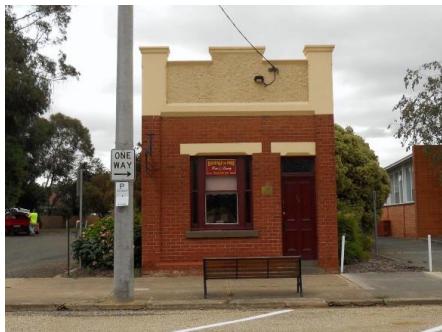
| 35 High Street, Rushworth | Place Type | Former welfare centre |

Place Description – Former office from the early 20<sup>th</sup> century with panelled door entrance, double hung sash windows with side lights and a typical parapet from the 1910-15 era with rough-cast stucco infill.

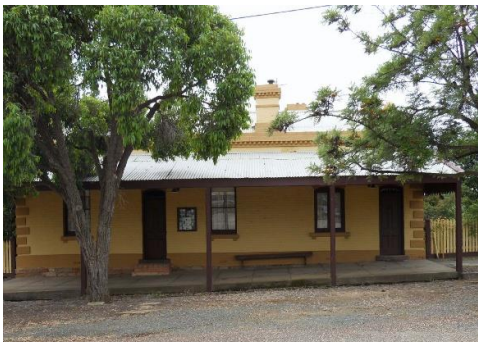
| 38 High Street, Rushworth (Imperial Hotel) | Place Type | Hotel |

Place Description – The former Imperial Hotel has a straight profile verandah to the full extent of its façade. The building has a parapet running along the High Street façade with distinctive dog-tooth frieze and/ or brick course under. Similar dog-tooth occurs at the chimney cornices. The brickwork has been painted with the quoining picked out in a contrasting colour. The windows are timber framed double hung sash windows. The verandah appears to be new and at least one door is not original.

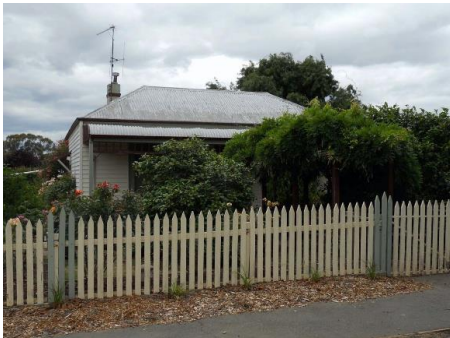
| 40 High Street, Rushworth | Place Type | Commercial |

Place Description – 40 High Street is a single storey cottage with a corrugated galvanised hipped roof with roll top ridge cappings. A straight profile verandah extends across the front façade. The facade is symmetrical. The front fence, hedging and gate complement the architecture of this house. Its design is typical for the 19th century and can be considered a vernacular response to local conditions. On the gold fields these cottages are often referred to as miner's cottages and this type of domestic architecture contributes to the quintessential 19th century mining character of Rushworth.

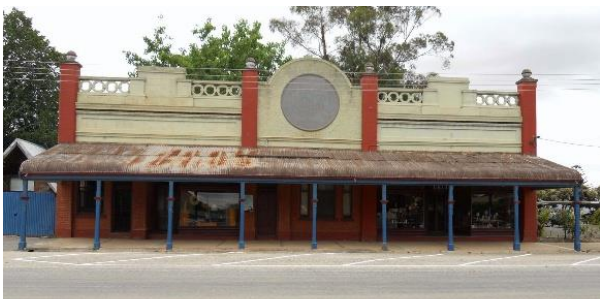
| 41-47 High Street, Rushworth (Glasgow Buildings) | Place Type | Commercial |

Place Description - the Glasgow Shops are an impressive trio of shops. They were formerly of face red brickwork but now the pediment is painted. The shops possess a fine bull-nosed verandah with stout timber columns and high stuccoed parapets with dividing piers and orbs. The parapet has a guilloche pattern balustrade and a severe squared raised entablature on the flanking bays to the central arched parapet which bears the name Glasgow Buildings 1880. The shops are from c1911 and have relative unaltered interiors.

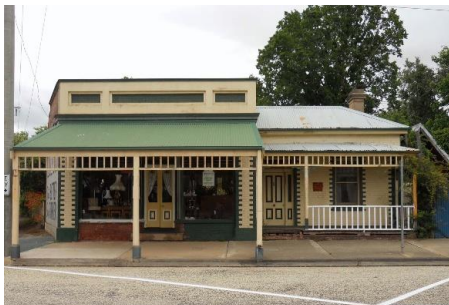
| 53 High Street, Rushworth | Place Type | Shop and Residence |

Place Description – Shop and residence with shop verandah and convex profile house verandah adjoining. Residential section has a typically hipped roof form with now painted face brickwork. The verandah frieze slatting and are c1910. The adjoining shop is parapeted with panels set into the brickwork using applied stucco above the cornice line. The parapet scrolls down to the house

roofline facing Wigg Street, providing a picturesque assembly of forms at the corner. The chimney type and house form indicate late 19th century.

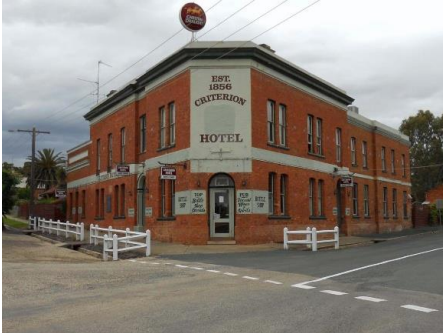
| 59 High Street, Rushworth (Criterion Hotel) | Place Type | Hotel |

**Place Description** – The Criterion Hotel(1890 is a two storey brick and stucco parapeted corner hotel with splayed corner form, arched entryway to the bar at the corner and residential section in High Street. The design is austere with paired windows and recessed bays providing a punctuation to the facade. An adjoining single storey section appears to have been augmented with a parapet extension but otherwise the hotel is generally externally original except for painted brickwork, the demolished verandah. There is a stable block at the rear.

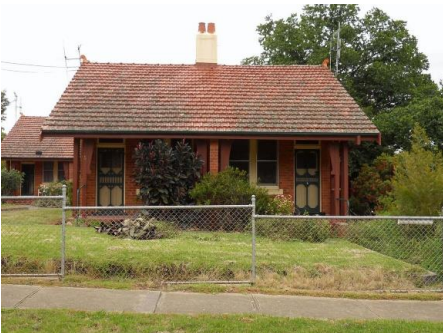
| 63 Miller Homes, High Street, Rushworth | Place Type | Set of Dwellings |

**Place Description** – The Alexander Miller Homes were constructed to provide philanthropic accommodation. The bungalows are constructed from red face brickwork with a gable roof clad with Marseilles pattern, terra cotta tiles; timber framed double hung windows and timber doors, brick verandah piers with concrete cappings, low brick balustrades flanking the entry steps and stuccoed chimney stacks central to each bungalow. The bungalows are located in a generous garden setting with a number of mature trees. There were a number of these types of Miller Homes in regional Victoria but many have been either demolished or are significantly altered.

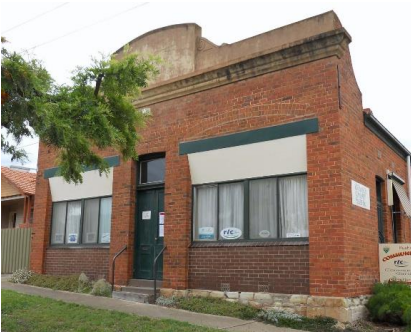
| 67 High Street, Rushworth (Community House) | Place Type | Commercial/office |

**Place Description** – 67 High Street is a large red brick parapeted building with what appears to be altered shopfronts either side of entrance door. The parapet is austere and built from render with a segment arch, raised entablature and subtle scrolling to either end. This pediment has remain unpainted and demonstrates an original finish – which is now rare. The footings are stone.

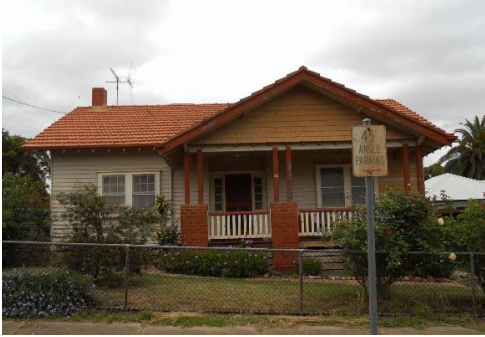
| 69 High Street, Rushworth | Place Type | Dwelling |

**Place Description** – 69 High Street is an Interwar Bungalow. It designed with a dominant gable front and a transverse gable the roof is clad with terra cotta roof tiles. The projecting gable front has a deep porch with paired timber columns and this feature contributes strongly to the architectural character of the bungalow.

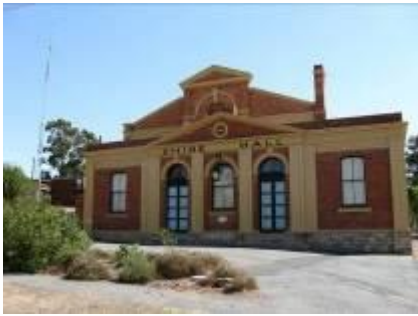
| 71 High Street, Rushworth (Rushworth Shire Hall) | Place Type | Former Shire Hall |

**Place Description** – The former Shire Hall was designed by Vahland and Getzschman and built by T P Price of local Rushworth brick. The Hall was opened in 1869. Extensions were completed in 1883 to the west and south sides. The foundation stone was stolen immediately after laying on 25th July, 1868, and never seen again.

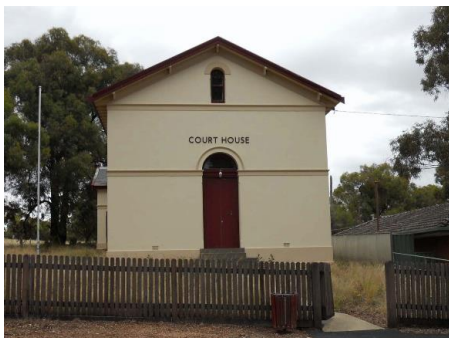
| 77 High Street, Rushworth | Place Type | Rushworth Courthouse |

**Place Description** – The original Court House was built on this site in 1853 but became inadequate for the requirements of the district so the court, along with its furniture and fittings was moved into the nearby Shire Hall (built in 1869). Erected in the late 1870s the extant Court house is a single storey but lofty Court House. It has a gable front with slim lancet like windows and an austere central arched entry via a set of basalt steps. The central entrance leads in to a single volume court room containing panelled magistrate's bench, clerk's and jury docks and arcaded bench seat barriers. Located high above the court room on the northern and southern walls are four double hung sash windows. King post trusses support a timber lined gable ceiling. A transverse skillion addition at the rear was constructed in a similar design to the main court following the demolition of the 1857 structure prior to the construction of the first police station and contains magistrate's and clerk's rooms.

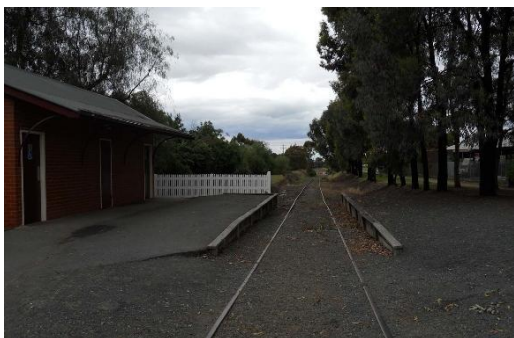
| Rail Reserve, High Street, Rushworth | Place Type | Former railway |

**Place Description** – The railway corridor has a number of surviving infrastructure elements and these include track, and remnants of platforms/sidings. A number of the gates have been reconstructed in High Street and these provide valuable interpretation.

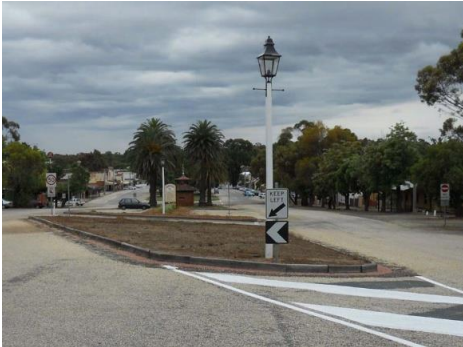
| Central Reserve, High Street, Rushworth | | Place Type | Central road reserve |

**Place Description** – The character and significance of the town is largely a function of its landscape setting and in particular the generous width of High Street which provides a formalised urban space that is unprecedented in other town within the Campaspe Shire or the region in general. The central reserve includes a number of historic items including the rotunda, lamp post, drinking fountain, war memorial, palm trees and other landscape features.

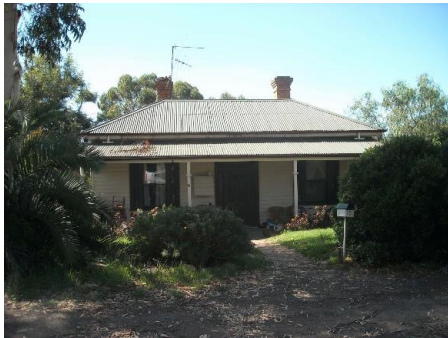
| 10 Horne Street, Rushworth | | Place Type | Dwelling |

**Place Description** – 10 Horne Street is a single storey weatherboard cottage with a corrugated galvanised hipped roof with roll top ridge cappings and a straight profile verandah that extends across the front facade. The prominent corbelled brick chimneys contribute to the 19th century character and are a typical feature for this type of cottage. The facade is symmetrical with a central front door flanked on either side by timber sash windows. Its overall design is typical for the 19th century and can be considered a vernacular response to local conditions. On the gold fields these cottages are often referred to as miner's cottages and this type of domestic architecture contributes to the quintessential 19th century mining character of Rushworth.

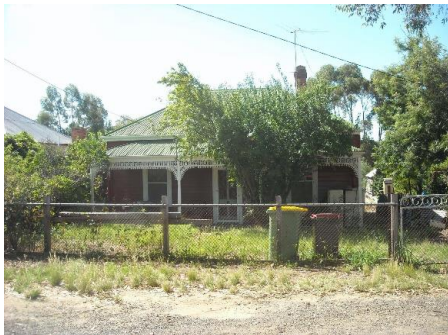
| 12 Horne Street, Rushworth | | Place Type | Dwelling |

**Place Description** – 12 Horne Street is a single storey cottage with a corrugated galvanised hipped roof with roll top ridge cappings and a straight profile verandah that extends across the front facade. The cast iron frieze and capitals contribute to the architectural presentation of this cottage. The prominent brick chimneys contribute to the 19th century character and are a typical feature for this type of cottage. The facade is symmetrical with a central front door flanked on either side by timber sash windows. Its overall design is typical for the 19th century and can be considered a vernacular response to local conditions. On the gold fields these cottages are

often referred to as miner's cottages and this type of domestic architecture contributes to the quintessential 19th century mining character of Rushworth.

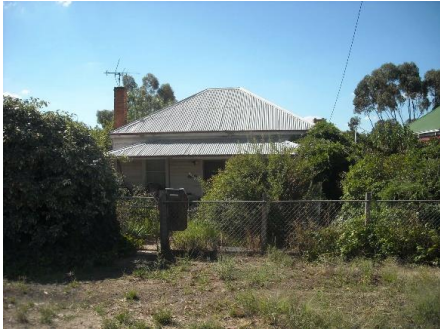
| 14 Horne Street, Rushworth | | Place Type | Dwelling |

**Place Description** – 14 Horne Street is a single storey weatherboard cottage with a corrugated galvanised hipped roof with roll top ridge cappings and a straight profile verandah that extends across the front facade. The relatively steep pitch of the roof is of note and is often associated with an earlier timber shingle cladding. The prominent brick chimney contributes to the 19th century character and is a typical feature for this type of cottage. The facade is symmetrical with a central front door flanked on either side by timber sash windows. Its overall design is typical for the 19th century and can be considered a vernacular response to local conditions. On the gold fields these cottages are often referred to as miner's cottages and this type of domestic architecture contributes to the quintessential 19th century mining character of Rushworth.

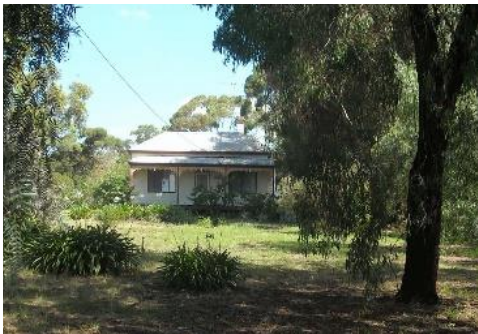
| 17 Horne Street, Rushworth | | Place Type | Dwelling |

**Place Description** – 17 Horne Street is a single storey weatherboard cottage with a corrugated galvanised hipped roof with roll top ridge cappings and a straight profile verandah that extends across the front facade. The cast iron frieze and capitals contribute to the architectural presentation of this cottage. The prominent brick (painted) chimney contributes to the 19th century character and is a typical feature for this type of cottage. The facade is symmetrical with a central front door flanked on either side by windows (not original windows). Its overall design is typical for the 19th century and can be considered a vernacular response to local conditions. On the gold fields these cottages are often referred to as miner's cottages and this type of domestic architecture contributes to the quintessential 19th century mining character of Rushworth.

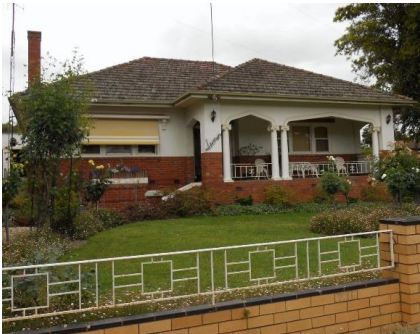
| 3 Moora Road, Rushworth | Place Type | Dwelling |

Place Description – 3 Moora Road is an unusual architectural example for Rushworth. Its form is bungalow in scale and presentation but the architectural features hint at other more exotic sources with a mixture of Tudor arches to the entrance porch and stylised paired and single columns with a version of an Ionic capital. This is complemented by the colour and textural variation found between the smooth render finish to the upper walls and the lower 'rough' brick base walls. The windows are in groups of three (double hung timber sash windows). The fence is later and typical for the 1950s – with cream brick pillars and decorative wrought iron panels.

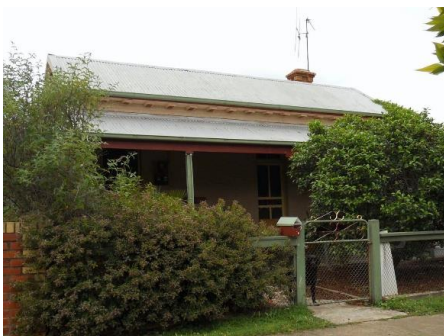
| 5 Moora Road, Rushworth | Place Type | Former doctor's surgery & Dwelling |

Place Description – 5 Moora Road is a double gabled house with a return verandah with a straight profile and the timber posts are stop chamfered. The overall form is typical of early colonial house forms and the metopes in the eaves are characteristic of that period – although the use of a bi-chrome colour scheme for the brickwork (evidence of this is found around the openings) would place it as being constructed during the establishment of Rushworth c1860/70.

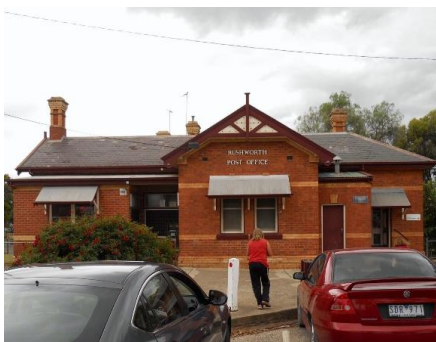
| 6 Moora Road, Rushworth | Place Type | Rushworth Post office |

Place Description – The Rushworth Post Office (c1886) is constructed from polychromatic brickwork with bands of cream brickwork contrasted against red face brickwork. There is a trussed timber gable on both elevations of the L- shaped plan. Ribbed chimneys

with corbelled cornices provide further detail extending down the north facade. The former verandah has been bricked in a sympathetic manner and other alterations have been carried out including additional window hoods. The building is prominent at the corner of High and Station Street and relates to the red brick buildings that extend to the south down High Street.
