# ***Heritage Review 2014 - Part B***

## ***Heritage Precincts***

**Heritage Review 2014**  
**PART B – Heritage Precincts**

**September 2014**  
**(Amended February 2016)**

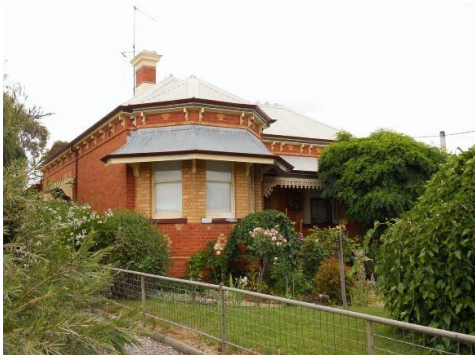
| 7 Moora Road, Rushworth | Place Type | Dwelling |

**Place Description** - 7 Moora Road is a typical asymmetrical Italianate house of late 19th century, with a projecting faceted room bay and matching window hood in the form of a cantilevered verandah. The verandah proper has a decorative cast iron frieze with brackets. The eaves are bracketed and chimney cornices are further ornamentation along with the polychromatic brickwork.

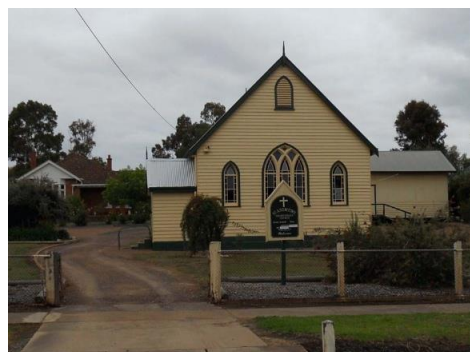
| 9 Moora Road, Rushworth | Place Type | Church |

**Place Description** - St Andrews Presbyterian Church dates from c1892. It demonstrates the principles of primitive Gothic Revival architecture – a simple stripped Gothic interpretation. The main gable front has with a large central pointed arch with narrow pointed arches on either side. There are also decorative roof vents and a gabled roof porch. The timber finials provide further decorative features. The red brick residence to the rear demonstrates many of the architectural characteristics associated with the Edwardian era.

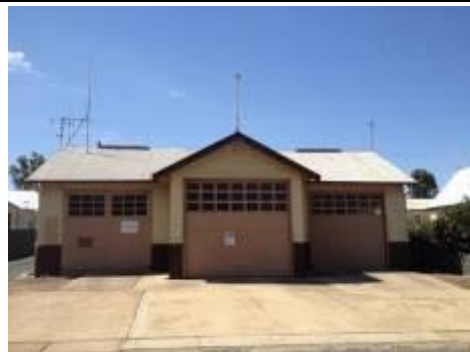
| 11 Moora Road, Rushworth | Place Type | CFA station |

**Place Description** – The station has three bays with large doors either side of a central office section which is gabled. The cladding consists of asbestos sheet with a weatherboard dado - typical of this period. The windows are bands of small paned windows – which run across the three bays. The transverse roofs are clad with corrugated metal. Country Fire Authority Station: opened

24/2/1939 by Councillor W H Taylor, the past president, assisted by E A Coyle, MLA, who was also a member and officer of the brigade for some 20 years. The brigade was established in 1894: the chief officer of 1939 being A McPherson, Captain J Collard and the secretary, L C Coyle.

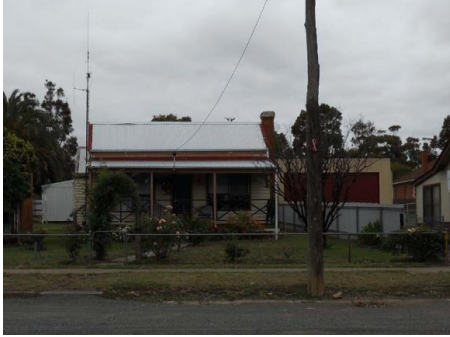
| 13 Moora Road, Rushworth | Place Type | Dwelling |

Place Description – 13 Moora Road Rushworth is a single storey weatherboard cottage with a corrugated galvanised hipped roof with roll top ridge cappings and a straight profile verandah that extends across the front facade. The facade is symmetrical with a central front door flanked on either side by windows (not original windows). Its overall design is typical for the 19th century and can be considered a vernacular response to local conditions. On the gold fields these cottages are often referred to as miner's cottages and this type of domestic architecture contributes to the quintessential 19th century mining character of Rushworth.

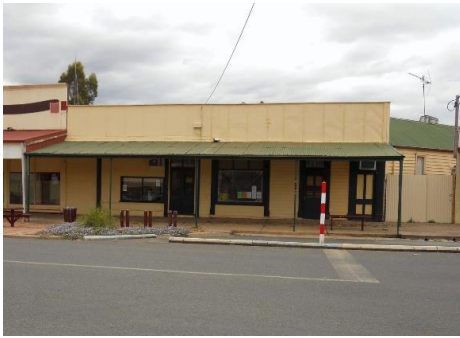
| 14-16 Moora Road, Rushworth | Place Type | Commercial |

Place Description - Weatherboarded shops and residences have retained a large proportion of the original shopfronts and some doors including verandah remnants although posts have been replaced. The sheet metal parapets appear to have been modified this century.

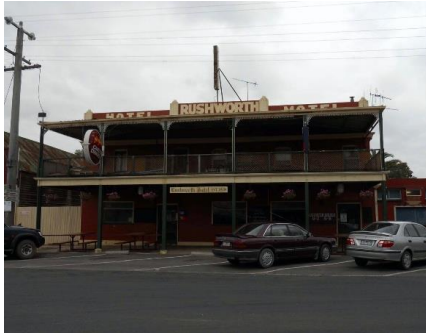
| 15 Moora Road, Rushworth | Place Type | Hotel |

Place Description - The Rushworth Hotel appears to have been modified early in the 20<sup>th</sup> century. The face brickwork has been painted and new openings placed on the ground level. The wide street verandah seems to be mainly original but much of the detail and some of the form has been altered. .

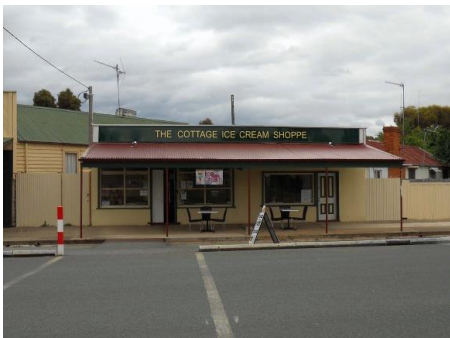
| 18 Moora Road, Rushworth | Place Type | Commercial |

Place Description – 18 Moora Road shopfronts have been redeveloped a number of times but they still retain limited original features. The glazed shop fronts are sympathetic to the other shopfronts found within Rushworth. The low parapet and straight profile verandah with modern verandah posts provide an eclectic mixture of new and old and this character is complementary to the Moora Road shopfronts.

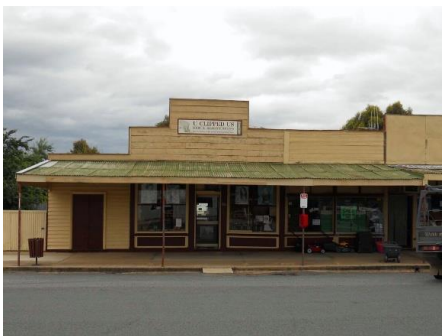
| 22A Moora Road, Rushworth | Place Type | Commercial |

Place Description – This row of timber shops has undergone redevelopment but they still possess a number of original features. This includes: original shopfronts, panelled timber stall boards, original four panel doors and some verandah details in the form of scalloped end boards. The verandah posts have been removed and replaced and the parapets have been altered on the western end. The timber boarded parapets indicate the original form.

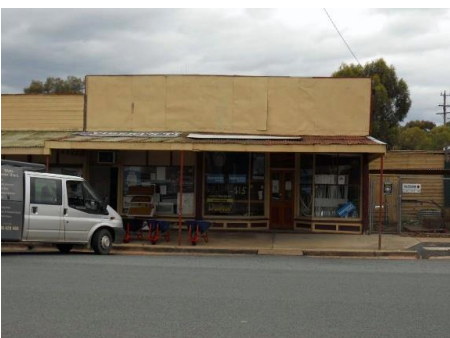
| 22 Moora Road, Rushworth | Place Type | Commercial |

Place Description - This timber shop has been modified but still retains fabric that is significant. The dwelling dates from the 19th century along with the original shop fronts, four panelled main entry doors and verandah remnants. The parapet has been modified, the walls re-clad with sheeting and the verandah post replaced together with a modification of what were perhaps the original shopfront on the west end.

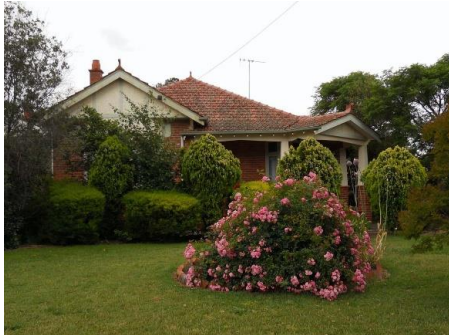
| 23 Moora Road, Rushworth | Place Type | Dwelling |

**Place Description** – This villa displays a number of features from two different stylistic periods: the Edwardian villa and the Interwar Bungalow (c1920s). The villa is constructed from face red brickwork and with render details to the gable and on the tapered verandah posts. The verandah turns the bayed corner with a gabled entry, showing typical Edwardian asymmetry and picturesque qualities.

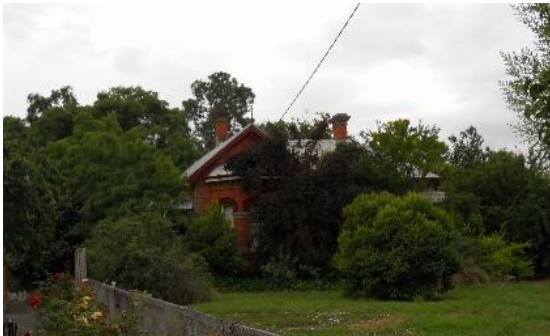
| 25 Moora Road, Rushworth | Place Type | Dwelling |

**Place Description** -25 Moora Road is a large Italianate picturesque villa face red brick villa with a gable and hipped corrugated metal roof. The chimneys contribute to the picturesque character. It has a projecting bay window with an ogee profile roof and with flat arches to the windows openings. The porch has a decorative cast iron frieze. The eaves have bracketed. Of note are the unpainted vermiculate quoins. The garden setting is integral to the picturesque character.

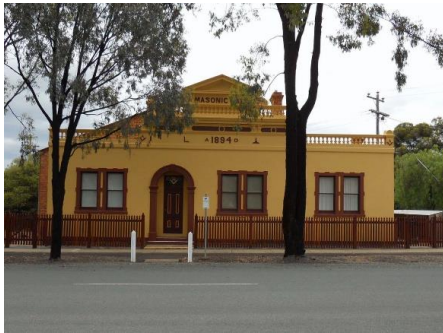
| 26 Moora Road, Rushworth | Place Type | Masonic Lodge |

**Place Description** - The Masonic Hall (189) possesses a parapeted roofline with balustraded detail and raised entablature topped by a vermiculated pediment and vermiculated piers terminate the balustrading and brass bracketing supports the raised entablature. The finish is ruled render and the footings are stone. There are four panelled timber doors and these provide entry through archway which is strangely asymmetrical - combining with three sets of paired windows with unusual architrave detailing. At the rear is a large gabled face brick section.

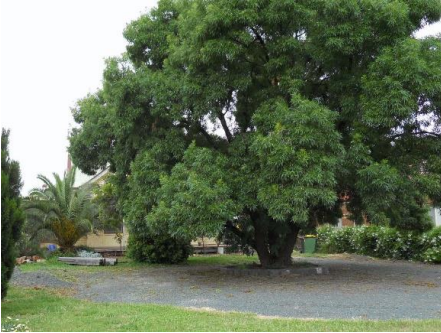
| 29 Moora Road, Rushworth | Place Type | Dwelling |

Place Description – A stylish Federation era weatherboard house with half-timbering to the gable. There is atypical half –timbering to the front wall – in the style of Queensland half-timbered buildings. There is a return straight profile concave verandah with subtle cast iron ornamentation. The roof has other interesting details in the form of vents and metal crestings.

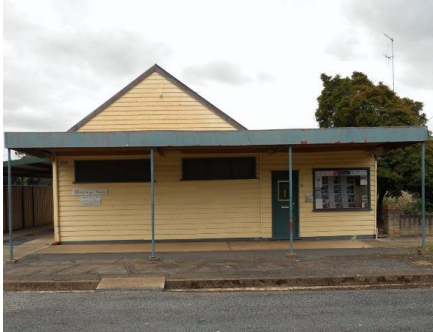
| 33 Moora Road, Rushworth | Place Type | Commercial |

Place description – A simple gable roofed building with a pair of horizontal proportioned windows. There is a small addition to the east and this consists of a flat roofed building with a door and relatively large glazed window.

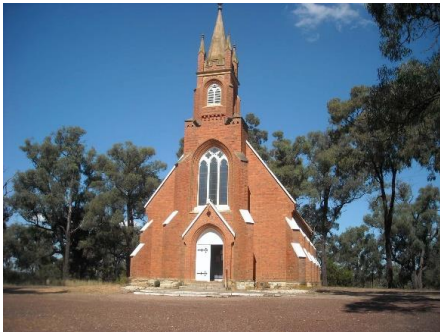
| St Pauls Anglican Church, Nuggety Hill Road, Rushworth | Place Type | Church |

Place Description –St. Paul's Anglican Church is a face red brick building with rendered dressings. It is a Gothic revival church, set high on hill with an impressive central bell tower with cemented spire and orb and cross placed at its tip. Four spirelets surround the bell tower on each corner pier, each is adorned with gablets and linked by a battlement frieze. Below the louvred bell openings, corner buttressing and corbelled brickwork together with the arcading around the haunches of the upper tower provide structure borne ornamentation below a three-light traceried window possessing coloured glass with border contrasts, the whole being built up with timber to simulate stone. A simple pointed archway and gabled porch is the lowest point on this progression of forms and detail that rises to the steeple. The church rests on a stone plinth, has a simple gabled form with four buttress bays running down the knave and the same number of gabled roof vents. Picturesque chapel and vestry forms adorn the rear of the church. It was dedicated in 1870. Note that at the rear of the church, there are two picturesque chapel or vestry forms.

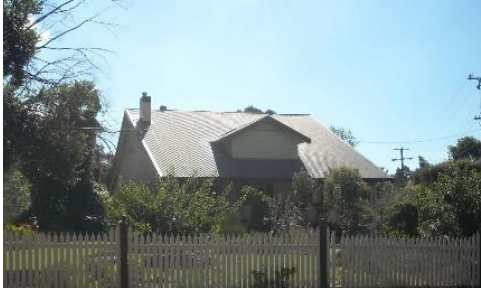
| 1 Phillips Street, Rushworth | | Place Type | Dwelling |

Place Description - 1 Phillips Street is a bungalow type house with unusual attic form gable protruding from a broad gabled main roof. It has rough -cast stucco tapered piers that support similarly tapered timber columns and leaded glass is typical of the era (1925c). The fence is original as is the pergola and vine at the gateway. It is well oriented to its corner site.

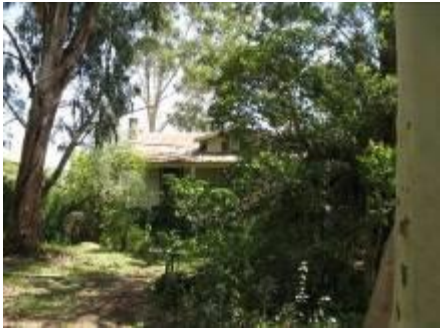
| 3 Phillips Street, Rushworth | | Place Type | Dwelling |

Place Description - 3 Phillips Street is a weatherboard bungalow and with a protruding gable above the main roof line. The wire fabric fence is original but the bungalow appears to have been a later addition.

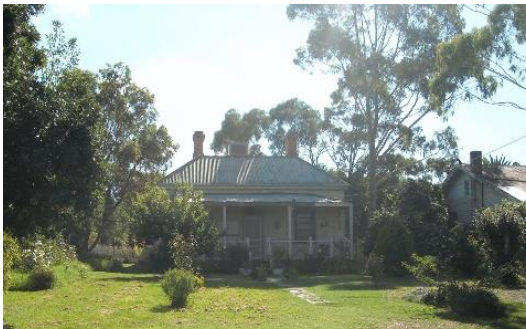
| 5 Phillips Street, Rushworth | | Place Type | Dwelling |

Place Description - 5 Phillips Street is a single storey weatherboard clad cottage with a corrugated galvanised hipped roof with roll top ridge cappings. A straight profile verandah extends across the front facade. The brick chimneys contributes to the 19th century character and are a typical features for this type of cottage. The facade is symmetrical with a central front door flanked on either side by timber sash windows. On the gold fields these cottages are often referred to as miner's cottages and this type of domestic architecture contributes to the quintessential 19th century mining character of Rushworth.

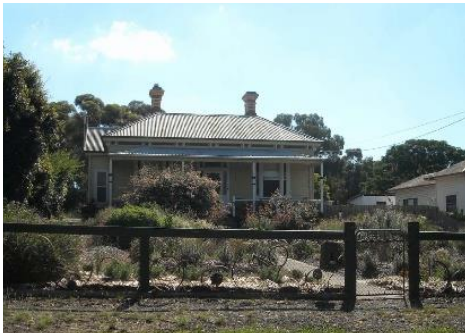
| 9 Phillips Street, Rushworth | Place Type | Dwelling |

Place Description – 9 Phillips Street is a single storey weatherboard clad cottage with a corrugated galvanised hipped roof with roll top ridge cappings. A straight profile verandah extends across the front facade. The timber posts are turned timber posts which are more typical for the early 20<sup>th</sup> century. The brick chimneys contribute to the 19th century character and are a typical feature for this type of cottage. The facade is symmetrical with a central front door flanked on either side by timber sash windows. The doors and windows have side lights and the door has a highlight. The eaves have paired timber brackets. On the gold fields these cottages are often referred to as miner's cottages and this type of domestic architecture contributes to the quintessential 19th century mining character of Rushworth.

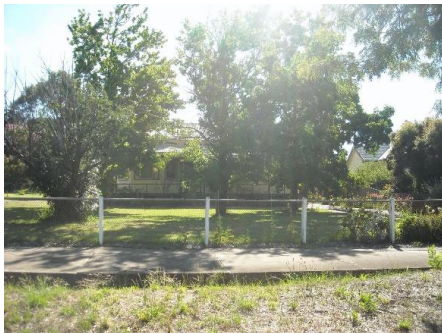
| 11 Phillips Street, Rushworth | Place Type | Dwelling |

Place Description - A hipped roof asymmetrically planned timber house from 1900c with return cast iron ornamented verandah.

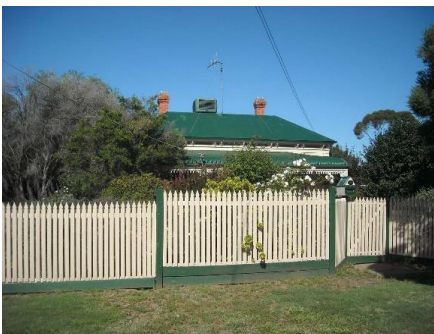
| 12 Phillips Street, Rushworth | Place Type | Dwelling |

Place Description – 12 Phillips Street is a single storey weatherboard clad cottage with a corrugated hipped roof. A bullnosed verandah extends across the front facade. The verandah with its cast iron frieze is a decorative feature. The brick chimneys contribute to the 19th century character and are a typical feature for this type of cottage. The facade is symmetrical with a central front door flanked on either side by timber sash windows. The eaves have paired timber brackets. On the gold fields these cottages are often referred to as miner's cottages and this type of domestic architecture contributes to the quintessential 19th century mining character of Rushworth.

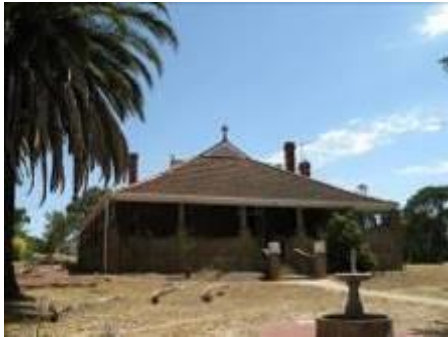
| 13-15 Phillips Street, Rushworth | Place Type | Dwelling associated with church |

Place Description – 13 – 15 Philips Street is a large rectangular masonry terracotta hipped roof manse constructed in the style of a bungalow but with overtones of religious architecture. It has a gabled vents to the roof with crosses at the apex. There is a distinctive masonry walled verandah with slender columns. The flight of stairs from the verandah are finished with masonry piers.

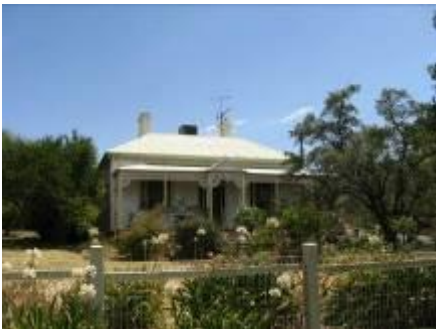
| 17 Phillips Street, Rushworth | Place Type | Dwelling |

Place Description – 17 Phillips Street is a double fronted weatherboarded hipped roof house with attached front verandah which is ornamented with cast iron brackets and frieze work. The verandah has a breakfront with additional decorative features. The brick chimneys are a feature of the architectural style.

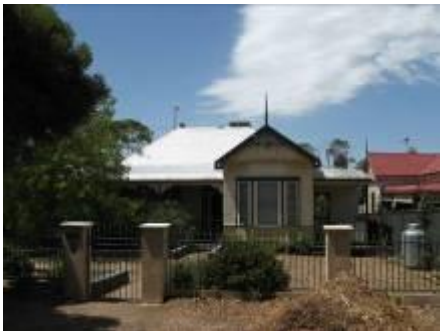
| 18 Phillips Street, Rushworth | Place Type | Dwelling |

**Place Description** – 18 Phillips Street is a typical Edwardian/Federation era bungalow with an asymmetrical plan. The projecting gable front has timber finials and a flat bay window. The recessed hip roofed structure with the entry porch has a decorative frieze and bracket.

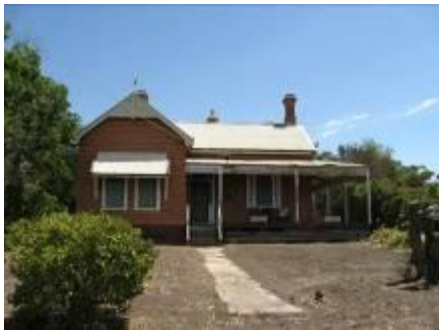
| 19 Phillips Street, Rushworth | Place Type | Dwelling |

**Place Description** – 19 Phillips Street is an asymmetrically planned weatherboarded and gabled roof house from the early 20<sup>th</sup> century. It has a panellled cast iron detail to the verandah. A double gable facing the north is a distinctive element of this house. Other details include the gabled trussing and the window hoods.

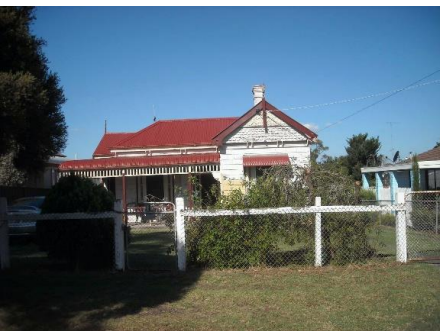
| 20 Phillips Street, Rushworth | Place Type | Dwelling |

**Place Description** – 20 Phillips Street is a block-fronted, gabled and hipped roof Edwardian period house with a bull nose verandah, timber slatted frieze and distinctive fan brackets. The balustrading has been removed but the scalloped boarding and rough cast stucco of the gable along with the trussing survive.

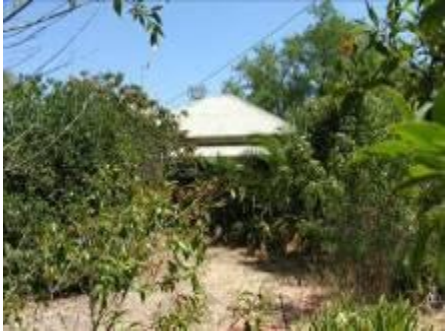
| 21 Phillips Street, Rushworth | Place Type | Dwelling |

Place Description – 21 Phillips Street has a high hipped corrugated metal roof. This pitch and style is typical of an early period. The cottage displays many characteristics from its date of construction – albeit modified. It has a symmetrical front façade with a verandah to the full extent.

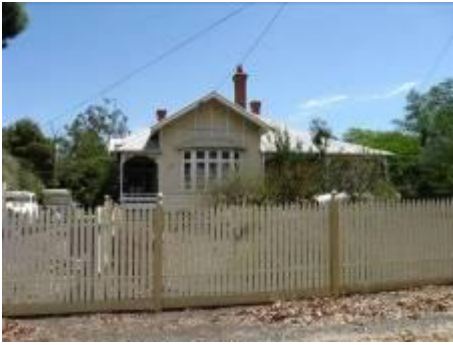
| 23 Phillips Street, Rushworth | Place Type | Dwelling |

Place Description - 23 Phillips Street is an Edwardian villa styled house in a transitional mode to bungalow period with distinguished fretted balustrading on part of the balcony. There are unusual verandah brackets and the rough cast stucco to the gables is a typical feature from the Edwardian period. The Chimneys and roof forms and verandahs add a picturesque note to the house.

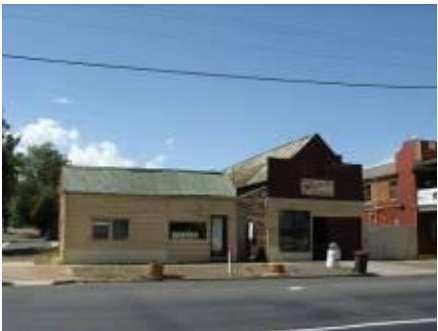
| 2 School Street Rushworth | Place Type | Commercial |

Place Description – These two vernacular structures demonstrate a utilitarian design and make-do character. The west structure has a gable roof with a corrugated metal roof. The windows are irregular and the door is rudimentary. The structure to the east has a high parapet with a corrugated metal gable roof forming a de facto pediment. The openings are rudimentary with a glazed window and a large door opening.

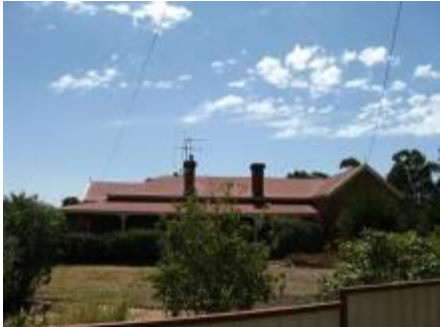
| 7 Simpson Street, Rushworth | Place Type | Dwelling |

Place Description – 7 Simpson Street is a large face-brick house composed of two gabled wings with scalloped barges and finials as abutments to a hip-roofed main section with encircling return verandah. Chimney cornices have dog-toothed courses and corbelled cappings but the verandah detail appears to be missing except for capitals to the columns. The house is large and austere and relies upon its luminous quality of its brickwork complimented by its red brick and a cream trim.

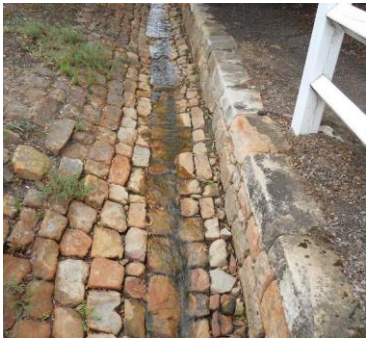
| Stone gutters, Wigg Street, Rushworth | Place Type | Stone gutters |

Place Description – the deep stone lined gutters contribute to the 19th century character of Rushworth. The colour of the stones evoke the surrounding landscape and the gold fields nearby. The regularity of the stonework is fine and displays a finesse not often found.

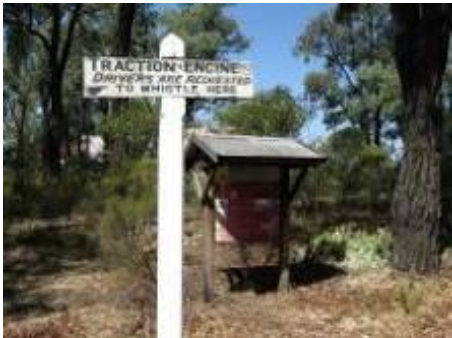
| Whistle Post, Rushworth, Rushworth Nagambie Road | Place Type | Former traffic warning whistle post |

Place Description – the Whistle Post is a simple timber post with a sign attached. It has been painted white and has black writing. It is a simple icon in the landscape.

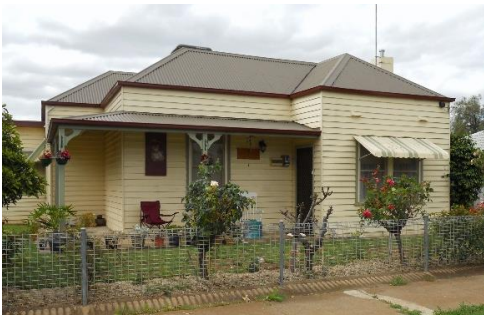
| 2 Barton Street, Lockington | | Place Type | Dwelling |

Place Description – 2 Barton Street is an early 20th century house timber house – with features associated with the Edwardian villa. It is an asymmetrical building with a recessed and return verandah. The roof is clad with corrugated metal. The front facade has a pair of timber framed windows and the verandah has timber posts with timber brackets. It has retained much of its integrity and intactness. It contributes to the architectural character of Lockington.

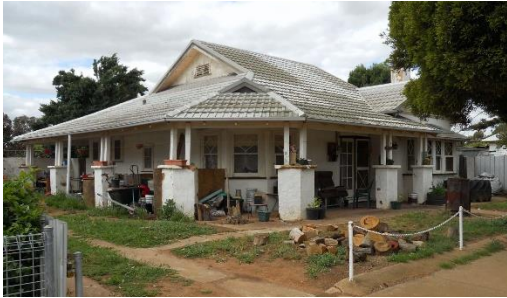
| 4 Barton Street, Lockington | Place Type | Dwelling |

**Place Description** – 4 Barton Street illustrates many of the architectural characteristics associated with the Interwar Bungalow. This includes the gable roofs, gable vents and gablet vents; the masonry piers with paired timber columns and the patterned glazing bars – in this instance diamond patterned. The rectangular window bay with its triplet windows is also a feature from this period.

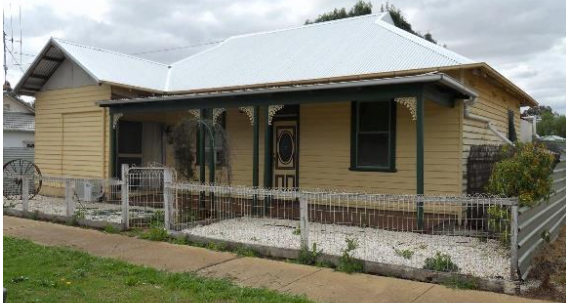
| 6 Barton Street, Lockington | Place Type | Dwelling |

**Place Description** – 6 Barton Street is an early 20th century house timber house – with features associated with the Edwardian villa. It is an asymmetrical building with a recessed and return verandah. The roof is clad with corrugated metal. The façade has a centralised front door and this is flanked on either side by timber framed double hung sash windows. The verandah has timber posts with cast iron brackets (not original). It has retained much of its integrity and intactness. It contributes to the architectural character of Lockington.

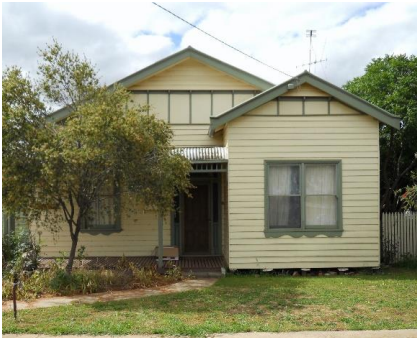
| 8 Barton Street, Lockington | Place Type | Dwelling |

**Place Description** – 8 Barton Street is an early 20th century house. It is a timber framed and timber weatherboard clad asymmetrical villa. It has a projecting front with timber strapping to the gable and timber brackets to the gable infill. The front façade has timber framed double hung windows with a scalloped timber detail under the sill. The recessed section has the same details to the gable and a small porch to the front door. It has retained much of its integrity and intactness. It contributes to the architectural character of Lockington.

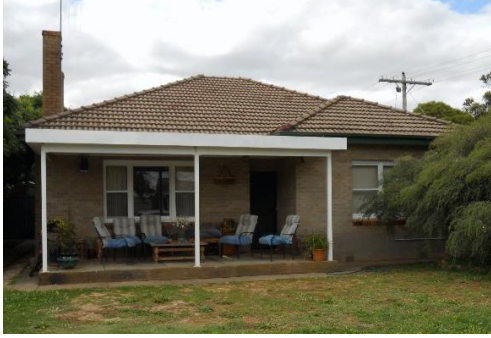
| 10 Barton Street, Lockington | Place Type | Dwelling |

Place Description – 10 Barton Street demonstrates typical architectural styling from the post war period. The house is a brick veneer with a double hipped and tiled roof. The windows are in groups of three and timber framed. The pergola/porch is a later addition. It has retained much of its integrity and intactness. It contributes to the architectural character of Lockington.

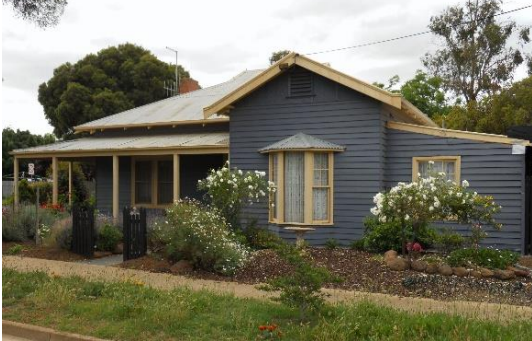
| 12 Barton Street, Lockington | Place Type | Dwelling |

Place Description – 12 Barton Street is an early 20th century house timber house – with architectural features associated with the Edwardian villa. It is an asymmetrical building with a recessed and return verandah. The roof is clad with corrugated metal. The front facade has a pair of timber framed windows and the verandah has timber posts. The main gable roof has timber strapping and a timber vent. It has retained much of its integrity and intactness. It contributes to the architectural character of Lockington.

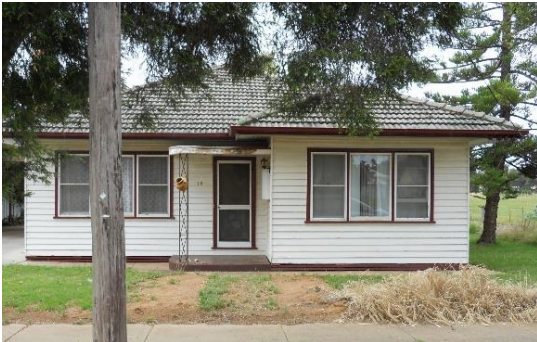
| 14 Barton Street, Lockington | Place Type | Dwelling |

Place Description – 14 Barton Street demonstrates typical architectural styling from the post war period. The house is a timber house clad with timber weatherboards with a double hipped and tiled roof. The windows are in groups of three and timber framed. The curved porch roof is a typical detail from this period. It has retained much of its integrity and intactness. It contributes to the architectural character of Lockington.

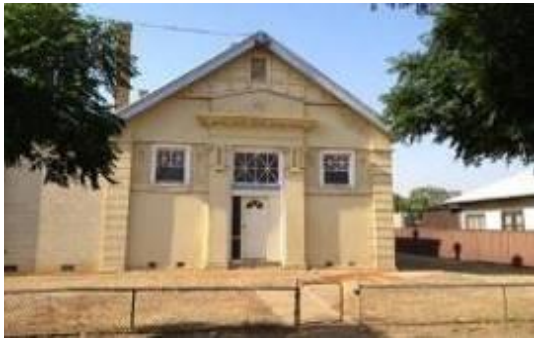
| 15 Barton Street, Lockington | Place Type | Masonic Hall |

**Place Description** – The hall at 15 Barton Street Lockington is a purpose designed poured concrete Masonic building, where the ancient connections of Freemasonry are linked with the use of the Free Classical style of architecture. This is seen in the simplified classical pilasters set in antis around the doorway with a pronounced horizontal cornice above a plain frieze. The gable end is decorated with strap work and plain pediment.

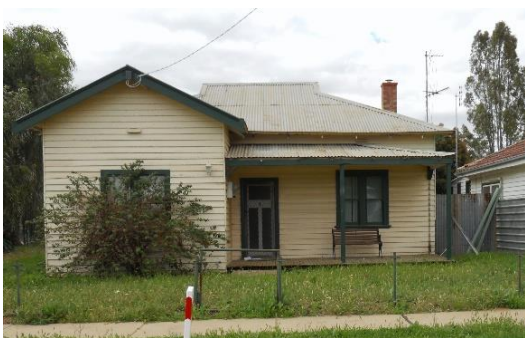
| 2 Deakin Street, Lockington | Place Type | Dwelling |

**Place Description** – 2 Deakin Street is an early 20th century house with an asymmetrical design. It is a weatherboard clad asymmetrical villa with a corrugated metal roof. The projecting gable roofed section has a pair of timber framed double hung windows. The recessed section includes an entrance and porch (with a hipped roof verandah) and a pair of timber windows. The hipped roof has gable vents. It has retained much of its integrity and intactness. It contributes to the architectural character of Lockington.

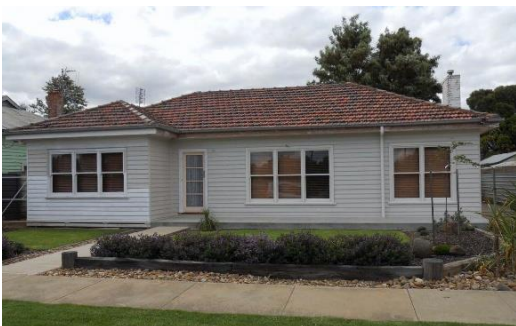
| 4 Deakin Street, Lockington | Place Type | Dwelling |

**Place Description** – 4 Deakin Street demonstrates typical architectural styling from the post war period. The house is a timber house clad with timber weatherboards with a double hipped and tiled roof. The windows are in groups of three or paired. They are timber framed and double hung. It has retained much of its integrity and intactness. It contributes to the architectural character of Lockington.

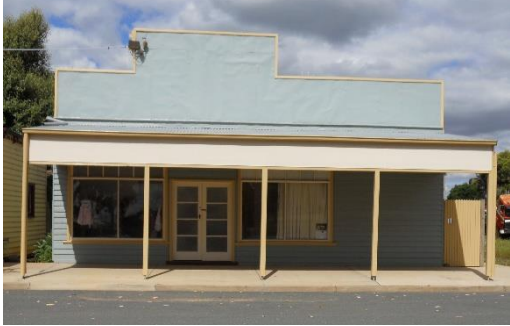
| 5 Hopetoun Street, Lockington | | Place Type | Commercial |

Place Description – 5 Hopetoun Street is a commercial shop front which has been extended. The shop front is clad with timber weatherboards and the parapet is clad with sheet metal. The original section includes the main entrance and this was flanked on either side by the glazed shop fronts. The upper glazing consists of small panes of glass – typical of the period. It has retained much of its integrity and intactness. It contributes to the architectural character of Lockington.

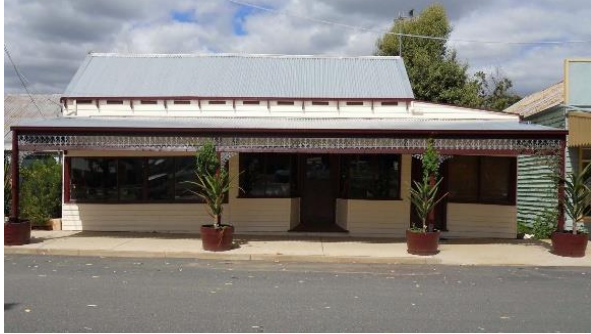
| 7 Hopetoun Street, Lockington | | Place Type | Commercial |

Place Description – 7 Hopetoun Street is a modified building that appears to have been a shop front. It is a gable roofed building that is clad with timber weatherboards and corrugated metal roof. The shop front windows are now a continuous band of windows with a recessed and splayed entrance. The verandah has a shallow pitched straight profile with introduced cast metal frieze and brackets. It contributes to the architectural character of Lockington.

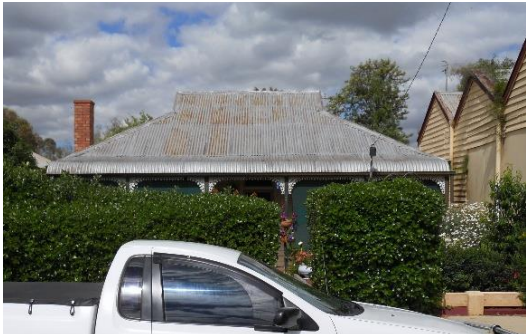
| 9 Hopetoun Street, Lockington | | Place Type | Dwelling |

Place Description – 9 Hopetoun Street is timber weatherboard cottage with a hipped corrugated metal roof with gablet vents. The verandah is contiguous with the roof and has a bull nosed profile. The façade is symmetrical with windows on either side of the central entrance. It contributes to the architectural character of Lockington.

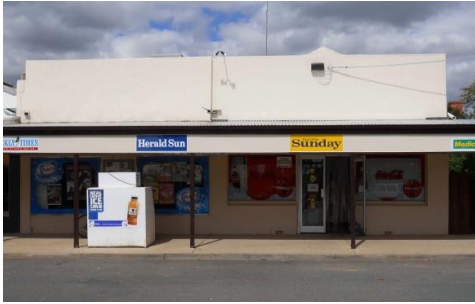
| 11 Hopetoun Street, Lockington | Place Type | Commercial |

Place Description – 11 Hopetoun Street is a commercial shop front with a rectangular parapet to the full extent of the shop. The verandah roof has a shallow pitch falling to a deep fascia. It contributes to the architectural character of Lockington.

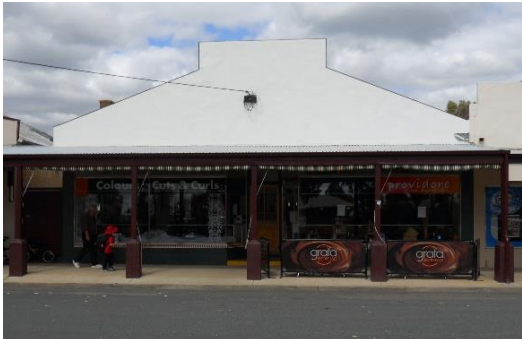
| 13 Hopetoun Street, Lockington | Place Type | Commercial |

Place Description – 13 Hopetoun Street is a commercial shop front with a glazed shopfronts to either side of the recessed splayed entrance. The parapet has a central rectangular section with sloping sides. The verandah has a shallow pitch and is supported by verandah posts with substantial plinths. It contributes to the architectural character of Lockington.

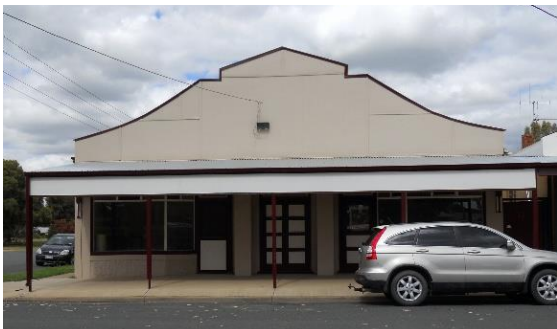
| 15 Hopetoun Street, Lockington | Place Type | Commercial |

Place Description – 15 Hopetoun Street is a large commercial shop front with a glazed shopfronts to either side of the recessed splayed entrances. The metal clad parapet has a pedimented central rectangular section falling to a step and then sloping sides. The verandah has a shallow pitch with a deep fascia and is supported by verandah posts. It contributes to the architectural character of Lockington.

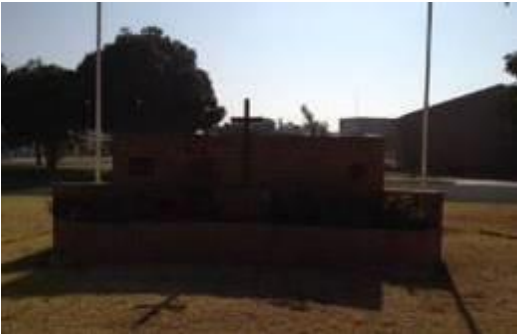
| The Lockington Wall of Remembrance<br>Hopetoun Street, Lockington | Place Type | Memorial |

Place Description – The Wall of Remembrance is a simple face brick wall with a garden bed to the front. It includes a number of plaques. It contributes to the architectural character of Lockington.

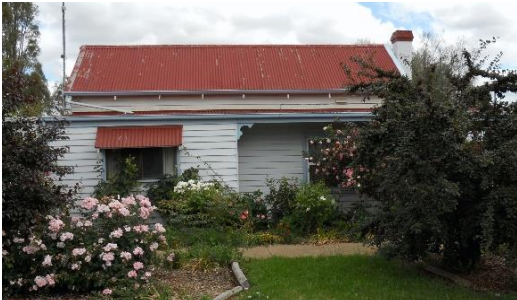
| 1 McColl Street, Lockington | Place Type | Dwelling |

Place Description – 1 McColl Street is a small vernacular timber cottage with a gable roof clad with corrugated metal. The front verandah has been partially filled in. It contributes to the architectural character of Lockington.

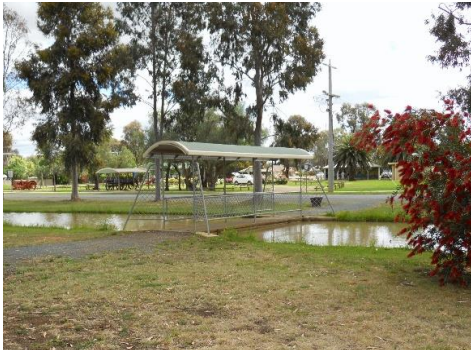
| Lockington Road and Hopetoun Street, Lockington | Place Type | Open reserve areas |

Place Description – The reserve includes an irrigation channel with small bridges with arched metal roof. The reserve is treed and provides a pleasant treed landscaped area. It contributes to the character of Lockington.

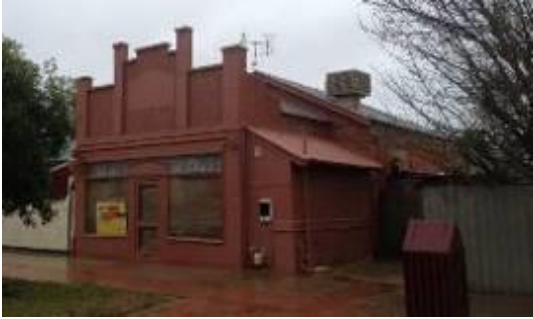
| 48 Mangan Street, Tongala | Place Type | Commercial |

Place Description – 48 Mangan Street is a former shop constructed from painted masonry. The parapet has typical Arts And Crafts architectural features from the Interwar period. These include a stepped parapet with capped pilasters. The shop front has retained a high degree of integrity with main changes confined to the modified canopy and metal verandah posts. The shop contributes to the historic and architectural character of the commercial precinct.

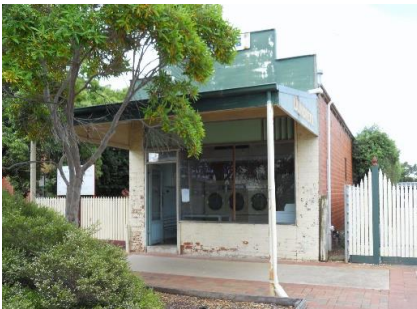
| 54 Mangan Street, Tongala | Place Type | Commercial |

Place Description – 54 Mangan Street is a shop constructed from painted masonry. The parapet is a simple stepped parapet. The verandah has a skillion profile and has metal verandah posts. The shop contributes to the historic and architectural character of the commercial precinct.

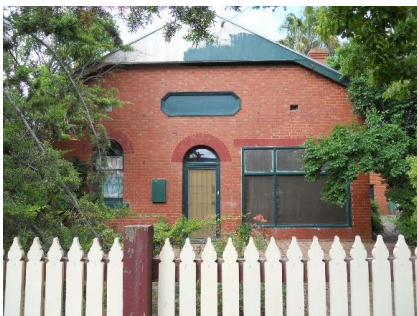
| 56 Mangan Street, Tongala | Place Type | Former Deakin Shire offices |

Place Description – The former Shire offices are constructed from face brickwork. The façade is asymmetrical as a consequence of later modifications. The entrance has a simple soldier course archway and this is replicated for the one remaining original window. The other window is a later modification and has a large rectangular metal framed window. Above the central door is a rendered plaque but there is no evidence of signage. The roof has a Jurken head and is clad with corrugated metal. The former Shire offices contribute to the historic and architectural character of the commercial precinct.

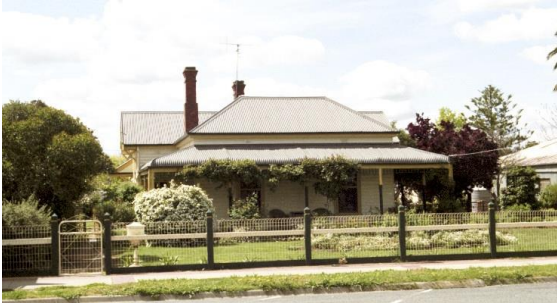
| 62 Mangan Street, Tongala | Place Type | Dwelling |

Place Description – 62 Mangan Street is a substantial late Victorian/early 20<sup>th</sup> century house. It is constructed from timber (weatherboards) with a hipped roof to the main body of the building and a gable roof to the rear. The roof is constructed from corrugated metal. The brick chimneys are distinctive both for their design and their height. The verandah is bullnosed and returns to both sides. The woven wire fence and metal gate complement the architecture of the house. The residence contributes to the historic and architectural character of the commercial precinct.

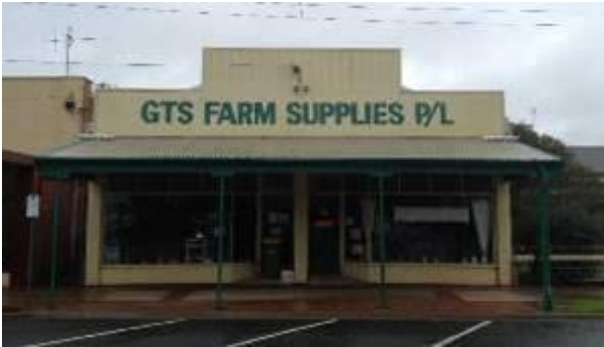
| 64 Mangan Street, Tongala | Place Type | Commercial |

Place Description - 64 Mangan Street demonstrates many of the typical architectural characteristics associated with regional late 19<sup>th</sup> and early 20<sup>th</sup> century commercial architecture. This includes the splayed entry, the simple rectangular parapet and the posted skillion verandah. The shop contributes to the historic and architectural character of the Tongala Township Precinct.

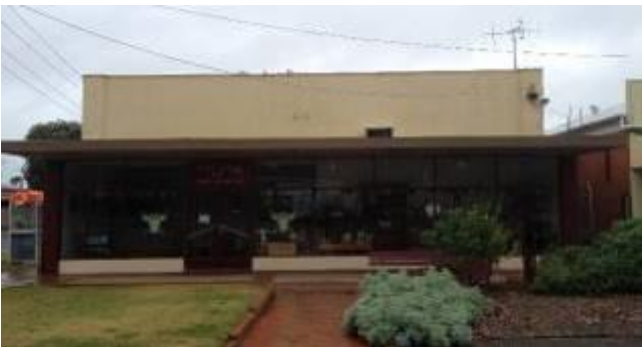
| 68 Mangan Street, Tongala | Place Type | Commercial |

Place Description – 68 Mangan Street demonstrates many of the typical architectural characteristics associated with regional 20<sup>th</sup> century commercial architecture. This includes the fully glazed shop front and simple rectangular parapet. The shop contributes to the historic and architectural character of the Tongala Township Precinct.

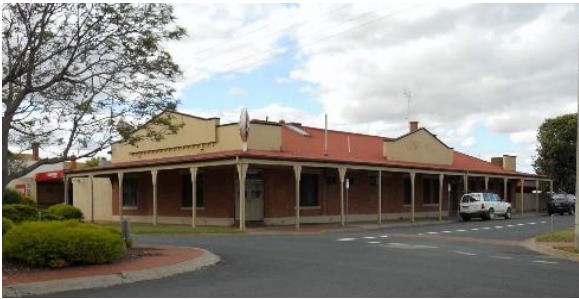
| 70-72 Mangan Street, Tongala | Place Type | The Tongala Railway Hotel |

**Place Description** – The hotel occupies a primary corner position and its design with both facades having architectural presence reflects this primacy. It is constructed from masonry and has a corrugated metal roof. The architecture of the hotel is typical for its period and region. It has a hipped roof with pediments to both facades. The broken back verandah extends over the footpath. The verandah has posts to both facades. The hotel contributes to the historic and architectural character of the commercial precinct.

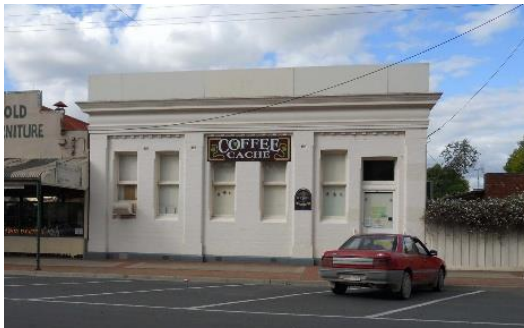
| 74 Mangan Street, Tongala | Place Type | Commercial |

**Place Description** - the former State Savings Bank building has retained a high degree of integrity. Its design is restrained and typical for State Bank Buildings from the Interwar period. The façade has been divided into three bays with two sash windows per two of the bays with the final bay including one window and the entrance doorway. There is a pronounced cornice line and simple rectangular parapet. This building contributes to the historic and architectural character of the commercial precinct.

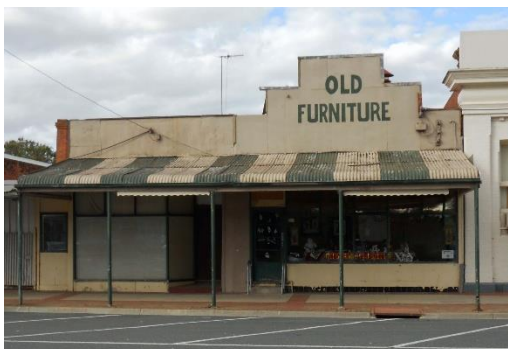
| 76 Mangan Street, Tongala | Place Type | Commercial |

**Place Description** – these shopfronts have retained a high degree of integrity. The use of metal cladding is notable as it demonstrates a typical response to commercial building in the region during the early 20<sup>th</sup> century – a time of restricted economic activity. The parapets are dissimilar with one a plain low profile rectangular parapet while the other parapet has a high profile and is steeply stepped. One of the shop fronts demonstrates typical shop front design for the period with a splayed entry, a large glazed area with smaller glazed highlights. The second shopfront has possibly been modified as it is now one large glazed shopfront with an adjacent doorway. The verandah has a skillion profile with verandah posts. The shop fronts contributes to the historic and architectural character of the commercial precinct.

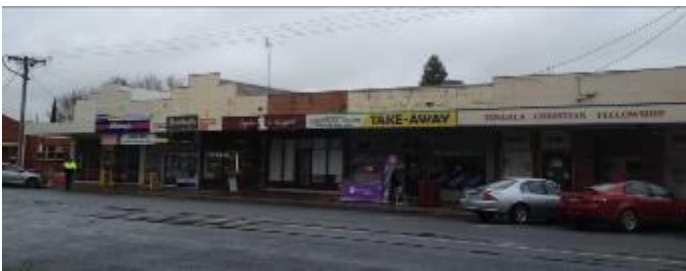
| 80-90 Mangan Street, Tongala | Place Type | Commercial – row of shops |

Place Description – The row of shops is distinctive within the streetscape. The extensive use of metal clad parapets contributes to an understanding of the limited range of materials employed during periods of economic stagnation. The use of 'short' sheets of metal contributes to the character of the parapets. The diversity of the parapet profiles provides a pleasing variety to the streetscape. The shop fronts have retained varying degrees of integrity. Of note is the survival of early electricity brackets these can be found on some of the parapets. The shop fronts contributes to the historic and architectural character of the Tongala Township Precinct.

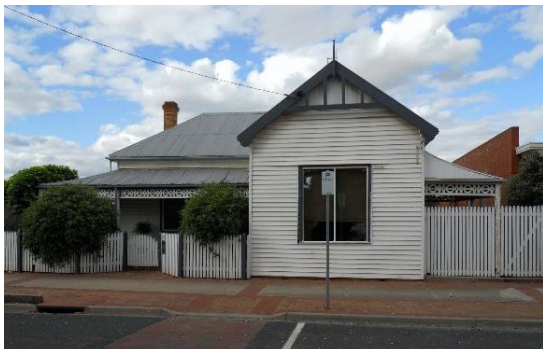
| 98 Mangan Street, Tongala | Place Type | Dwelling |

Place Description – this residence is distinctive for its absolute street frontage. It is possible that this was once a shop front with a residence to the rear. The gable front has decorative timber strapping to the apex with a timber finial. The rear section has a typical hipped and corrugated metal clad roof with a return verandah with decorative cast iron frieze. The timber picket fence complements the architectural character of this residence. The residence contributes to the historic and architectural character of the Tongala Township Precinct.

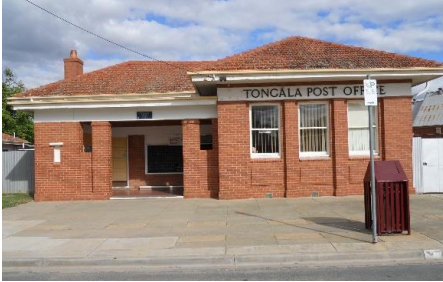
| 2 Cavell Street, Tongala | Place Type | Tongala Post Office |

Place Description – 2 Cavell Street is an Interwar Post Office constructed from face redbrick with terracotta-tiled hip roofs. It is an asymmetrical building with the entry and post office boxes in a recessed area. The projecting front façade has been divided into three bays with pilasters and timber sash windows. A contrasting band of render at the eave line provides an area for signage. The building contributes to the historic and architectural character of the commercial precinct.

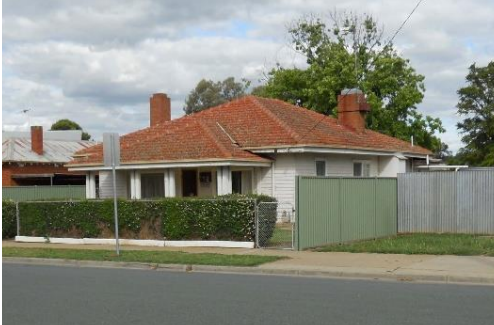
| 4 Cavell Street, Tongala | Place Type | Dwelling |

Place Description – 4 Cavell Street Tongala is a residential building with two terracotta tiled hip roofs and brick chimneys. The colonnaded porch distinguishes the façade. The residence contributes to the historic and architectural character of the commercial precinct.

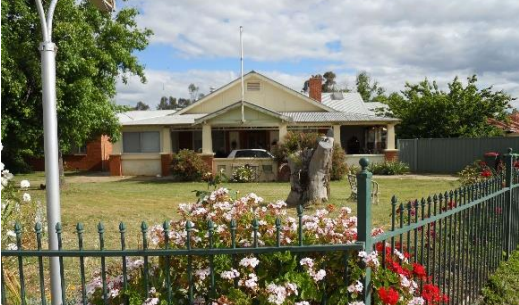
| 6 Cavell Street, Tongala | Place Type | Former Bush Hospital |

Place Description – 6 Cavell Street is the former Bush Nursing Hospital. It was constructed in 1925 to commemorate the First World War and there is a foundation stone that records the unveiling of the building by Brigadier General H E Elliot in memory of the 'The Gallant Dead'. It is a masonry Federation styled bungalow with a number of additional accommodation areas. The façade is distinguished by the *port cochère* with its gable front, masonry columns and the timber finial. There is a verandah to the side. The building has undergone a number of modifications. The large expanse of garden area is an atypical feature in Cavell Street. The building contributes to the historic and architectural character of the commercial precinct.

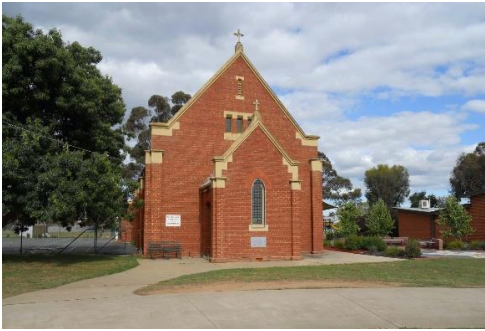
| 40 Mangan Street, Tongala | Place Type | St Patrick's Catholic Church |

Place Description – 40 Mangan Street is a gothic styled church from the Interwar period. It is constructed from red face brick and it has a steeply pitched gable roof with a corresponding pitched roof to the porch. The painted cement dressings provide a pleasing contrast to the red brick walling. The lancet windows contribute to the gothic flavour of the church. The triple band of pointed windows to the main gable adds to the decorative features. The church contributes to the historic and architectural character of the commercial precinct.

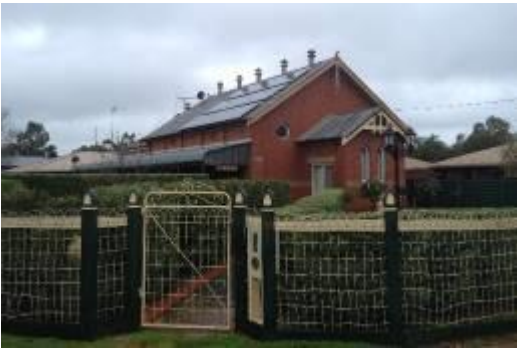
| 38 Miller Street, Tongala | Place Type | Former church - Dwelling |

**Place Description** – 38 Miller Street is a large red face rectangular brick building with a small entry porch. The porch has a modified door with a pair of pointed windows to the front façade. The gable to the porch has timber collar tie and timber strapping. The main body of the building is distinguished by the pitch of the roof and the roof ridge ventilators. There is a bull nosed porch to the length of the building (facing the street) and this is a later addition. The building contributes to the historic and architectural character of the commercial precinct.

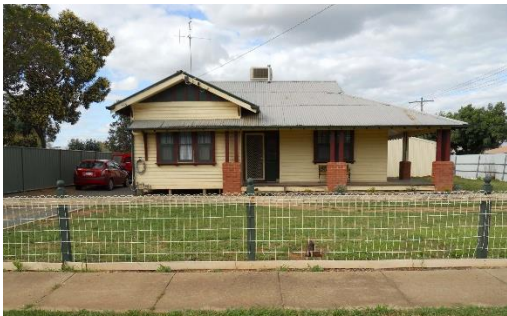
| 40 Miller Street, Tongala | Place Type | Dwelling |

**Place Description** – 40 Miller Street is timber (weatherboard) bungalow with a galvanised corrugated metal roof. The front façade has a projecting gable front (with a triple band of timber sash windows) and a verandah/porch that runs across the front facade and returns around to the side. The verandah posts are face red brick masonry plinths with paired timber posts. There is a hipped roof with gablet vent to the body of the house. The entry is from the porch and there is a window to one side. The residence contributes to the historic and architectural character of the commercial precinct.

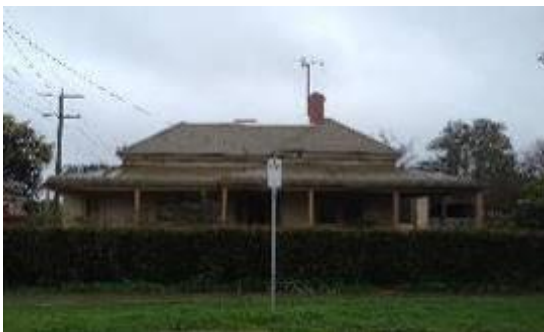
| 41 Miller Street, Tongala | Place Type | Dwelling |

**Place Description** – 41 Miller Street is a large timber house with hipped corrugated metal roof. The verandah is a bullnosed with timber verandah posts. The windows to the front façade are timber sash windows. There is a brick chimney. The residence contributes to the historic and architectural character of the commercial precinct.

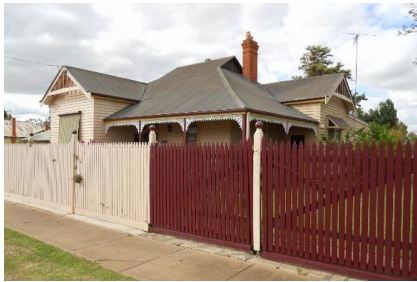
| 42 Miller Street, Tongala | Place Type | Dwelling |

**Place Description** – 42 Miller Street is a large Federation styled timber house with hipped and gable corrugated metal roof. The main body of the house has a large hipped roof with a gablet vent and this roof falls in an unbroken line to form the verandah. The verandah has a cast iron frieze with verandah posts. On either side of the hipped roof are gable roofed wings with decorative timber work to the gable. There is slender brick chimney. There are timber sash windows to all facades. The front fence is a timber picket fence. The residence contributes to the historic and architectural character of the commercial precinct.

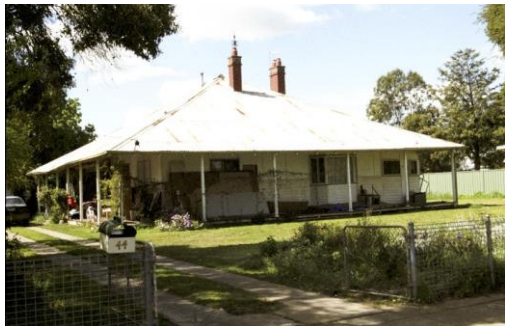
| 44 Miller Street, Tongala | Place Type | Dwelling |

**Place Description** – 44 Miller Street is a timber house with a pyramidal hipped corrugated metal roof that falls in an unbroken line to form the verandah. The verandah posts are a later modification. There have been a number of modifications to the openings. The style of this house is typical of regional areas to the north of Tongala and in particular the Riverina. The residence contributes to the historic and architectural character of the commercial precinct.

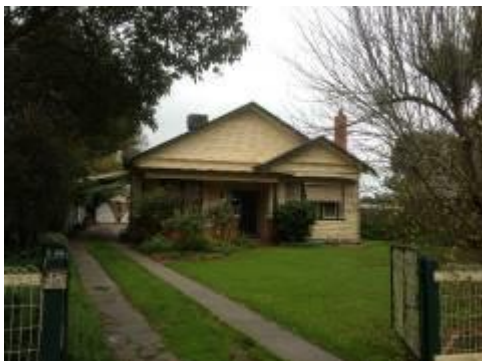
| 46 Miller Street, Tongala | Place Type | Dwelling |

**Place Description** – 46 Miller Street is a distinctive bungalow. It is constructed from timber with a double gable corrugated metal roof. The 'breakfront' gable with a shallow projecting bay has timber sash windows and these distinguish the façade. The gable façade has decorative timber shingle work and timber brackets. The main gable includes a recessed porch and entry. The porch has brick and rendered masonry posts. The gable façade shares the same finish as the breakfront – timber shingles with brackets. There is a slender red brick chimney. The residence contributes to the historic and architectural character of the commercial precinct.
