# Shire of Campaspe

## Aquatic Facilities Report

### Asset Review, Condition Summary, Capital Works Program & Recommendations.

January 2018

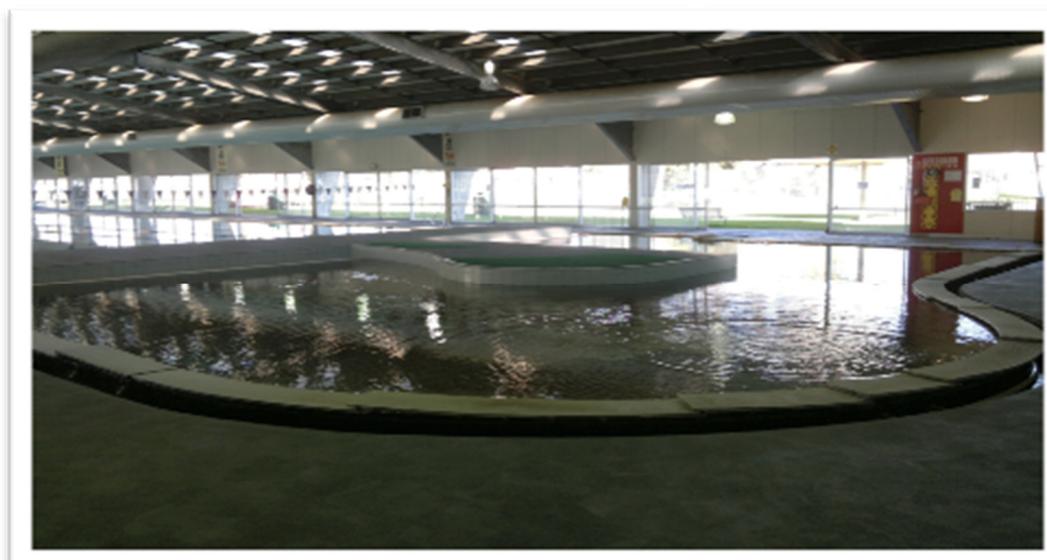
**Wading Pool**

The main/wading pool is constructed from reinforced concrete that is painted, i.e. no internal liner. The main pool was constructed in the 1950's and was renovated in 1996 when the site was redeveloped from an outdoor pool to an indoor complex including the addition of the wading pool area. Melbourne Pools & Spa inspected the structure in 2013 and advised that the original structure was renovated to include a wet deck and wading pool. It generally looked in reasonable condition but would require detailed core sampling and reinforcement scanning to determine the quality of the structure. It was last repainted in 2016 and is listed for repaint in 2022/23 on a 7 year cycle.

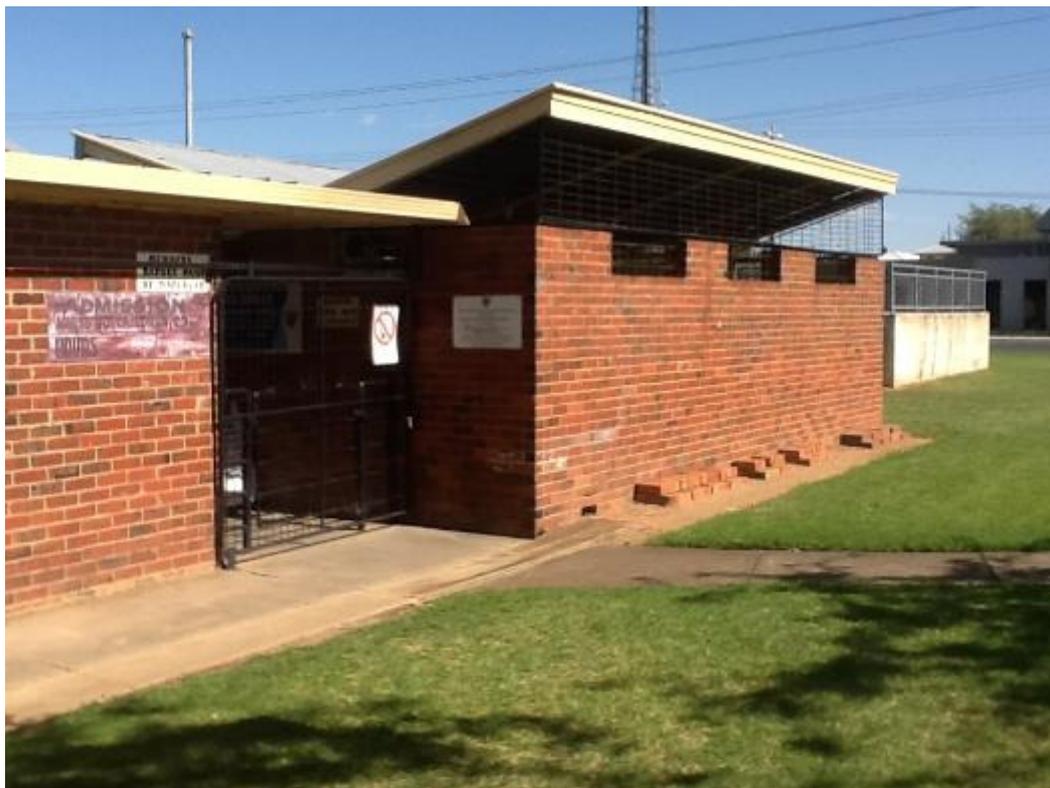
**Kyabram kiosk & amenities entry from Union St**

- Repair the roof including new box gutters, flashings, gutters and down pipes
- Remove all clothes hooks and replace with new along eastern, northern & southern walls.
- Repair all cracks in walls and provide a full internal repaint
- Shower rooms require a full refurbishment
- Remove all existing seating and replace with new along eastern, northern & southern walls along with new central benches under the roof supports
- Remove existing slide entry gate and replace with new roller door (retain old gate)
- Remove existing storeroom slide door and renew with roller door
- Install a new pool fence and gate to control access to the facility at an agreed location
- Renew pedestals, urinal, fixtures and fittings as required

Estimated cost of the project is \$173,500 and it will not provide full DDA compliance.

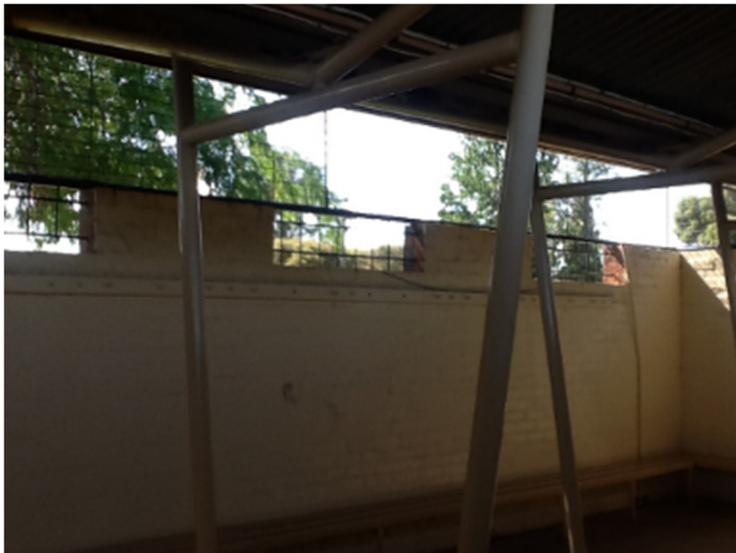
**Typical view of amenities structure**

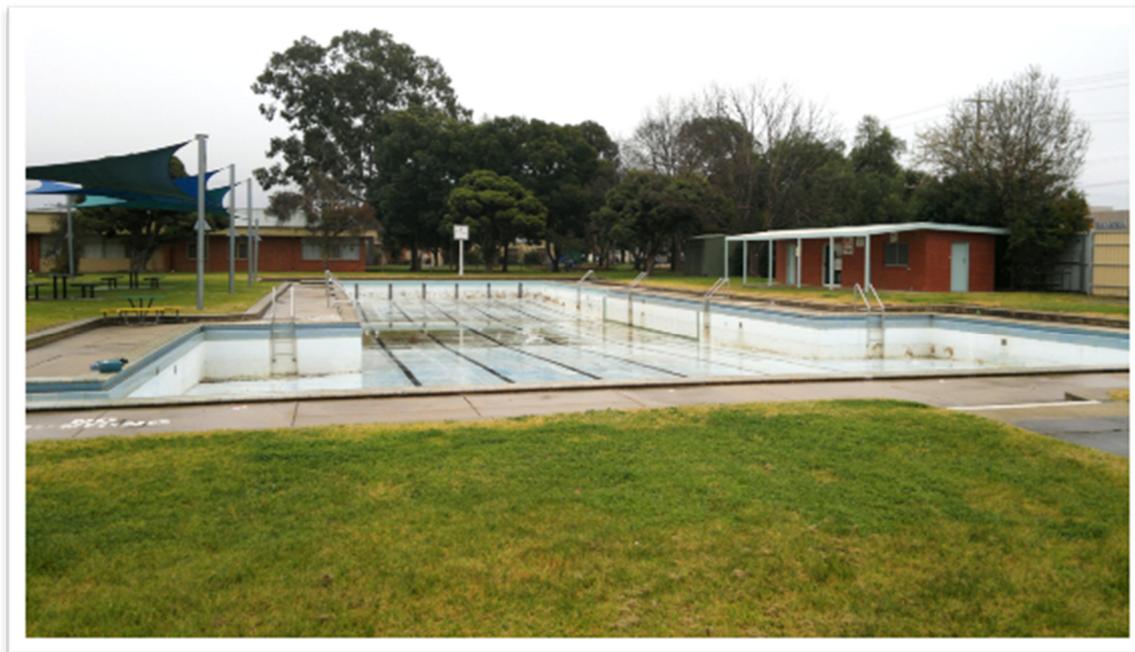
#### **Kyabram main pool 'Tee head' shape**

The pool is constructed from reinforced concrete that is painted, ie no internal liner. It appears that the tee section of the pool was added sometime after the original pool was built in the 1950's. Significant cracking along this construction joint is visible. It was last repainted in 2014 and is listed for repaint in 2021/22 on a 7 year cycle. Melbourne Pools & Spa recommended installing a plastic liner in the main pool to overcome the issues identified in their report. These included water losses through cracking, holes and water stops.

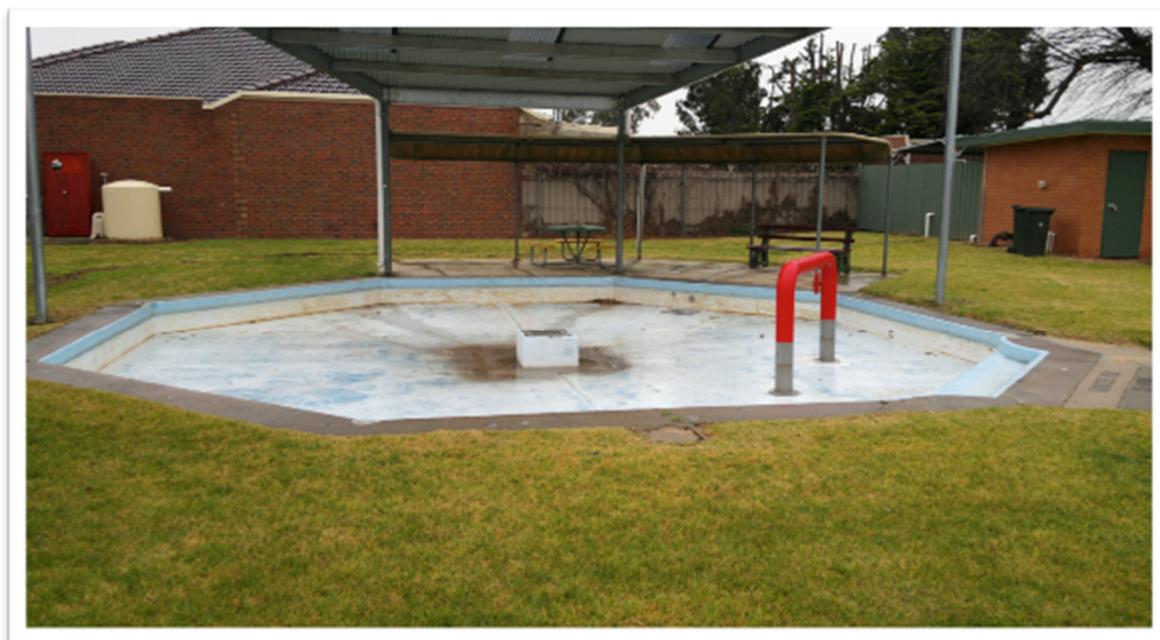
### **Wading pool octagonal shape with water feature and hard cover of part of the pool**

The wading pool is an octagonal shape approximately 10m wide. The pool is constructed from reinforced concrete. It was last repainted in 2014. It is listed for a repaint in 2021/22 on a 7year cycle.

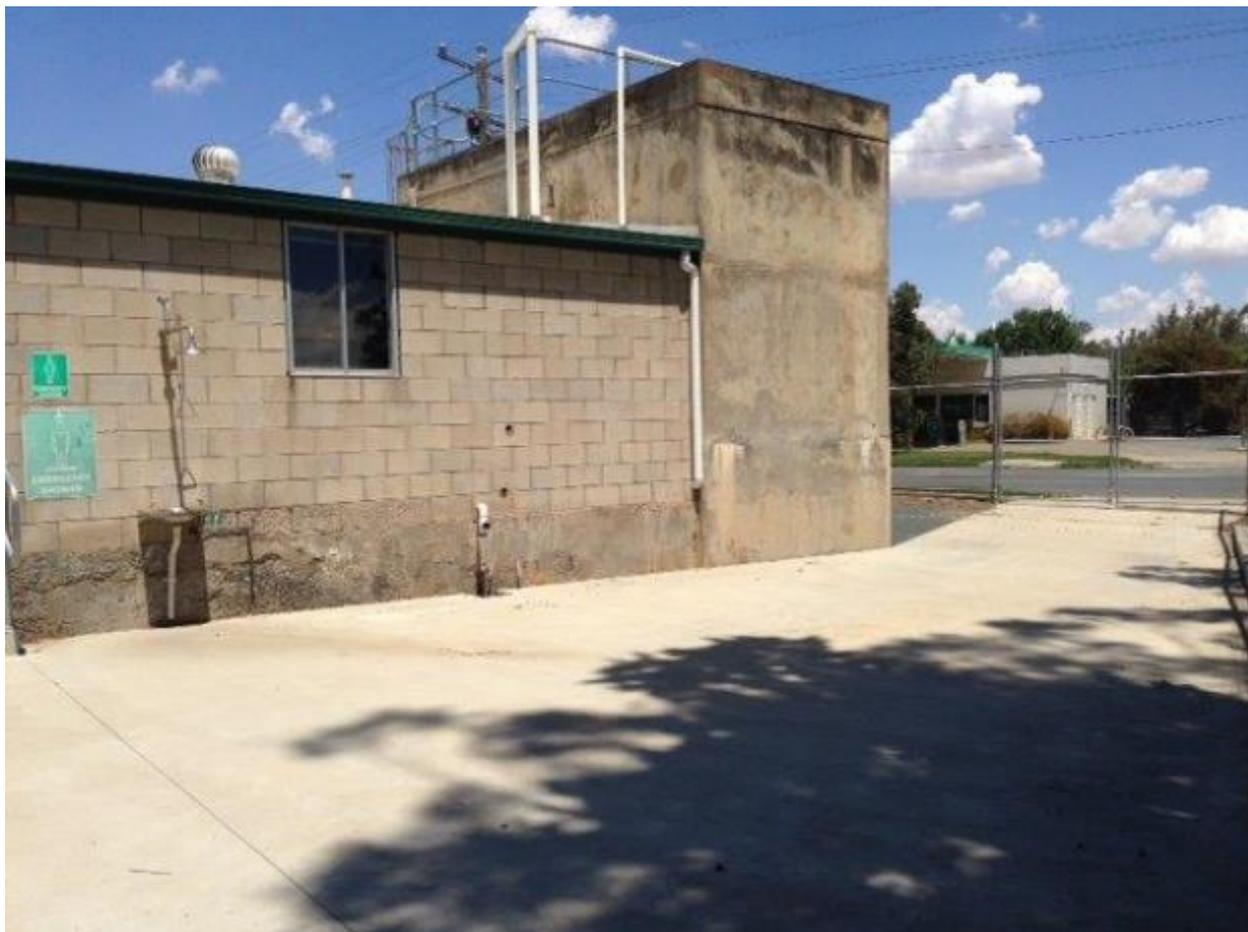
**Pump shed with concrete filters attached behind**

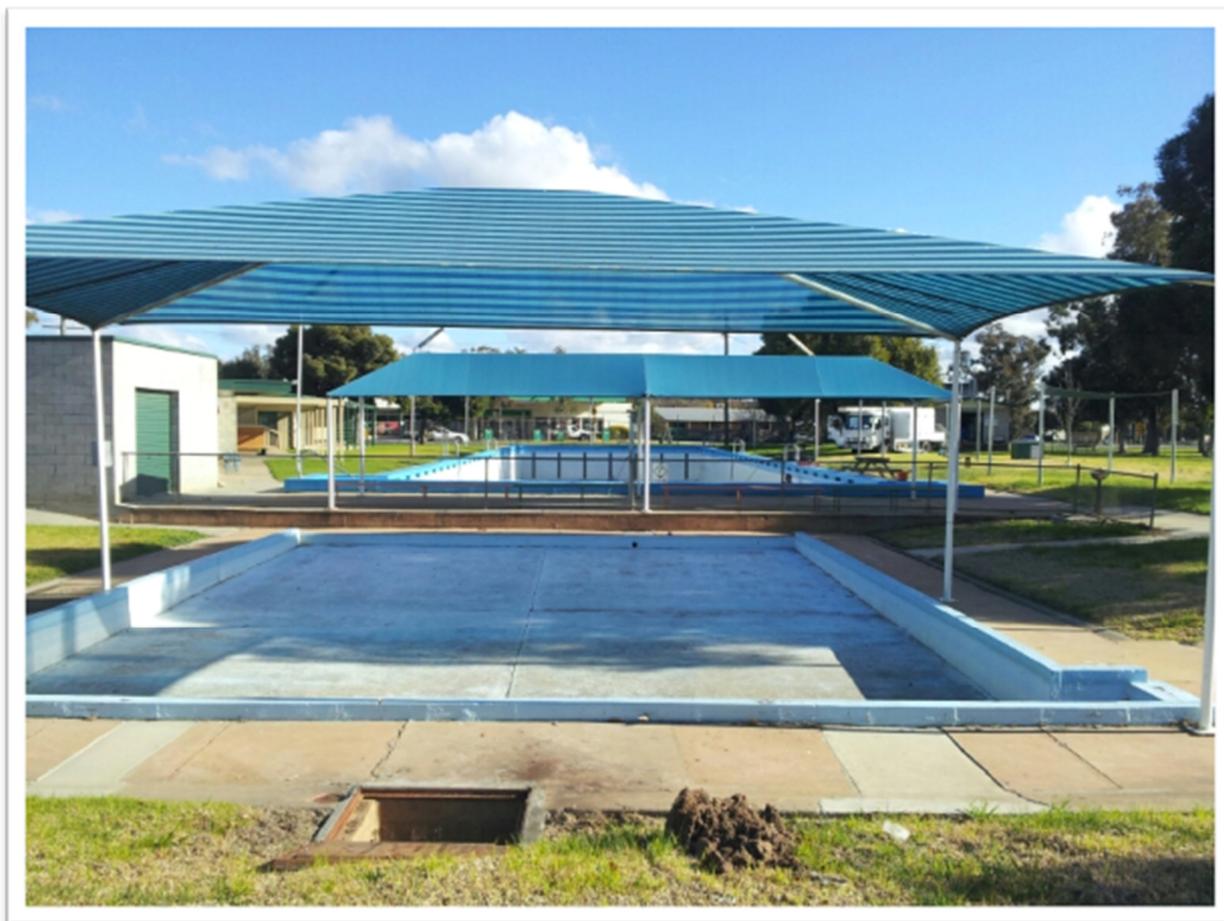
### **Rochester pool shade structures**

The shade structure over part of the wading pool is in average condition with less than 10 years life left. The covers are in good condition with the shade covers needing replacement every 7-10 years.

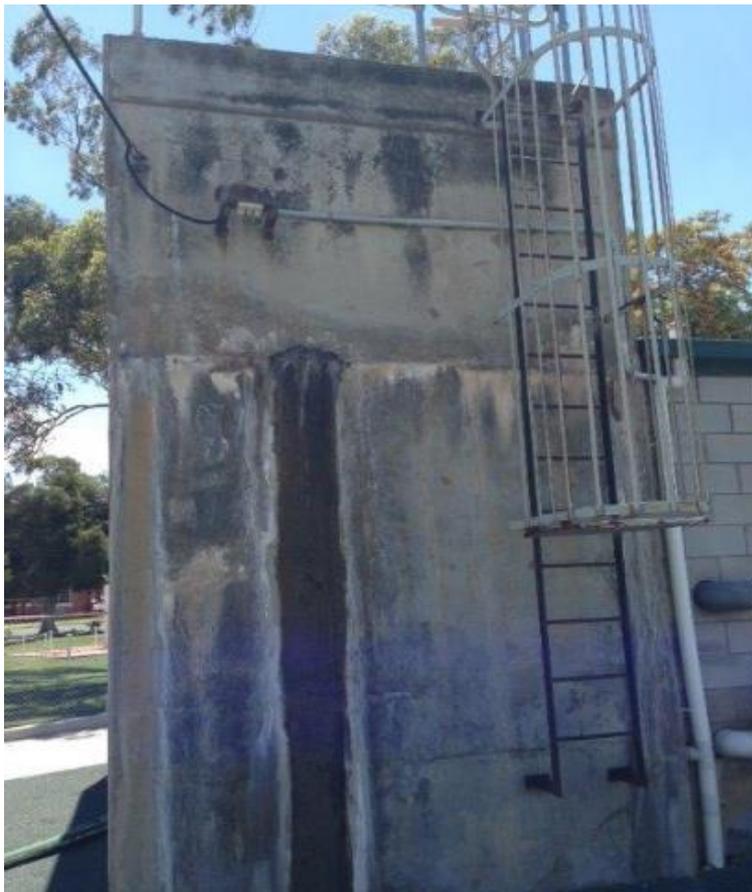
**Concrete twin cell gravity filters**

Filtering is provided through 2 x concrete twin cell gravity sand filters with an air scourer for backwashing. The concrete structure is in poor condition along with the inlet and outlet pipe work into the filters. They are at end of life and not suitable for a fully compliant new development.

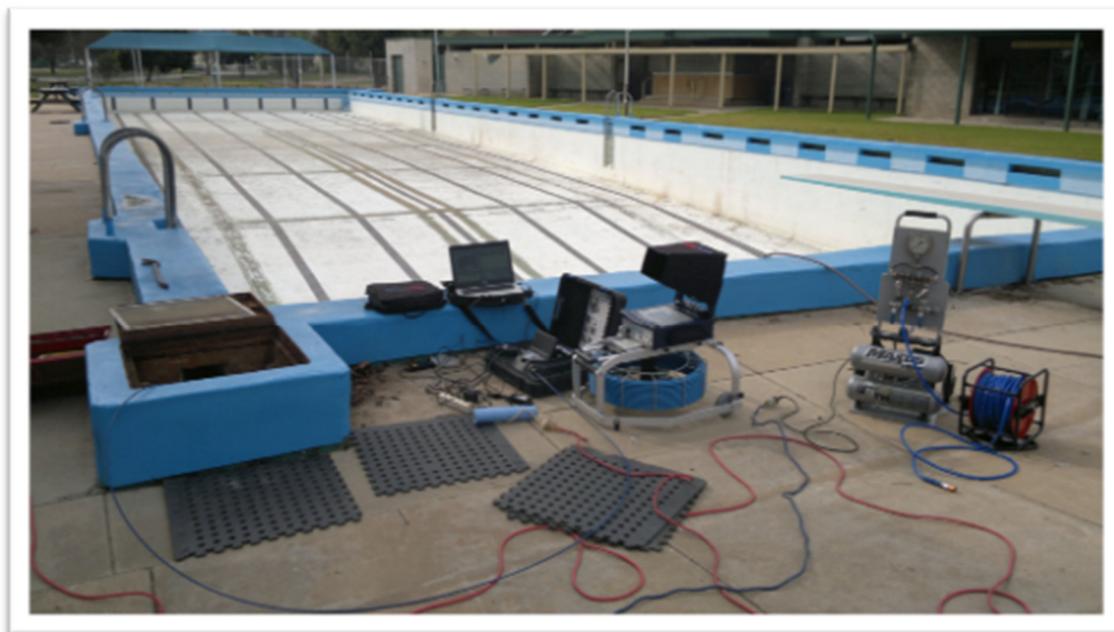
#### **Main pool noting skimmer boxes on sides & blue rubber protection over the raised edges**

The pool is constructed from reinforced concrete that is painted, ie no internal liner. It was constructed the 1950's. It is not recorded when it was last painted but it is estimated to be longer than 10 years and is listed for repaint in 2018/19 on a 7 year cycle. Melbourne Pools & Spa recommended installing a plastic liner in the main pool to overcome the issues identified in their report. These included water losses through cracking, holes and water stops. A more regular chalking and repaint program would maintain the current structure until a compliant facility is provided. This is a cost effective short term solution.

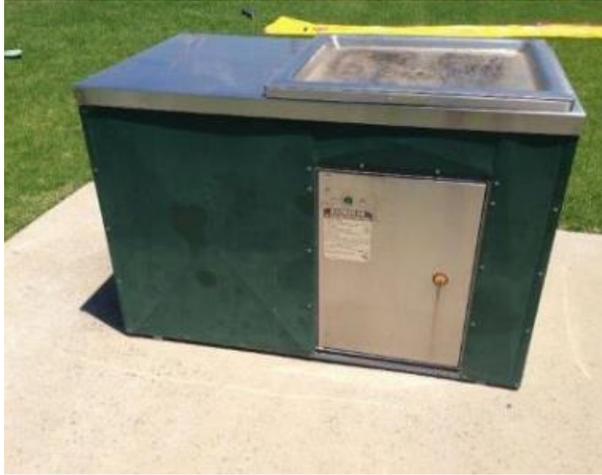
**Electric BBQ Rochester pool**

Electric BBQ is in very good condition suitable for reuse if the site is redeveloped. It would benefit from shade being provided over it.

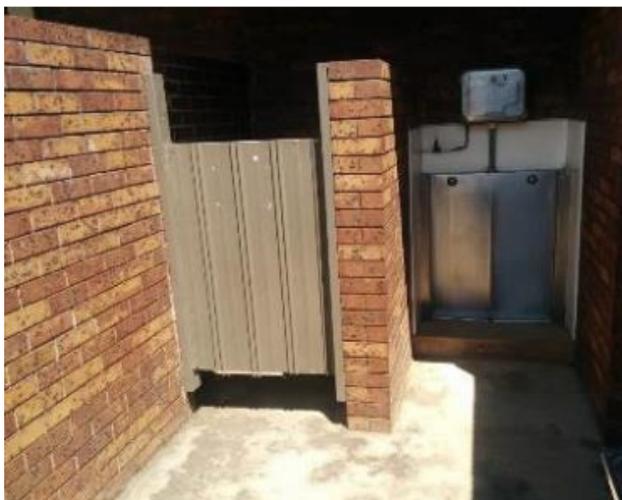
**Typical amenities fitout, Rushworth**

The amenities are constructed of brick and are open air. They are in an average condition and it is not economically viable to upgrade them to be DDA compliant. The facility requires a full basic refit.

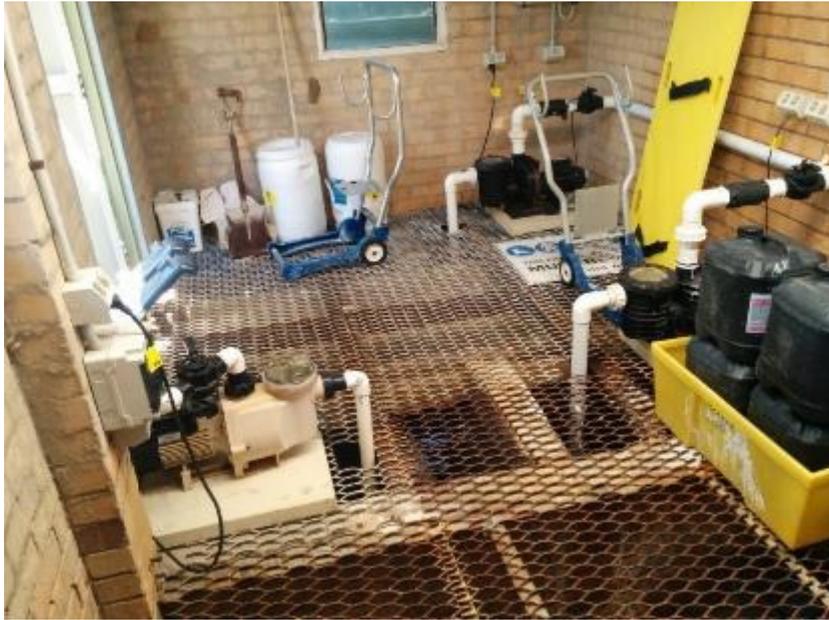
### **Pumps in brick plant room**

The main pool runs two Onga reticulation pump/motor sets with sieve baskets. They appear relatively new with a minimum of 10 years of life left.

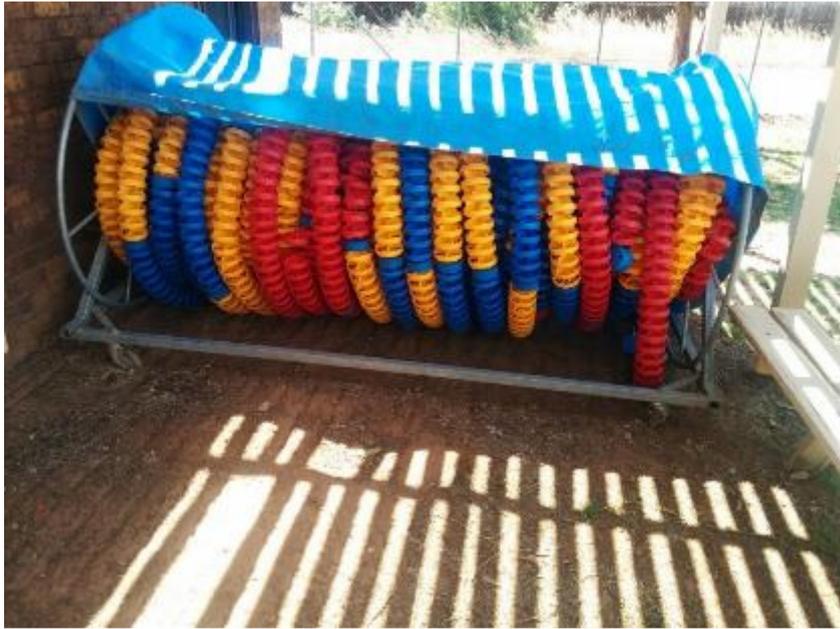
### **Roller & Lane ropes**

A galvanised roller with lanes ropes were identified. They are in good condition with lane ropes requiring replacement 7-10 years.

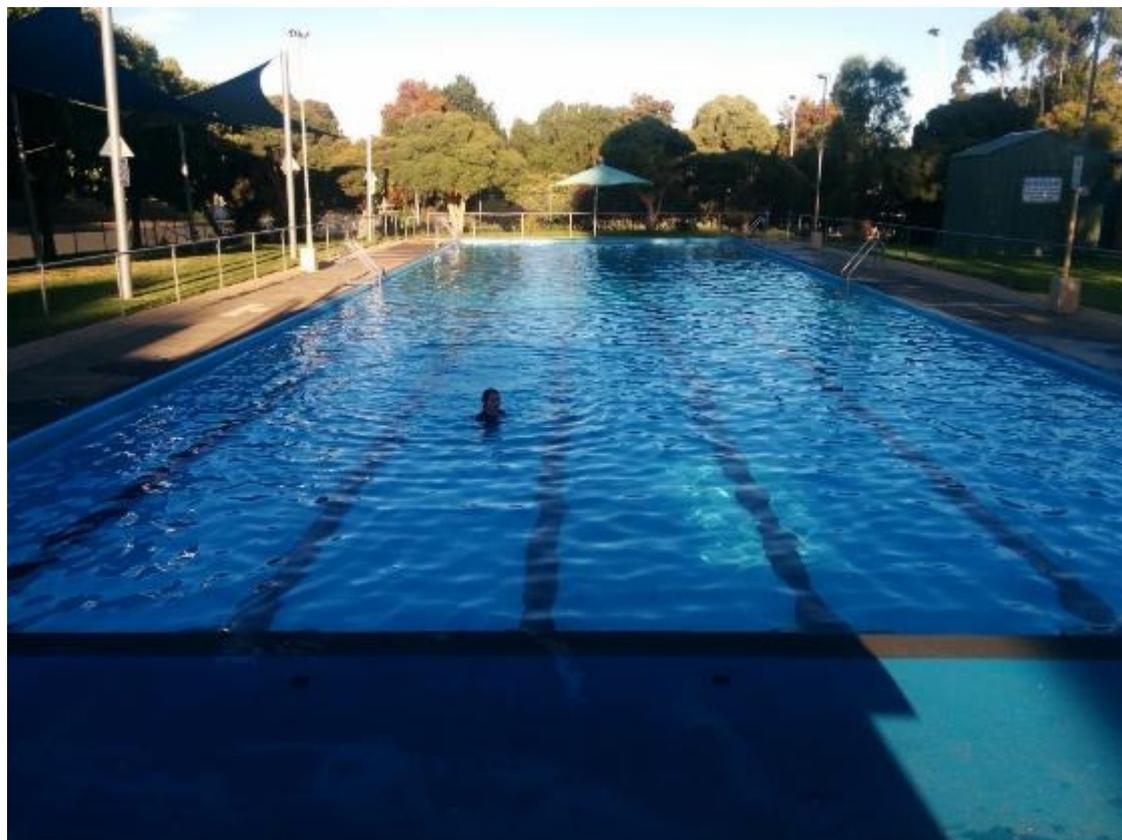
### **Main pool, Rushworth**

The pool is constructed from reinforced concrete that is painted, i.e. no internal liner. The pool was built in the 1930's. There is no record of when it was last repainted, but it was repainted prior to the current season. It is listed for repaint in 2024/25 on a 7 year cycle.

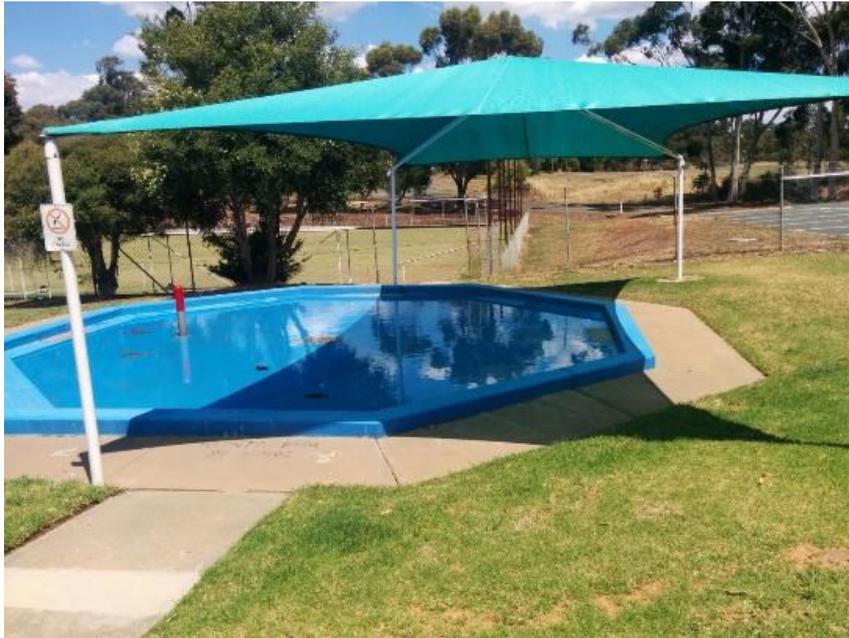
### **Wading pool octagonal shape with water feature and shade cover over part of the pool**

The octagonal wading pool is approximately 7m wide. The pool is constructed from reinforced concrete. The pool has had a fibre glass coating installed, although no record of the date was available.

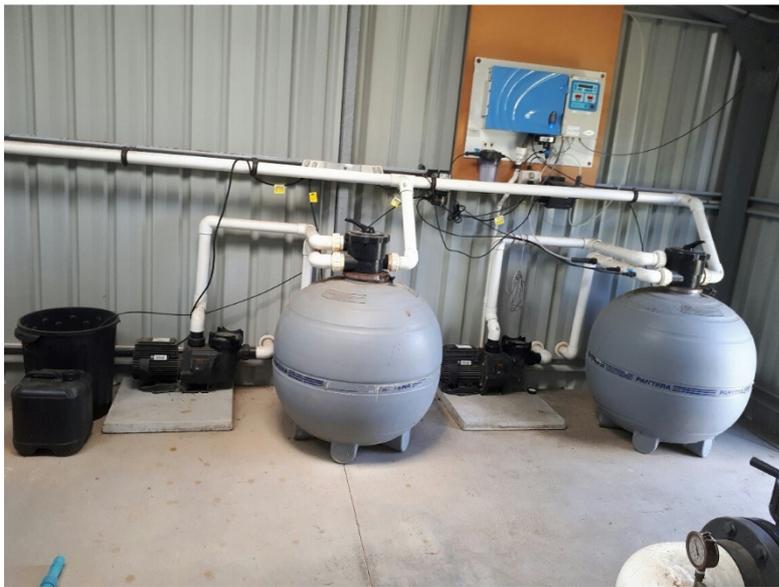
**Plant room with chemical controller, dosing pumps & toddlers pool filters.**

Filtering is provided to the main & wading pools through four vertical filter cells located in the plant room. They appear in good condition and their capacity were not assessed.

Filtering is provided to the toddler's pool through two vertical sand filters located in the plant room. They appear in good condition and their capacity was not assessed.

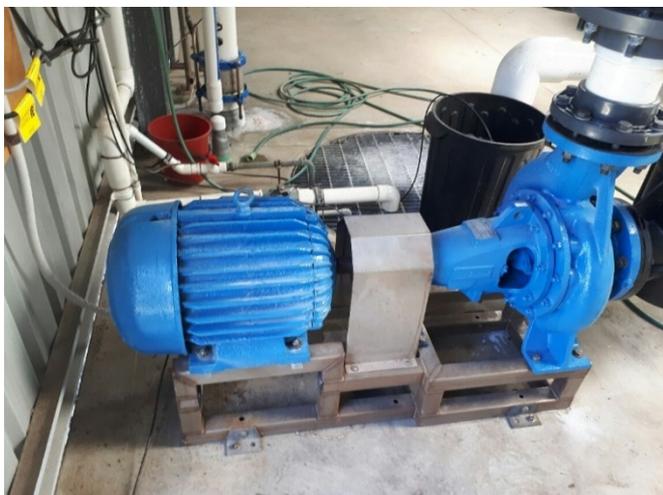
### **The main/learners pool runs an Ajax Elite reticulation pump/motor set.**

The main/learners pump set appears to have been refurbished in recent years with 5-10 years life left.

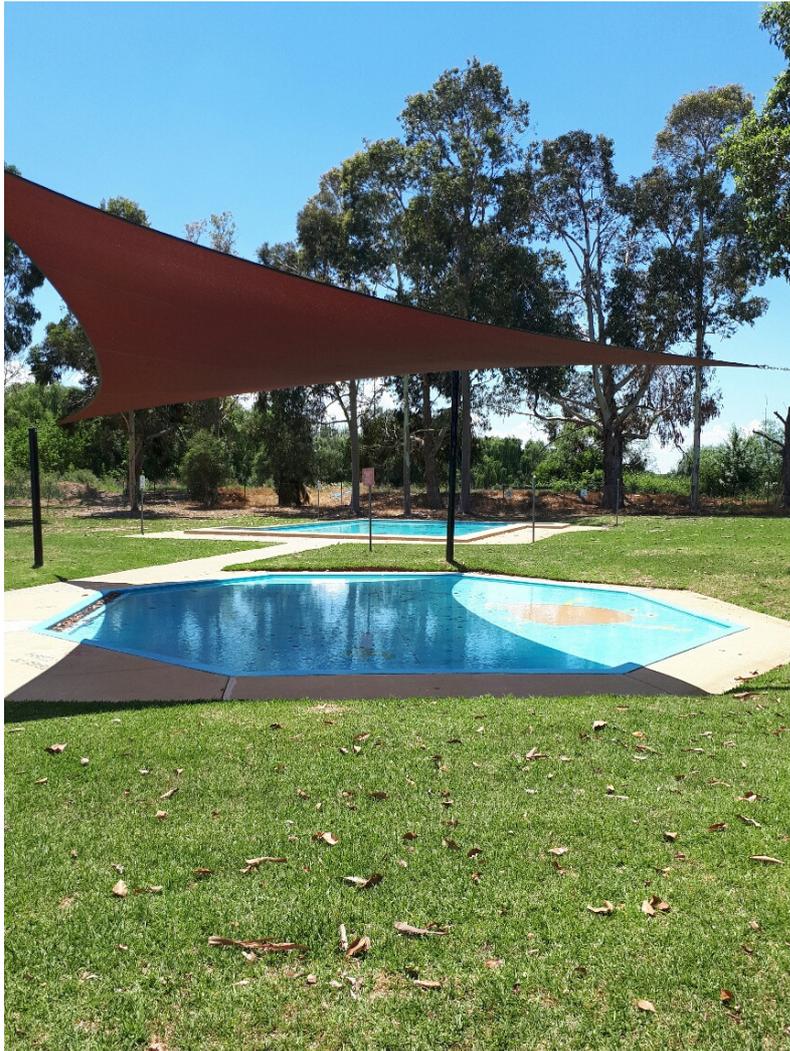
**Toddlers pool with learners pool in background.**

The learners pool is 8m x 8m and is constructed from reinforced concrete. The pool has a raised pebblecrete lip and concrete surrounds that are in good condition. It was repainted in 2016.

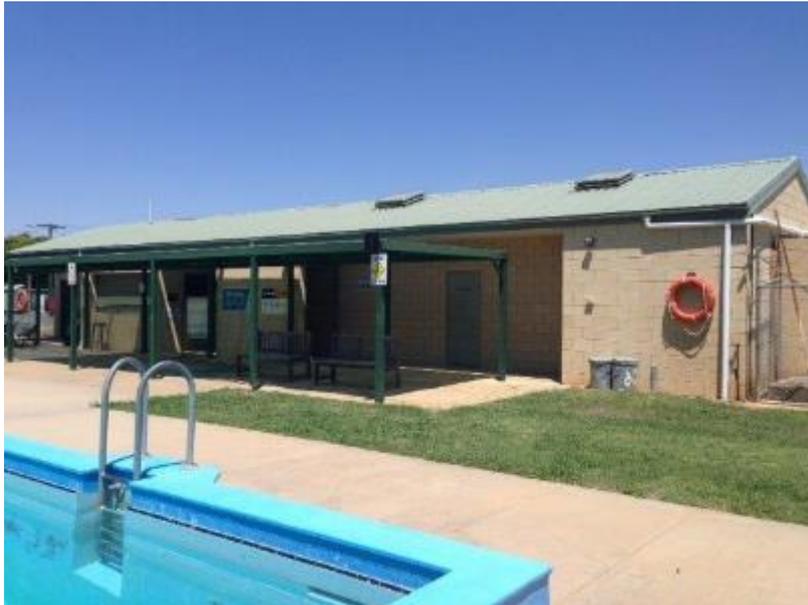
Kiosk & amenities building

The amenities/kiosk is constructed of concrete block with a steel roof. The general store and kiosk are on the southern end with amenities on the northern end. Structurally they are in very good condition but could benefit from a refit. Although not DDA compliant they could be upgraded to meet compliance.

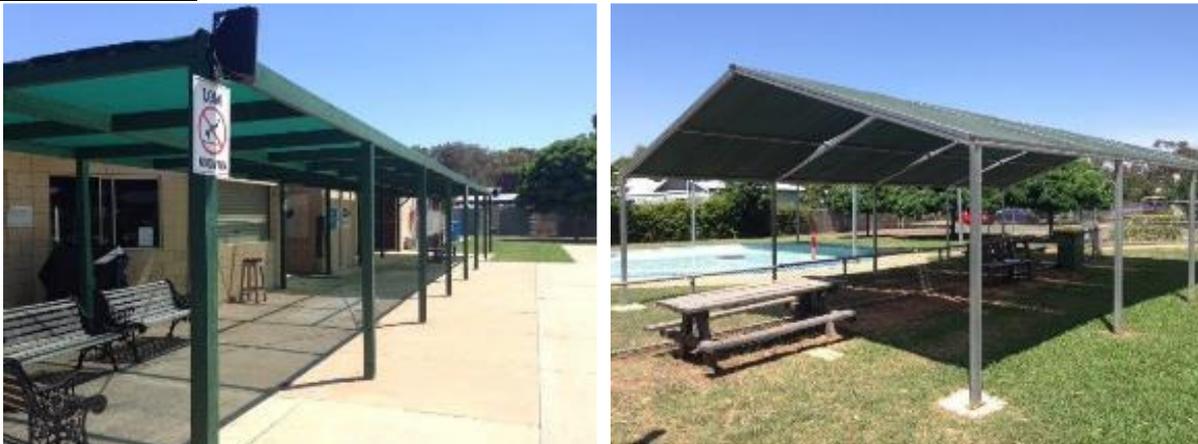
**Shade covers in front of kiosk and between main and wading pool**

There are seven shade structures in the complex with 6 shade covers. The structures are in very good condition along with the remaining covers generally in good condition. Covers will need replacement every 7-10 years.

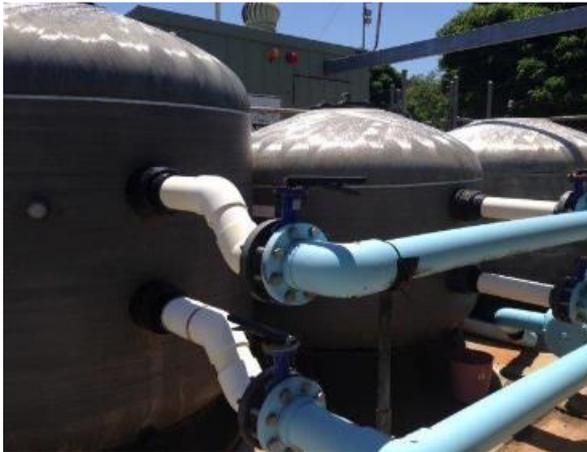
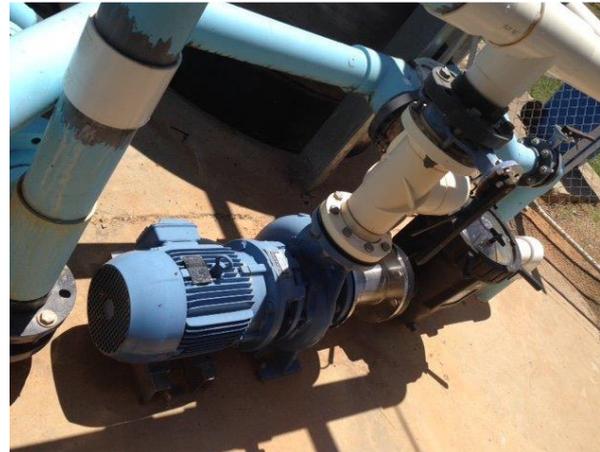
**Filter & plumbing in the open air.**

**Reticulation pump/motor set & strainer open air.**

Filtering is provided through three vertical filter cells located in the open air. The filters are showing the effects of not being covered and have a life of 5-10 years. Their capacity was not assessed. It has not been recorded if works recommended by GH&D to repair and recertify the vessels has been carried out.

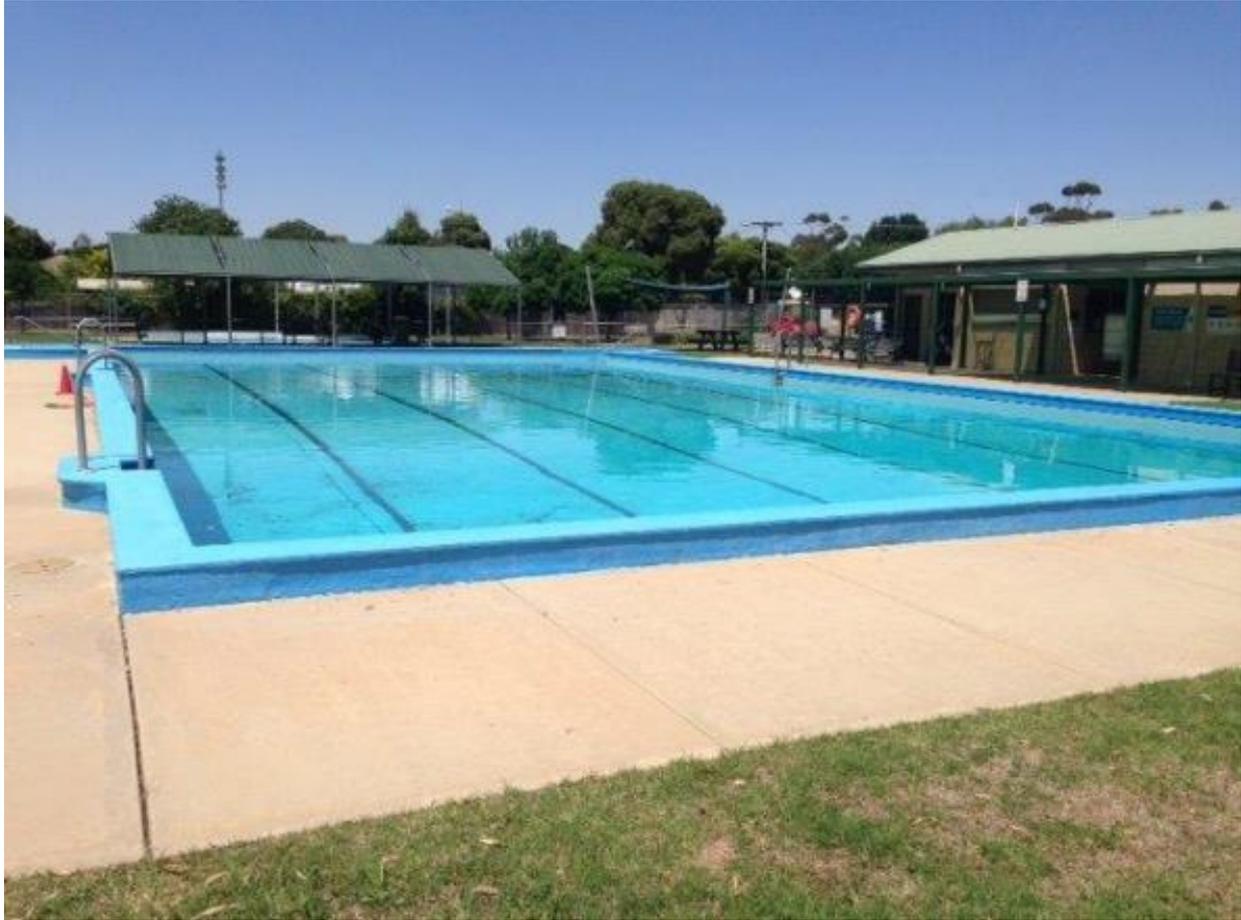
**Lockington main pool**

The pool is constructed from reinforced concrete that is painted, ie no internal liner. The pool was built in 1967. There is no record of when it was last repainted, but it is listed for repaint in 2019/20 and then on a 7 year cycle.

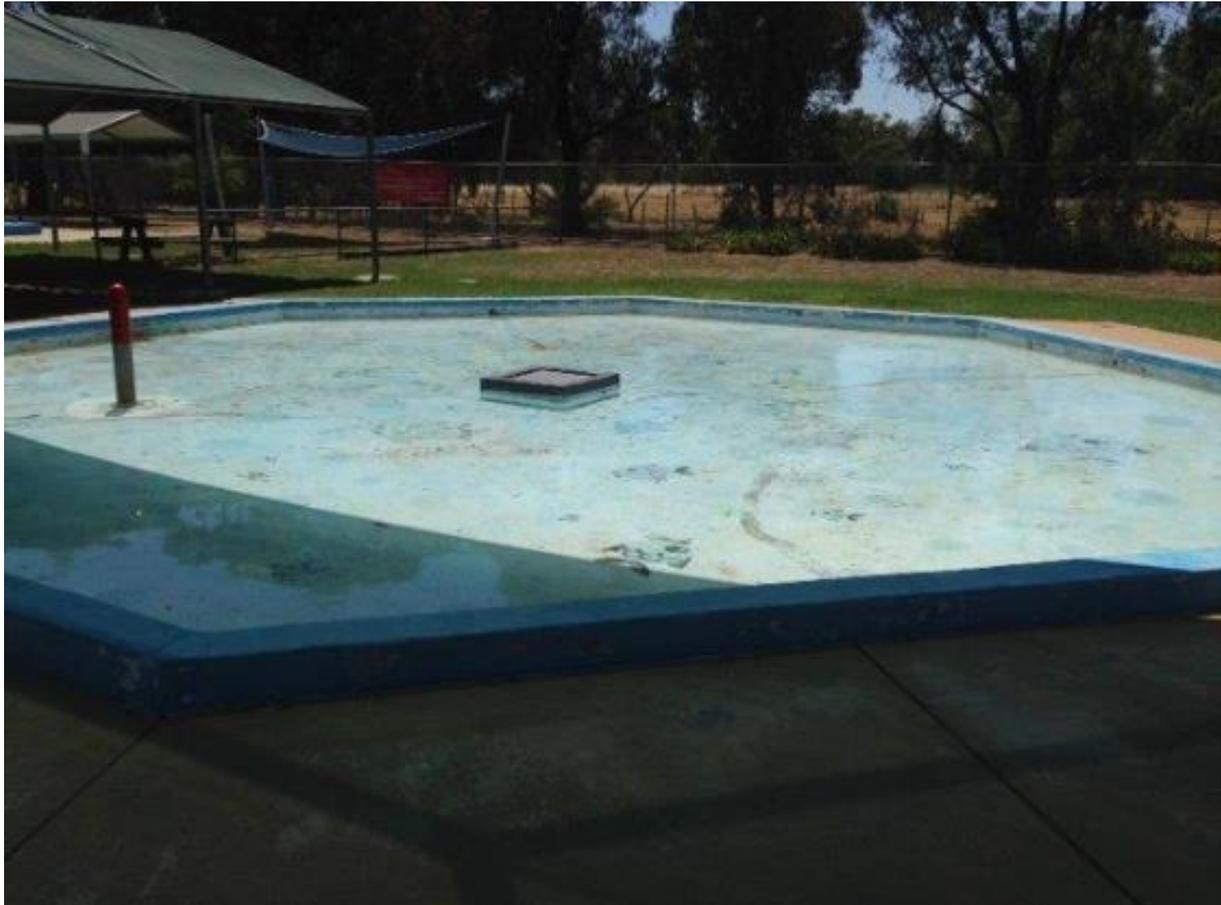
### **Wading pool octagonal shape with water feature**

The octagonal wading pool is approximately 8m wide. The pool was constructed in 1967 and is constructed with reinforced concrete. There is no record of when it was repainted but it is listed for repaint in 2019/20 and then on a 7 year cycle.

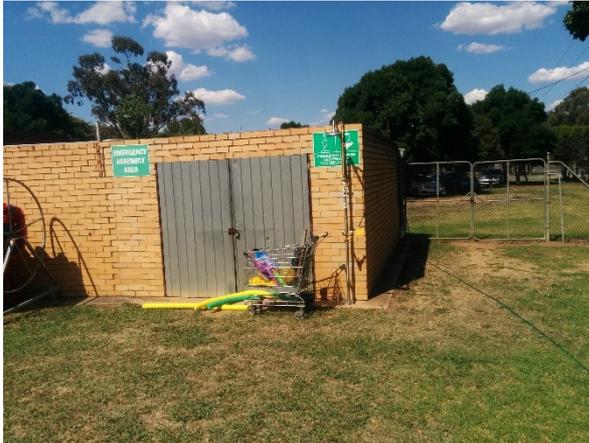
**Dry chemical store off end of male amenities**

Dry chemicals are stored on 2 bunded plastic pallets in a brick building with a steel roof off the end of the men's amenities. Appropriate eye/body wash shower is in place and appears in good condition.

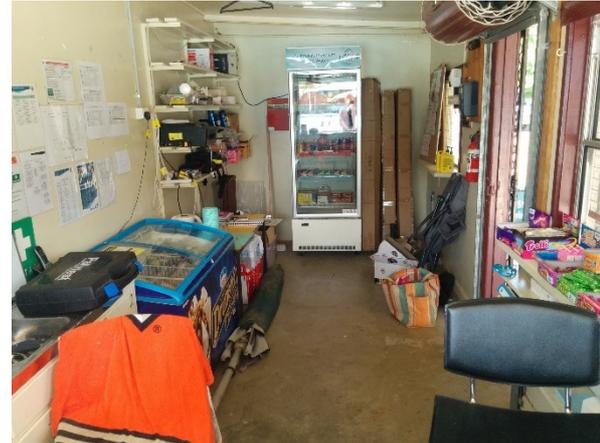
**Internal fit out of kiosk**

The kiosk is constructed of brick with a steel frame and an iron roof. The building is approaching end of life and is in an average condition. It requires a full refit to be fit form purpose.

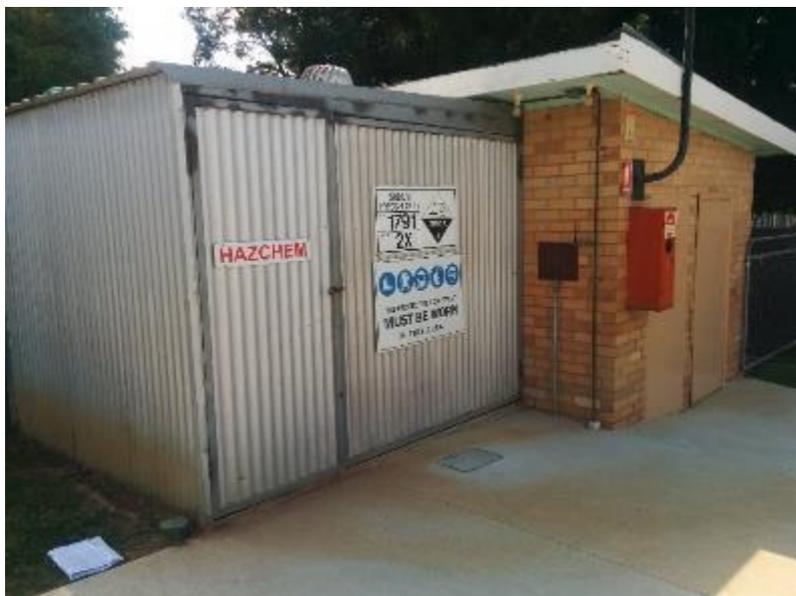
The plant room is constructed of brick with a steel roof and is used for pumping equipment only. The building is approaching end of life and requires a full rebuild similar to Tongala to overcome WPH&S issues. It needs renewing in the next 5-10 years.

**Sodium Hypochlorite Shed and Plant Room**

Sodium Hypochlorite is stored in a special plastic tank on a bund in a galvanised iron shed adjoining the plant room. The structure is in good condition. Appropriate eye/body wash shower adjacent to the hypo fill point is in place and appears in good condition.

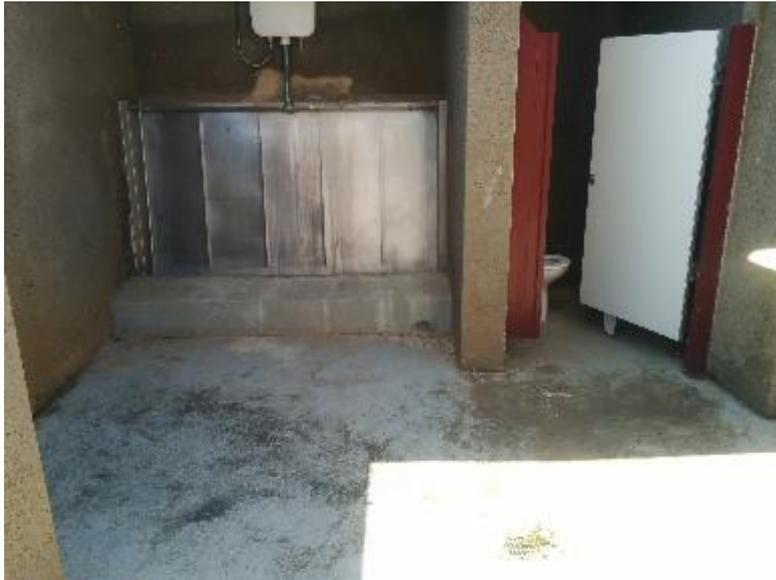
**Typical standard of amenities**

The amenities are constructed of brick and are open air. They are approaching end of life and are in an average condition. It is not economically viable to upgrade them to be DDA compliant. The facility requires a full basic refit to be fit for purpose.

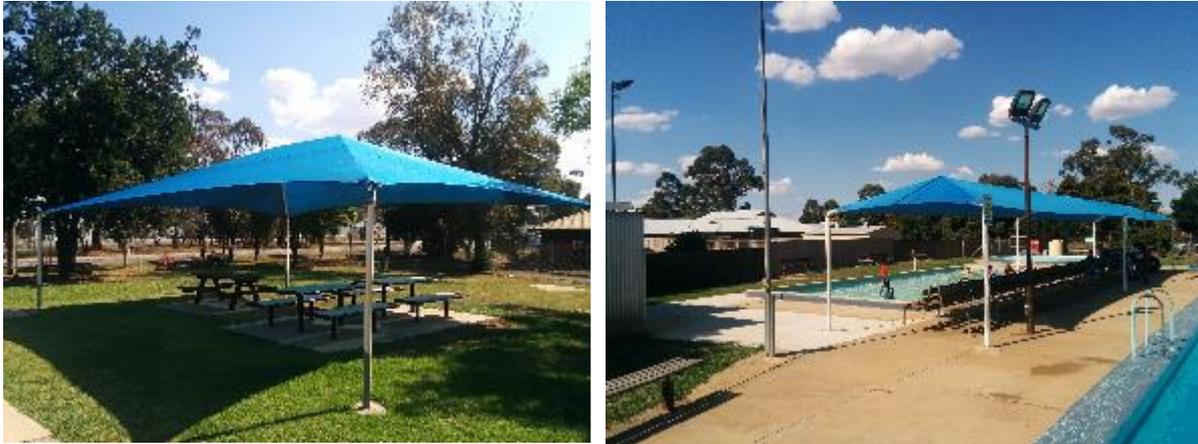
**Shade structures at Stanhope Pool**

The shade structure and cover between the wading pool and main pool is in a good condition. The structure is painted steel that needs regular maintenance. The cover is in good condition with covers needing replacement every 7-10 years.

The other shade structure is over the 3 table sets and is in good condition. The structure is painted steel that needs regular maintenance. The cover is in good condition with covers needing replacement every 7-10 years.

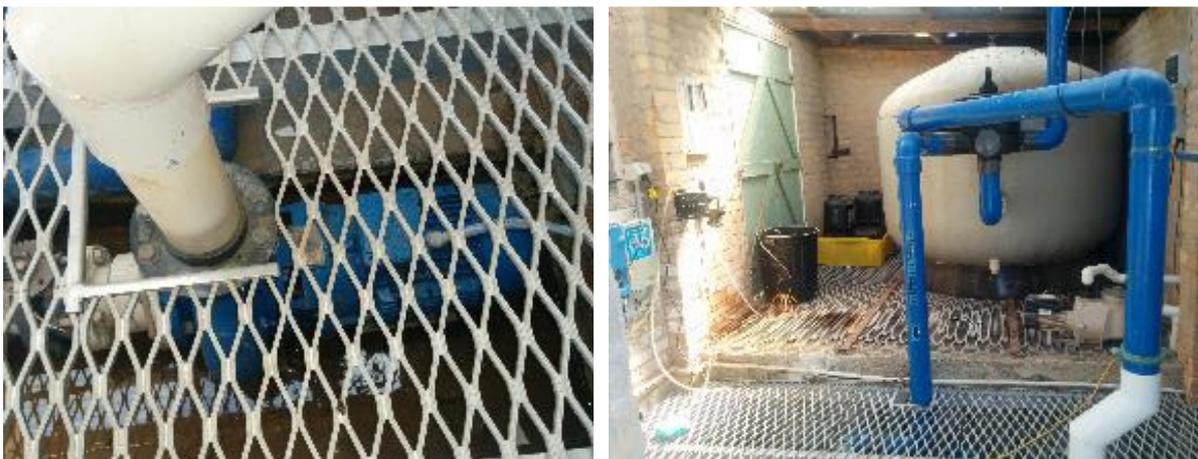
**Reticulation pump & motor set under grate with filter cell in plant room**

The main pool runs an Aquaplug reticulation pump/motor set located under the floor grate in the pump shed. It appears in relatively good condition with a minimum of 10 years of life left.

GH&D Report in 2016 advised of significant corrosion to the pipe work and valves for the water reticulation and back wash system. Recommend this be investigated and repaired as necessary.

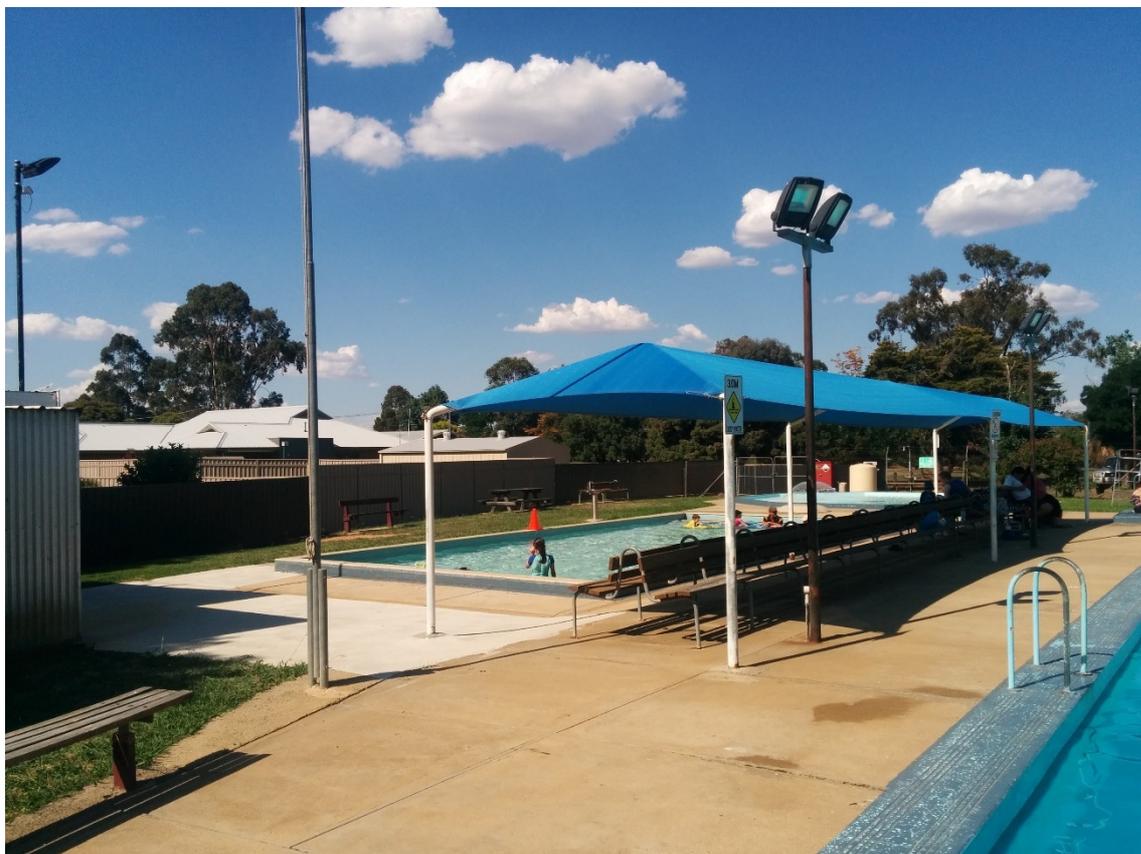
**Wading pool**

The wading pool is approximately 10m long and 4m wide. The pool was constructed in 1984 from reinforced concrete. The pool was last repainted in 2013 and is listed for repaint in 2020/21 on a 7 year cycle.

The option to modify this structure to form part of an interactive water play area to meet Council's new service standard would require detailed engineering inspection and testing to determine its suitability.

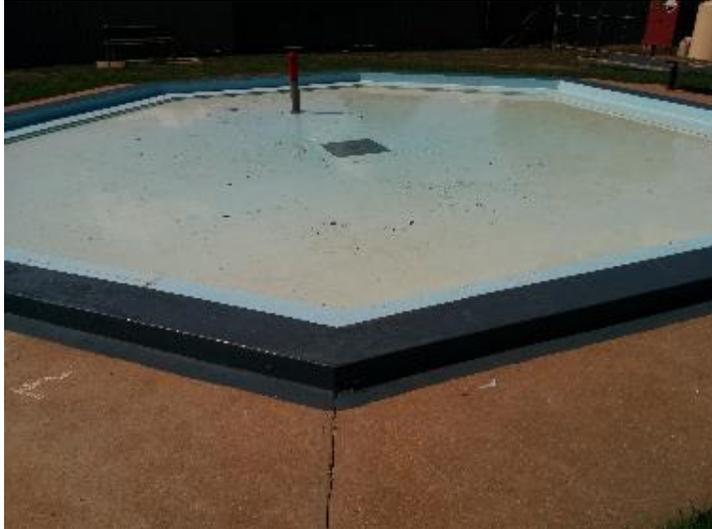
### **Toddlers pool**

The octagonal wading pool is approximately 7m wide. The pool was constructed in 1984 from reinforced concrete. The pool was last repainted in 2013 and is listed for repaint in 2020/21 on a 7 year cycle.

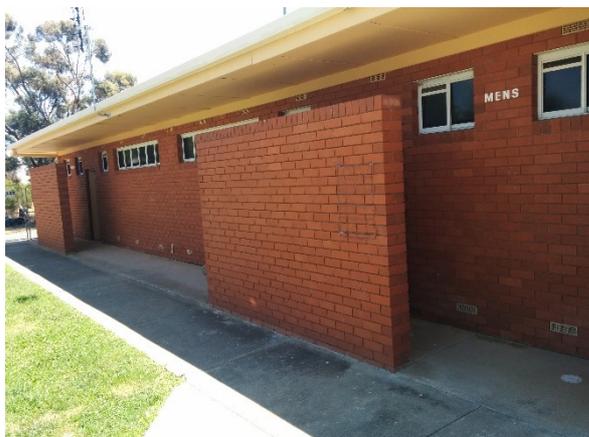
**Change rooms**

The amenities and kiosk are a part of the Colbinabbin Recreation Reserve main facility. It is constructed of brick with a steel roof. The structure is in very good condition. A small area within this facility is made available for pool use. The area is suitable but the fit out is in poor condition and not DDA compliant. The facility requires a full basic refit.
