# Shire of Campaspe

## Aquatic Facilities Report

### Asset Review, Condition Summary, Capital Works Program & Recommendations.

January 2018

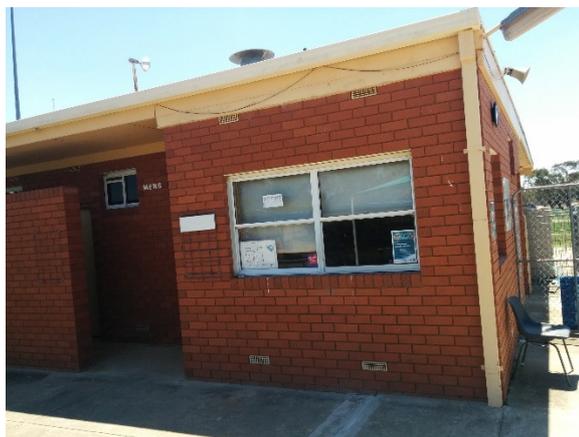
**Kiosk**

The amenities and kiosk are a part of the Colbinabbin Recreation Reserve main facility. It is constructed of brick with a steel roof. The structure is in very good condition. A small area within this facility is made available for pool use. The area is suitable but the fit out is in poor condition and not DDA compliant. The facility requires a full basic refit.

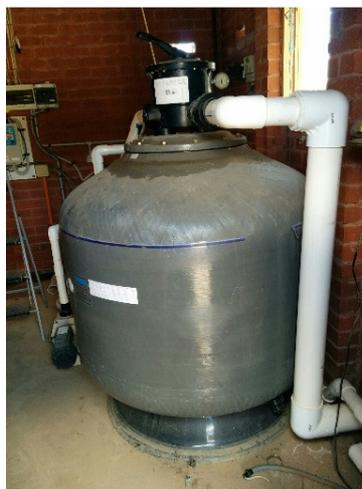
**Waterco filter in plant shed**

Filtering is provided through a single vertical filter cell located in the plant room. It appears in good condition. Its capacity was not assessed.

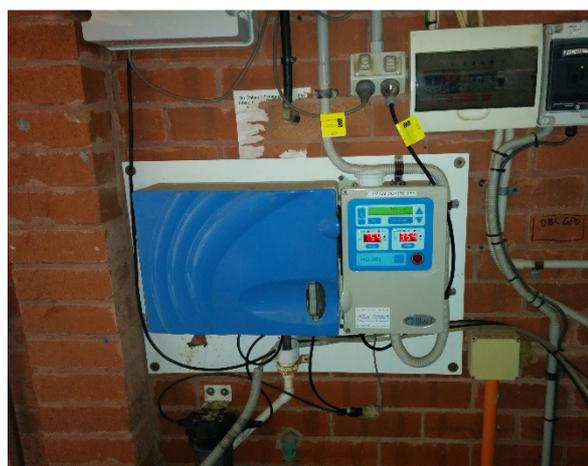
The Colbinabbin pool runs a chlorine/acid injection system through dosing pumps controlled by a Blue Chemical Controller HG302. The system is in good condition with the 2 dosing pumps requiring periodic maintenance/replacement.

**HG302 Chemical controller**

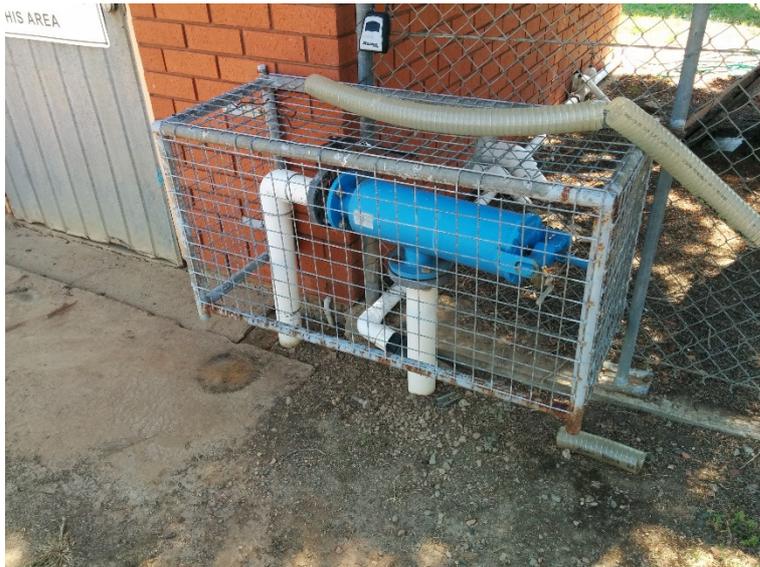
**Raw water strainer on plant shed**

A raw water strainer was identified on the wall of the pump shed. It appeared in good condition and not recorded in the Asset Register.

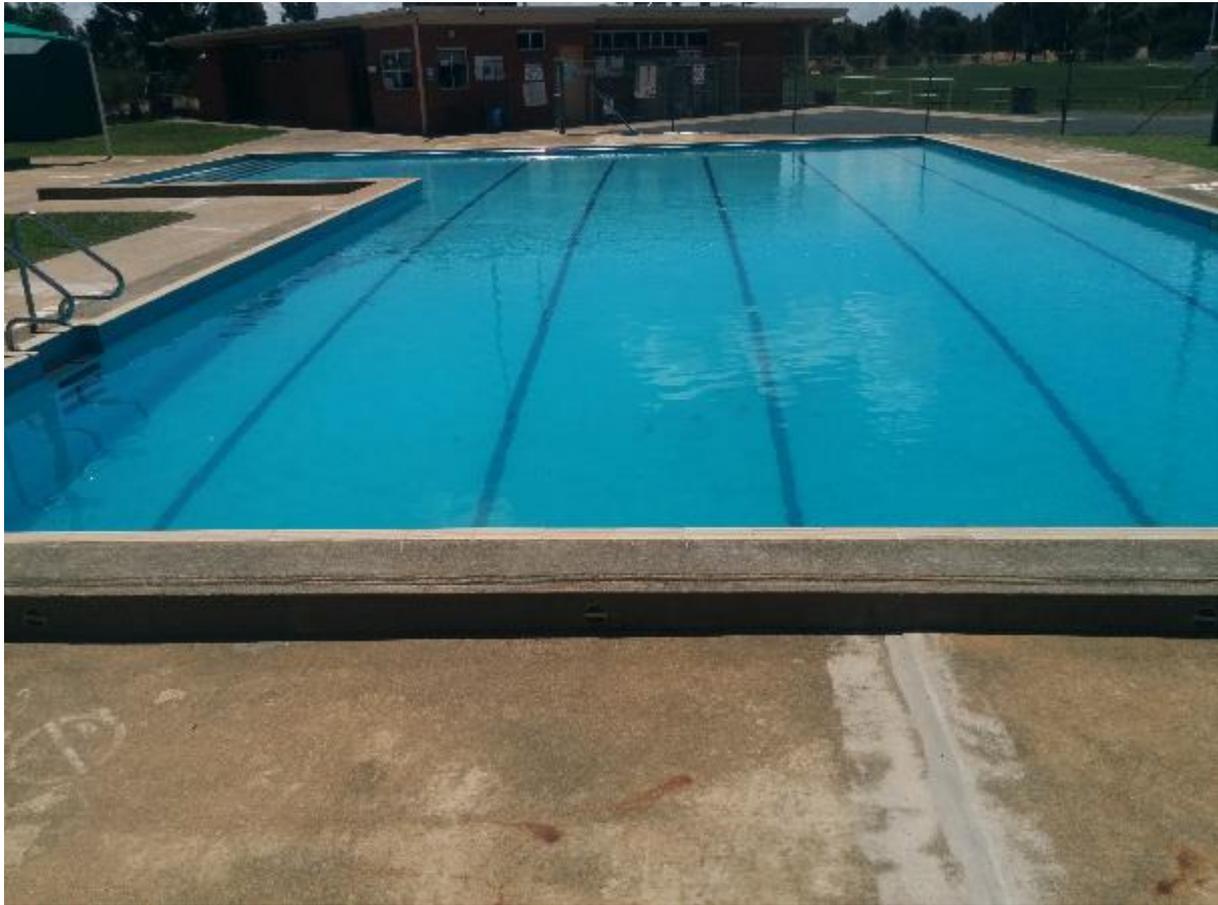
**Main pool**

The pool is constructed from reinforced concrete that is painted, ie no internal liner. The pool was built in the 1979. There is no record of when it was last repainted, but it listed for a repaint in 2019/20 on Councils 7 year cycle. It appears to be in good condition with no major cracking visible around the perimeter. No detailed technical inspection records are available.

The pool does not have any DDA access. This may be overcome by providing a mobile lift.

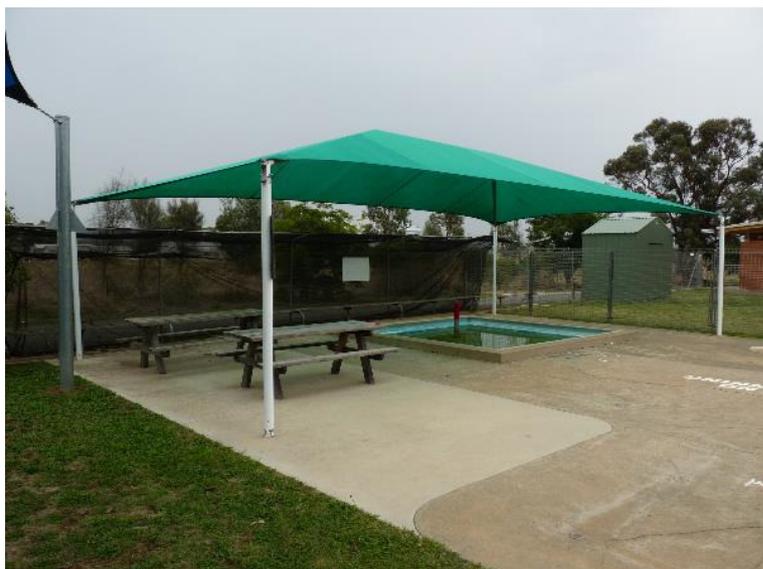
### **Wading pool with shade cover and table sets**

The wading pool is approximately 4m x 4m and was constructed 1979 from reinforced concrete. It is not recorded when it was repainted but it is due for a recalk and repaint in 2019/20 in Councils pool repaint program.
